## MEMORANDUM

**RE:** Select Beach Observations August 10, 2026

This memorandum is in response to Lisa Batchelor's request to perform select beach observations. Lee County staff had reported that there was erosion occurring at several locations, with some reference to the two (2) terminal groins. For purposes of this observation, the conditions at Redfish Pass groin, Blind Pass groin, and Jensen's Resort were observed. The conditions are described in the following sections.

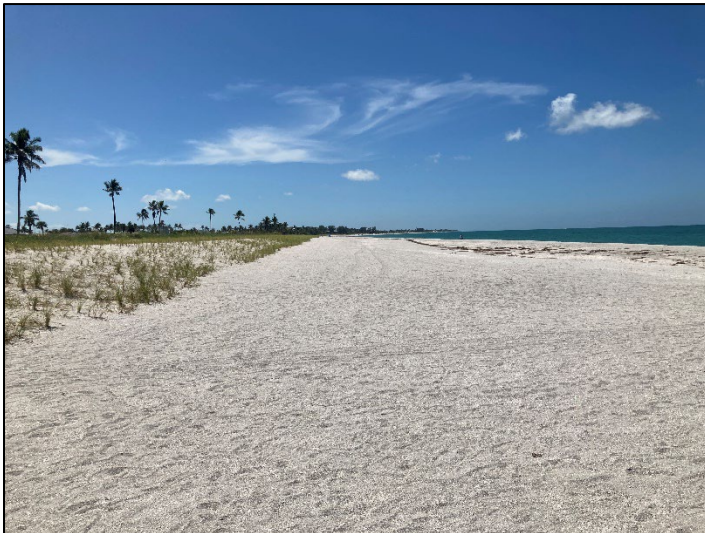
with the majority of the sand bypassing around the seaward side of the structure. The beach berm appears to be appropriately elevated and wide along the northern end of the South Seas Plantation (Figure 1). No significant loss of beach width has occurred. Therefore, the groin is functioning as intended.

*Figure 1. South view of the dune toe and the berm from the Redfish Pass groin.*

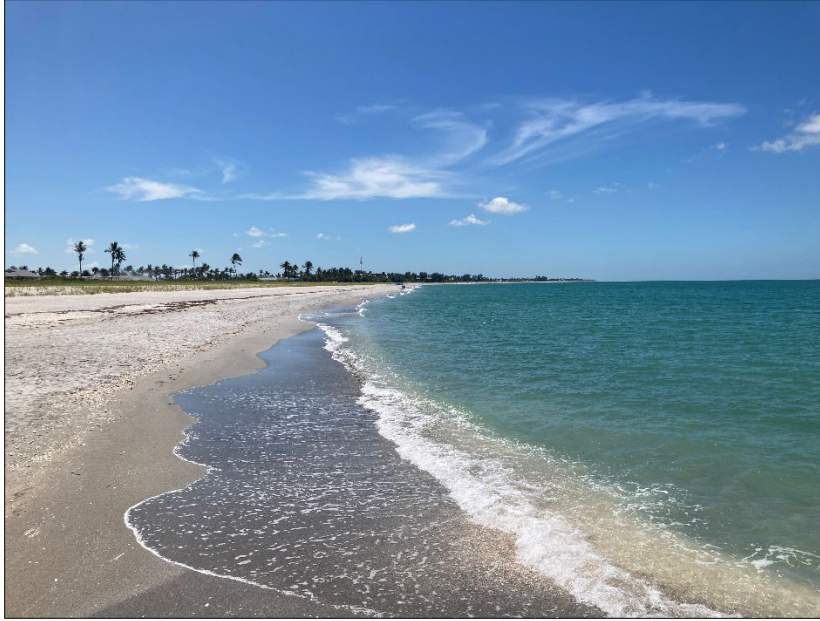
*Figure 2. Southview of the beach from the Redfish Pass groin near the mean high water line.*

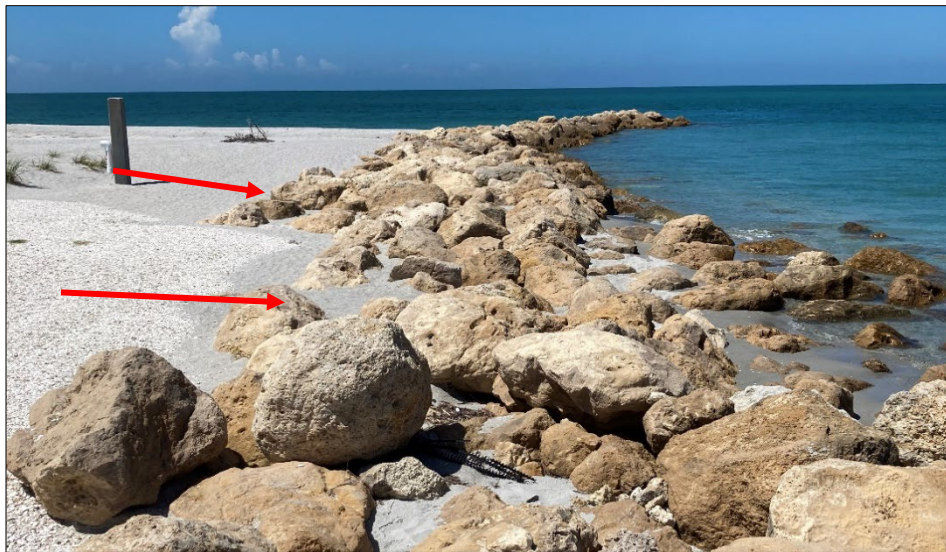
Observations of the landward end of the groin indicate that the crest of the structure is still above the elevation of the beach berm, with two small, localized depressions (small) at the landward end (Figures 3 and 4).

*Figure 3. West view of the Redfish Pass Groin with lower crest elevations identified.*

It is recommended that a topographic survey of the exposed portions of the structure be completed concurrent with the annual beach monitoring survey. Comparison to any as-built surveys and/or design plans should be performed to quantify structural changes.

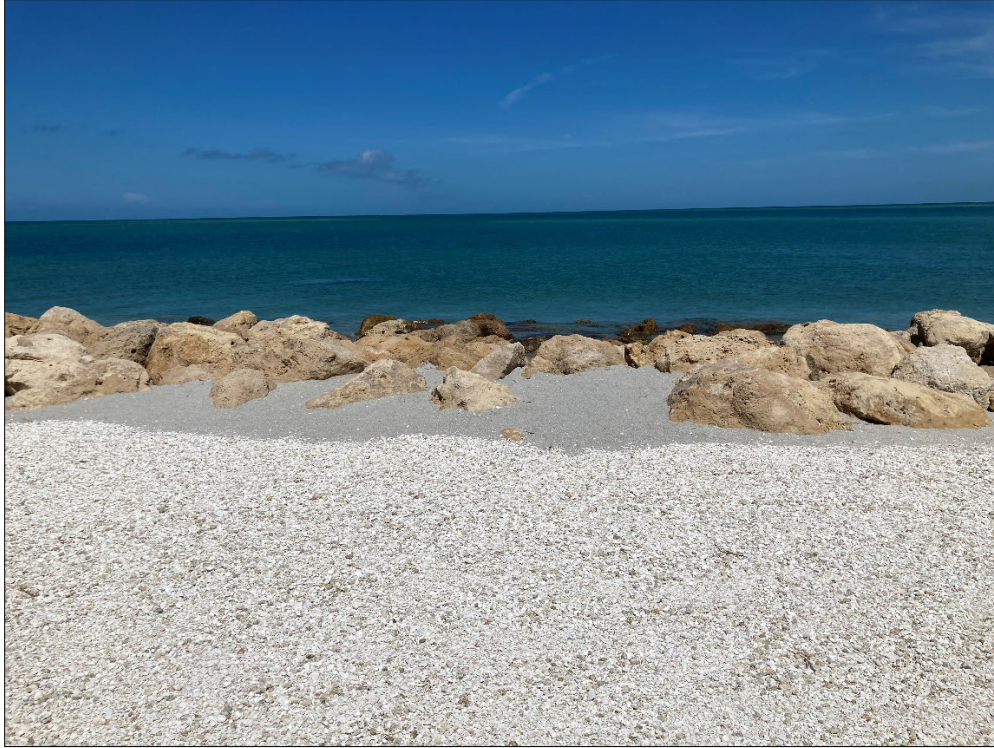
*Figure 4. North view of one of the small depressions in the groin.*

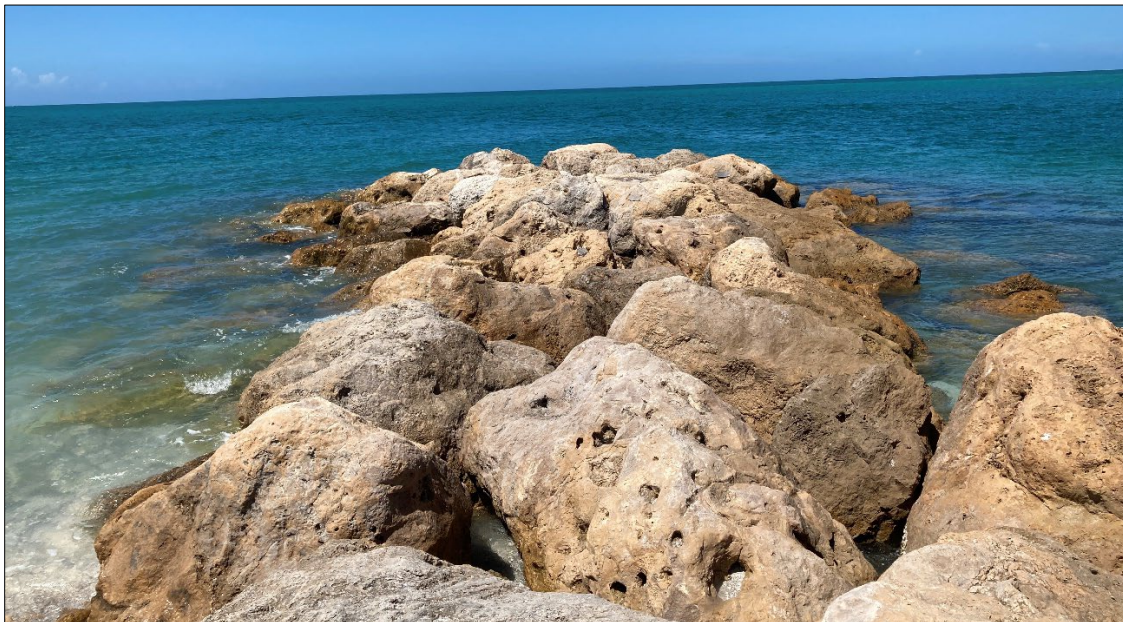
The seaward end of the structure remains a compact pile of interlocked stones, with the dimensions of the head of the structure (above the water) similar to the as-built widths. The end of the structure was constructed with flatter side slopes such that the footprint of the head of the structure is wider than the remainder of the structure (Figure 5).

*Figure 5. West view of the head of the groin at Redfish Pass.*

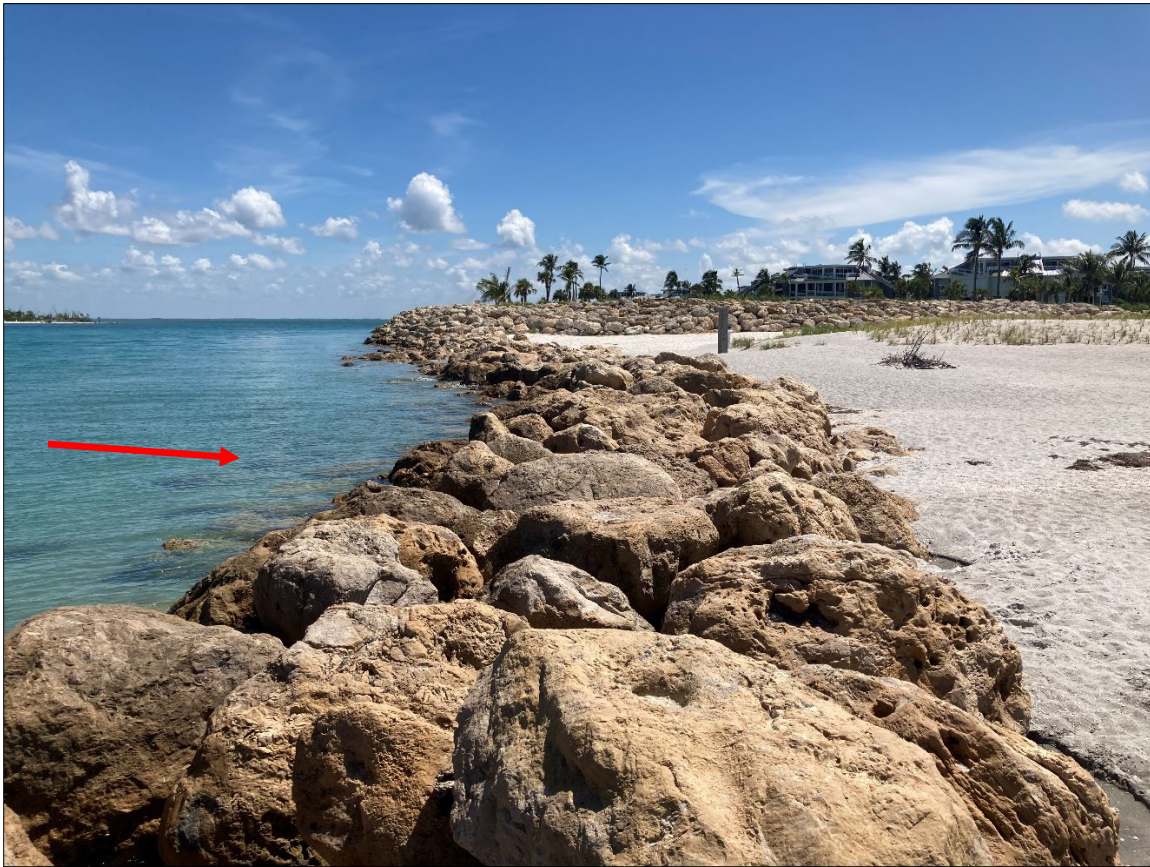
The north side of the structure is subject to wave action and tidal currents and thus more susceptible to scour and settlement. The transport of sand along the north side of the structure also prevents direct observation of the toe of the structure during any observation. Due to changes in alignment of the northside of the structure and randomly exposed stones, some settlement of the structure may have occurred over time (Figure 6).

*Figure 6. East view of the groin with randomly exposed stones on the northern side of the groin.*

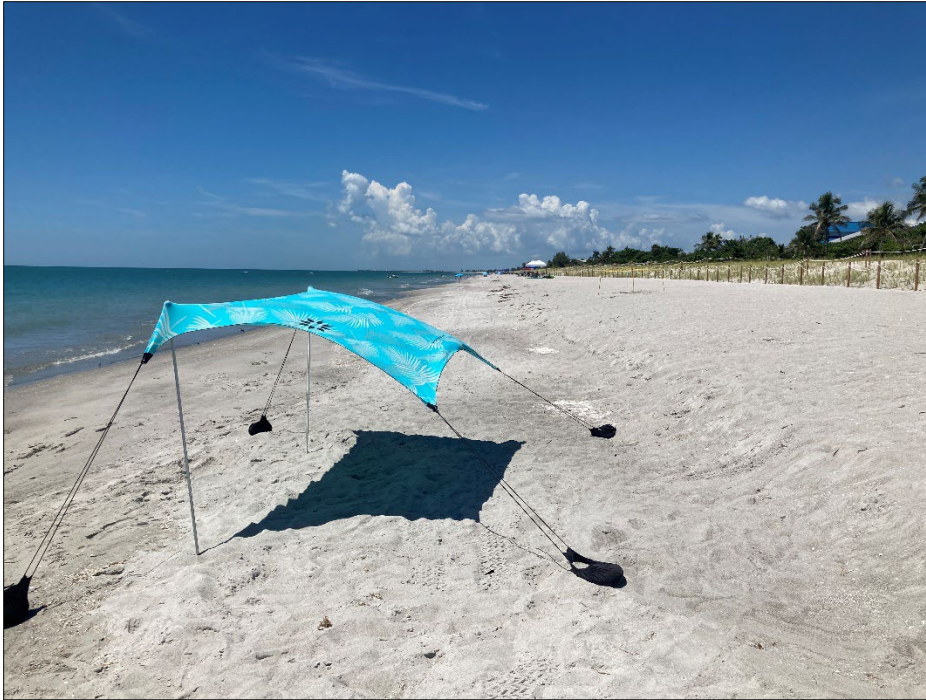
- a. The beach and dune system were observed from the public access at the curve in the road immediately adjacent to Jensen's Beach Resort. South of the access, the sloping beach berm has narrowed considerably and is scarped (Figure 7). The beach face is wide but low in elevation (Figure 8).

The area of erosional impact is a few hundred feet in length. The dune has not been impacted by erosion to date and remains the as-built width and cross section. This section of beach has been a historical area of higher-than-average erosion (a hot spot).

*Figure 7. North view from the beach access.*

The Board should continue to monitor this area through annual beach monitoring and direct observations. Comparison of the erosion rate with historic measurements is advised. Due to the erosion occurring in this area, reducing the investment in the proposed supplemental dune vegetation (north of the dune overwalk) along the first 500 feet is prudent.

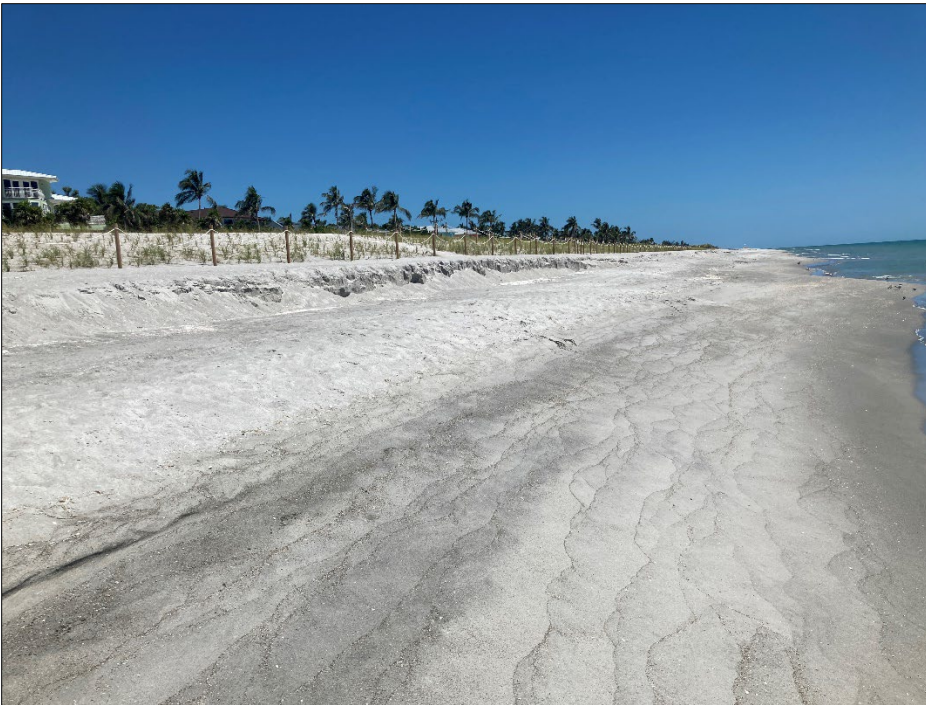
*Figure 8. South view from the beach access.*

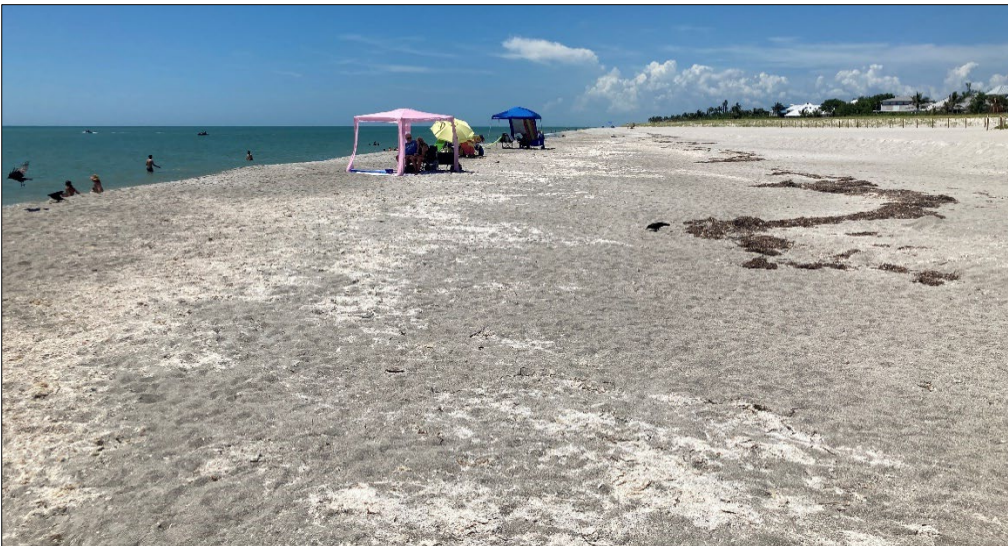
a. Function. The groin was designed to limit the loss of sand from the south end of the island, particularly in the southernmost 3,500 feet of island where the orientation bends slightly to the southeast. The majority of the sand is bypassing the groin around the seaward end of the structure. The beach berm appears to be appropriately elevated and wide north of the groin (Figure 9). No significant loss of beach width has occurred. Therefore, the groin is functioning

*Figure 9.  
Northwest  
view of the  
wide sand  
beach and  
dune  
immediately  
north of the  
Blind Pass  
terminal  
groin.*

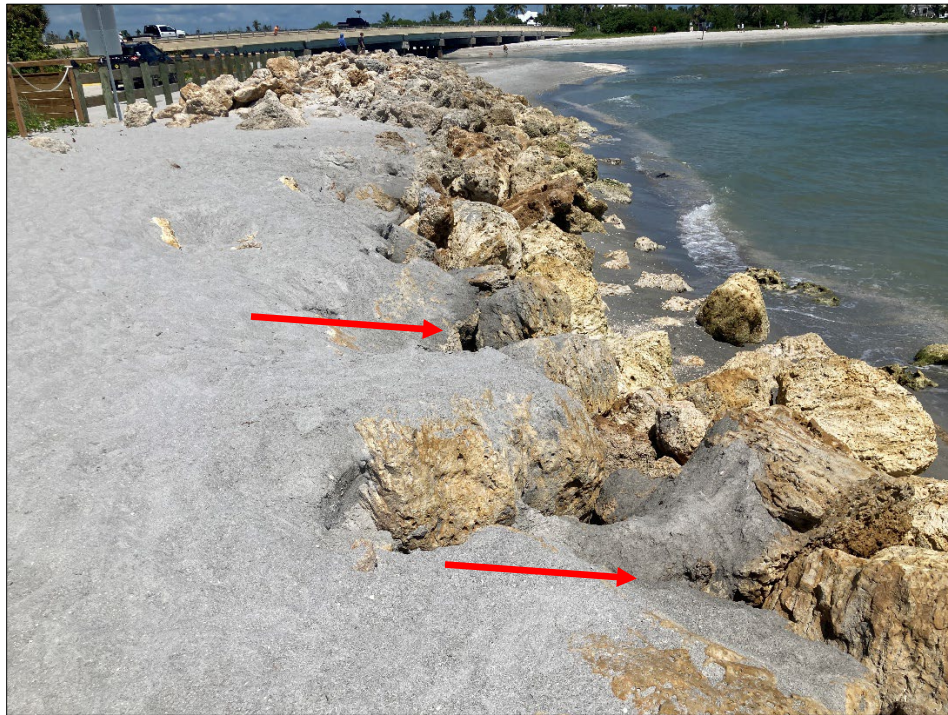
There are local settlements of some stones approximately 50 to 75 feet from the seaward end of the structure. This results in local loss of sand through or over the structure (Figure 10).

*Figure 10. Localized sand loss through or over the structure. There appears to be localized settlement of the stone.*

- c. Summary and Recommendations. Based on this brief observation, a preliminary rating of “Fair” is assigned to the terminal groin at Blind Pass (Appendix 1). The structure is performing well with some minor structural degradation.

It is recommended that a topographic survey of the exposed portions of the structure be completed concurrent with the annual beach monitoring survey. Comparison to any asbuilt surveys and or design plans should be performed to quantify the long term structural changes.

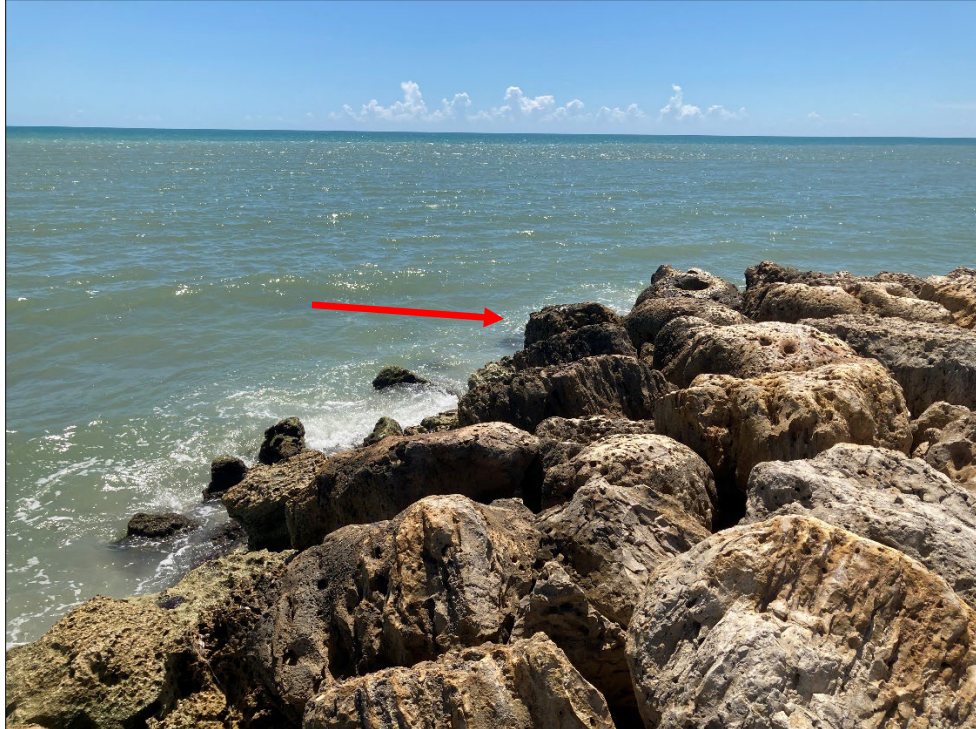
While there is a mass of stone on the seaward end of the structure, the south side slope appears to have steepened in a few locations as a result of select stone displacements (Figure 11).

*Figure 11. Southwest view of the seaward end of the Blind Pass terminal groin. Note the steep slope in some locations.*
