# Blind Pass Restoration Project

**Design Report  
May 2006**

**ECE**  
Erickson Consulting Engineers

# **BLIND PASS RESTORATION PROJECT DESIGN REPORT**

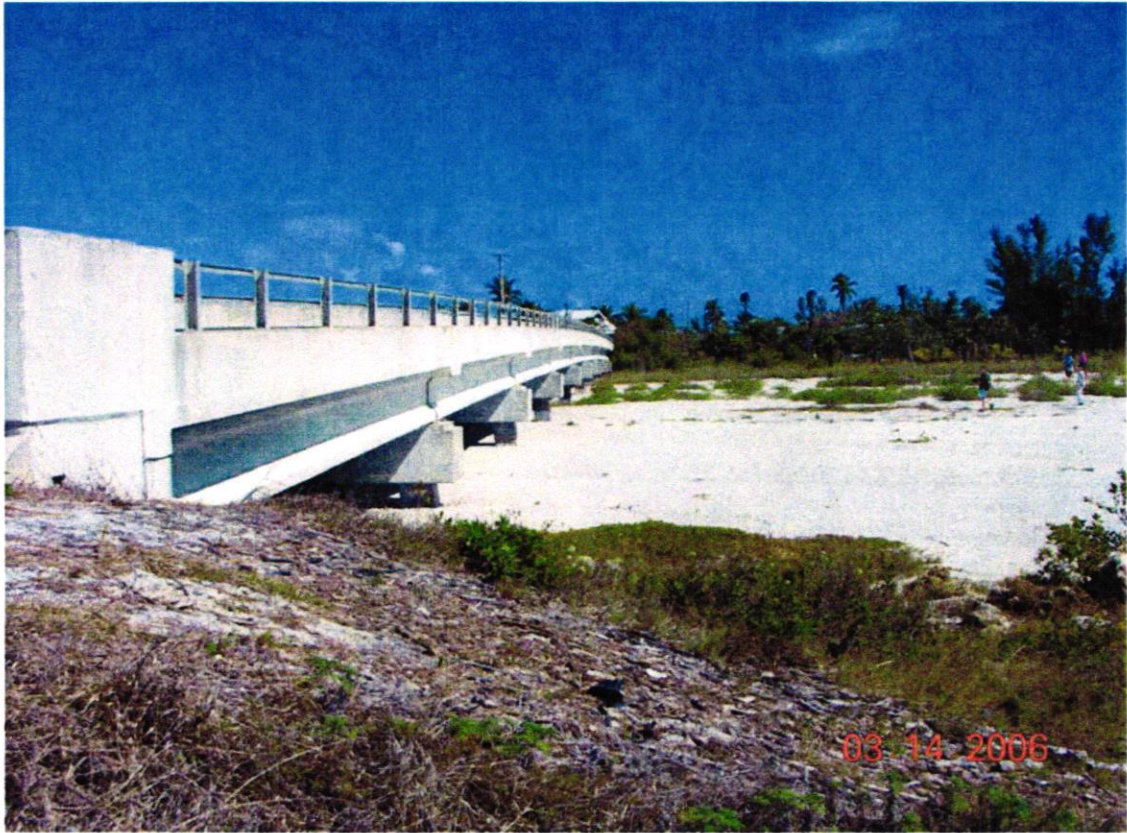
Figure 1-1 Current Conditions

Over the past 8 years, Blind Pass has remained closed as the result of instabilities in the channel geometry caused by storm induced shoaling and infilling. Since severe shoaling occurred at the Pass, the rates of erosion at Sanibel Island have increased and reduced tidal flows and flushing of Dinkins Bayou, Roosevelt Channel and Wulfert Channel have created conditions that has impaired light transmission and disturbed the historically pristine marine ecosystem. (See Figure 1-1, Current Conditions.)

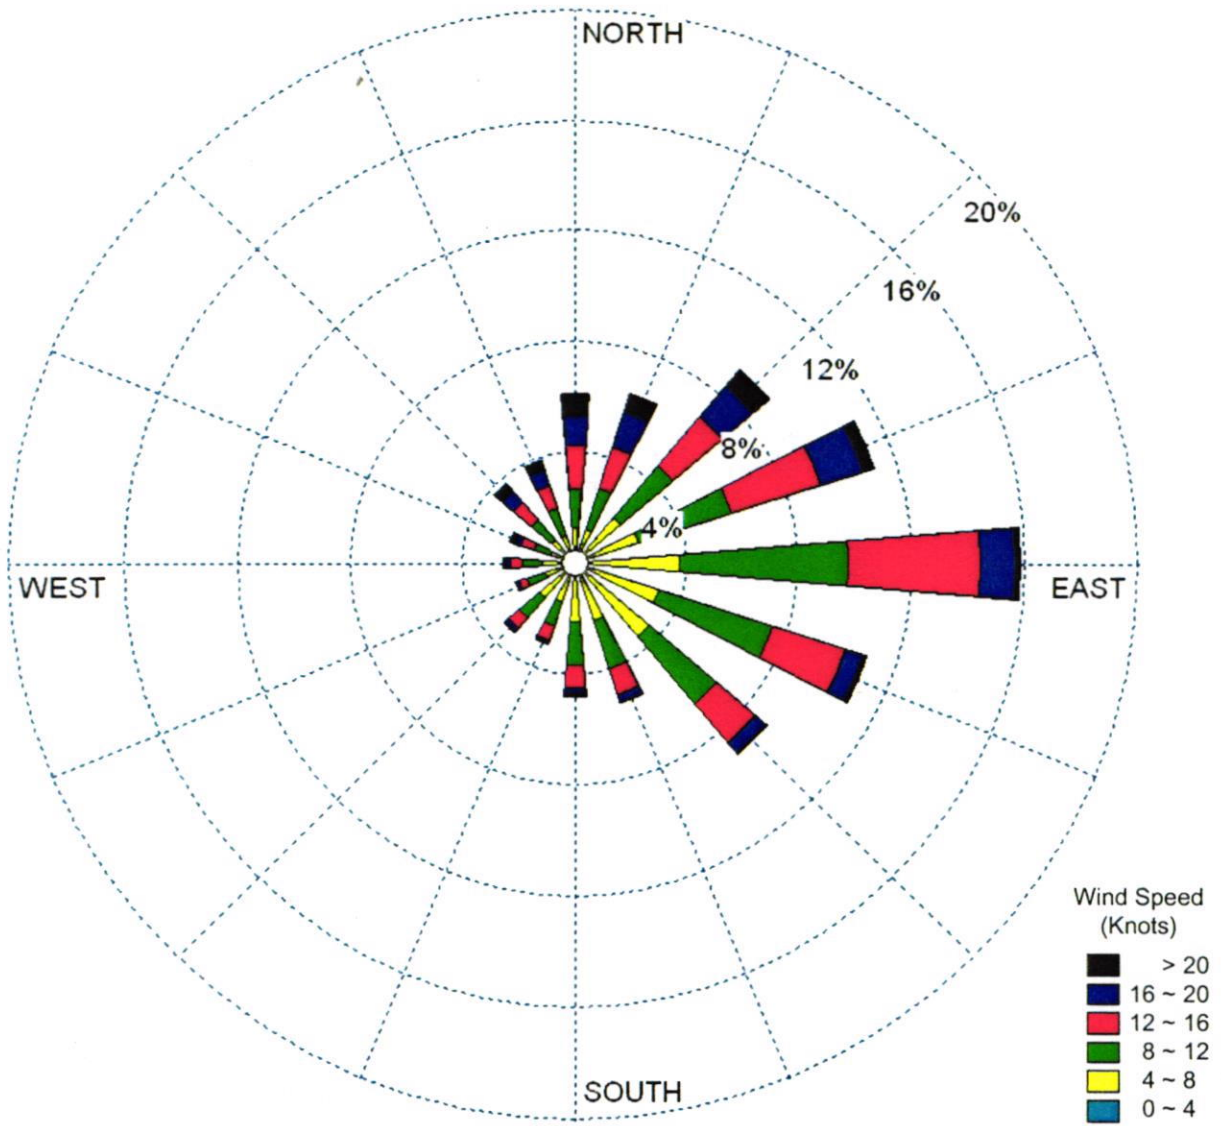
Figure 2-5 Wind Rose during the 20-years period at WIS Station #290

To estimate long term wind and wave conditions, hindcast wave data (WIS) is the most reliable information to characterize the wave and wind climate at offshore from the project site. Hindcast wave data is generated by numerical simulations of past wind and wave conditions and provides the wave climate data to apply to design projects located in coastal zones. WIS hindcast data ([http://frf.usace.army.mil/wis/wis\\_main.html](http://frf.usace.army.mil/wis/wis_main.html)) have been updated and uses a finer grid spacing, superior wind field, and higher resolution bathymetry for the period of 1980~1999 than older hindcast methods. Wind data was compiled for the WIS hindcast station #290 in Gulf of Mexico. This station is located at the offshore (26.42N and 82.33W, 16m depth) approximately 11 miles west of Blind Pass which is mapped in Figure 2-1. Figure 2-5 provides the wind rose for the most recently available twenty year (1980~1999) period.

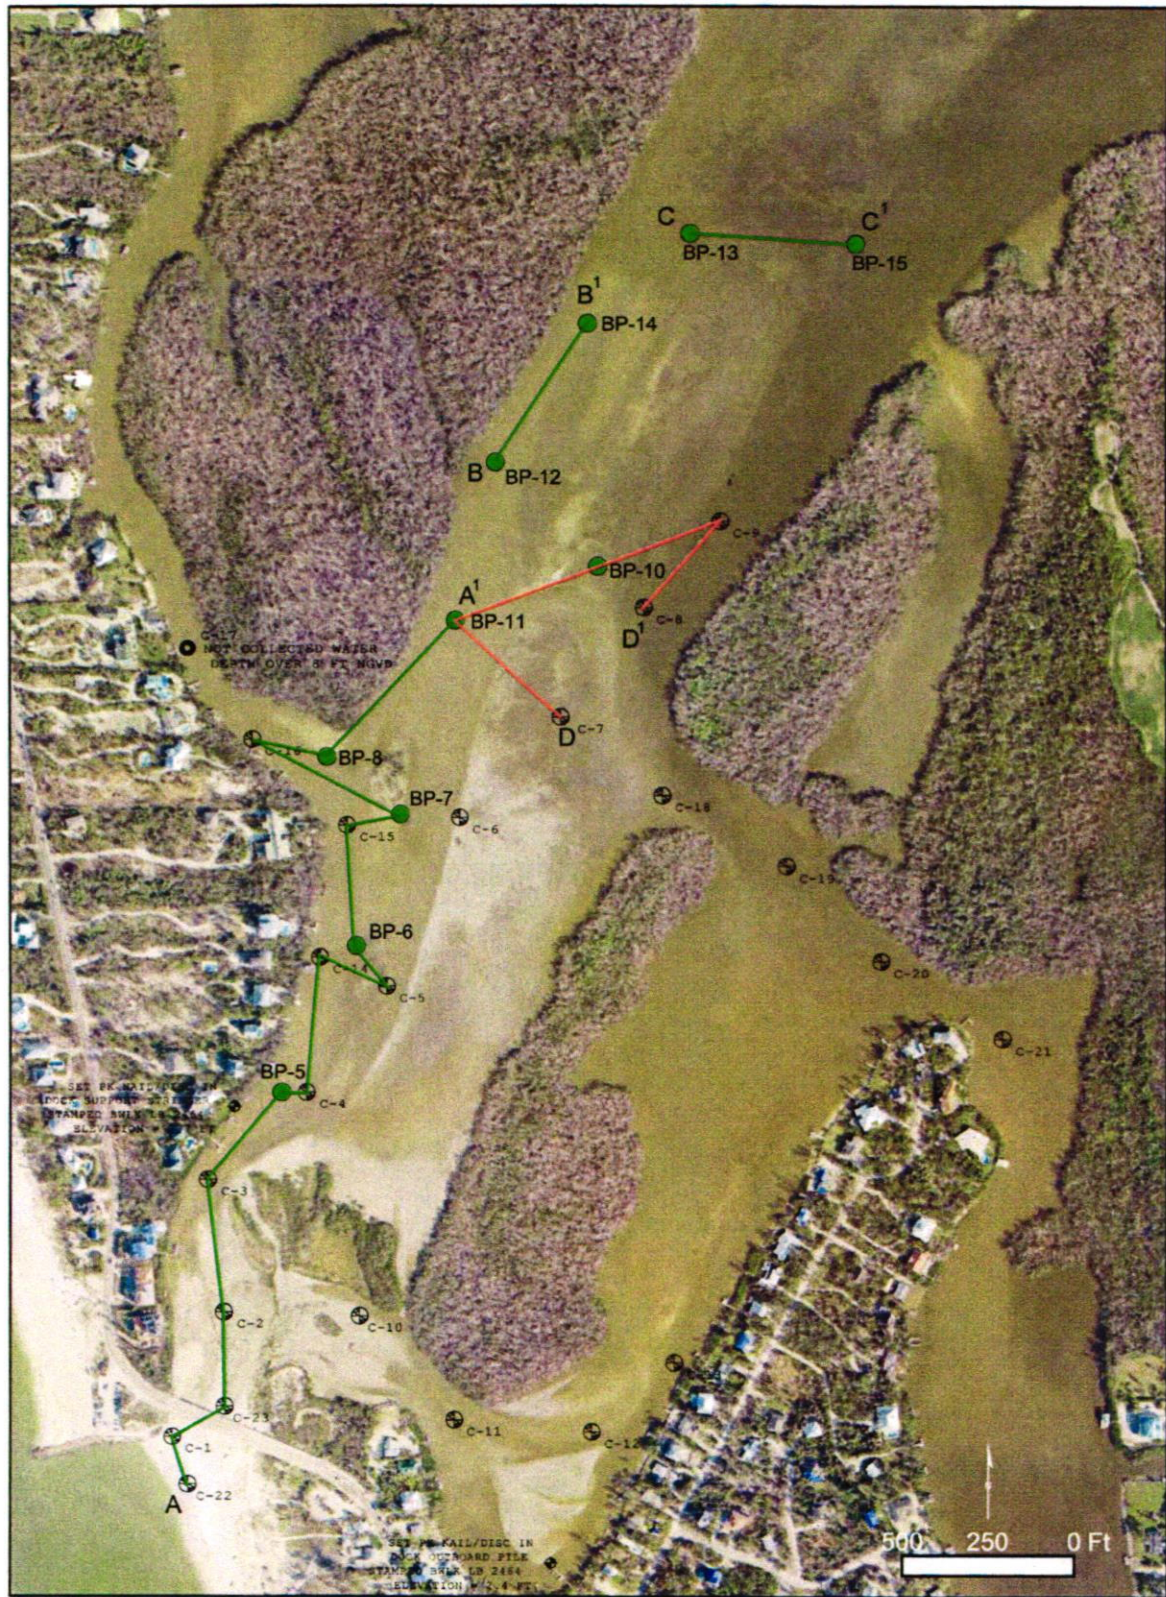
Figure 2-21 Plan view of core locations and geologic cross sections within the study area.

Soil tests indicate these sediments are SP type soils as identified by the Unified Soil Classification System. Layers of clayey sands can be found at differing depths and thicknesses within the Tidal Channel further inland of the bridge location. The

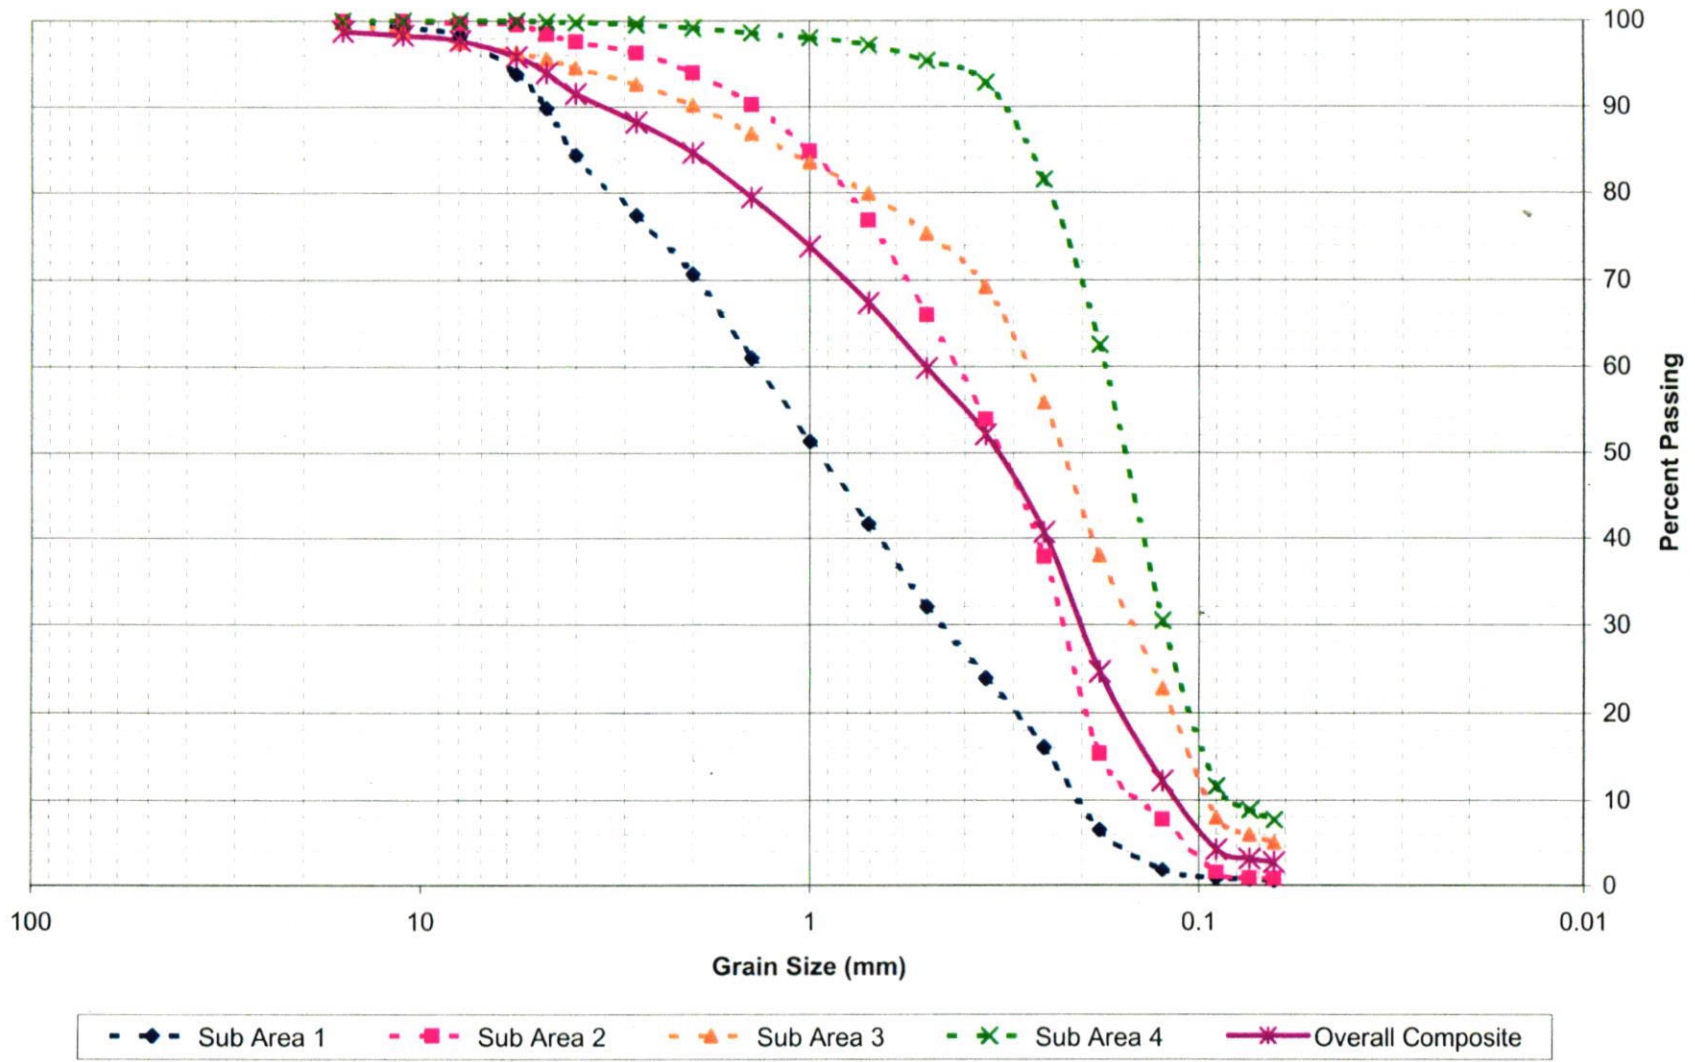
Figure 3-5 Preferred Alternative Sub Area Composite Grain Size Distribution Curves

An estimated volume of 115,184 cubic yards (CY) of material will be excavated to form the Preferred Alignment to restore Blind Pass (see Table 3.3). Existing elevations within the channel configuration range from +5 to -10 ft (NAVD 88). Composites of the material found in sub areas 1 and 2 resulted in 0.8 and 0.6 percent passing the 4 $\phi$  sieve, respectively. The material (approximately 74,000 CY) within these sub areas are highly beach compatible and will be placed directly on the beach as nourishment. Composites of approximately 17,500 CY of material within sub area 3 show approximately 5% fines or passing the 4 $\phi$  sieve. This material is beach compatible; however, a detailed sediment QA/QC plan shall be implemented to ensure that only beach compatible material is placed on the beach. Overall composites of the material within sub area 4 resulted in 7.7% fines. The 24,000 CY of material from sub area 4 will be placed in a sediment containment area and sorted. The unsuitable material (approximately 1,900 CY) will be disposed of at an approved upland site. Detailed sediment grain size distribution composites are shown in Tables 3-5 to 3-9 and graphically in Figure 3-4.

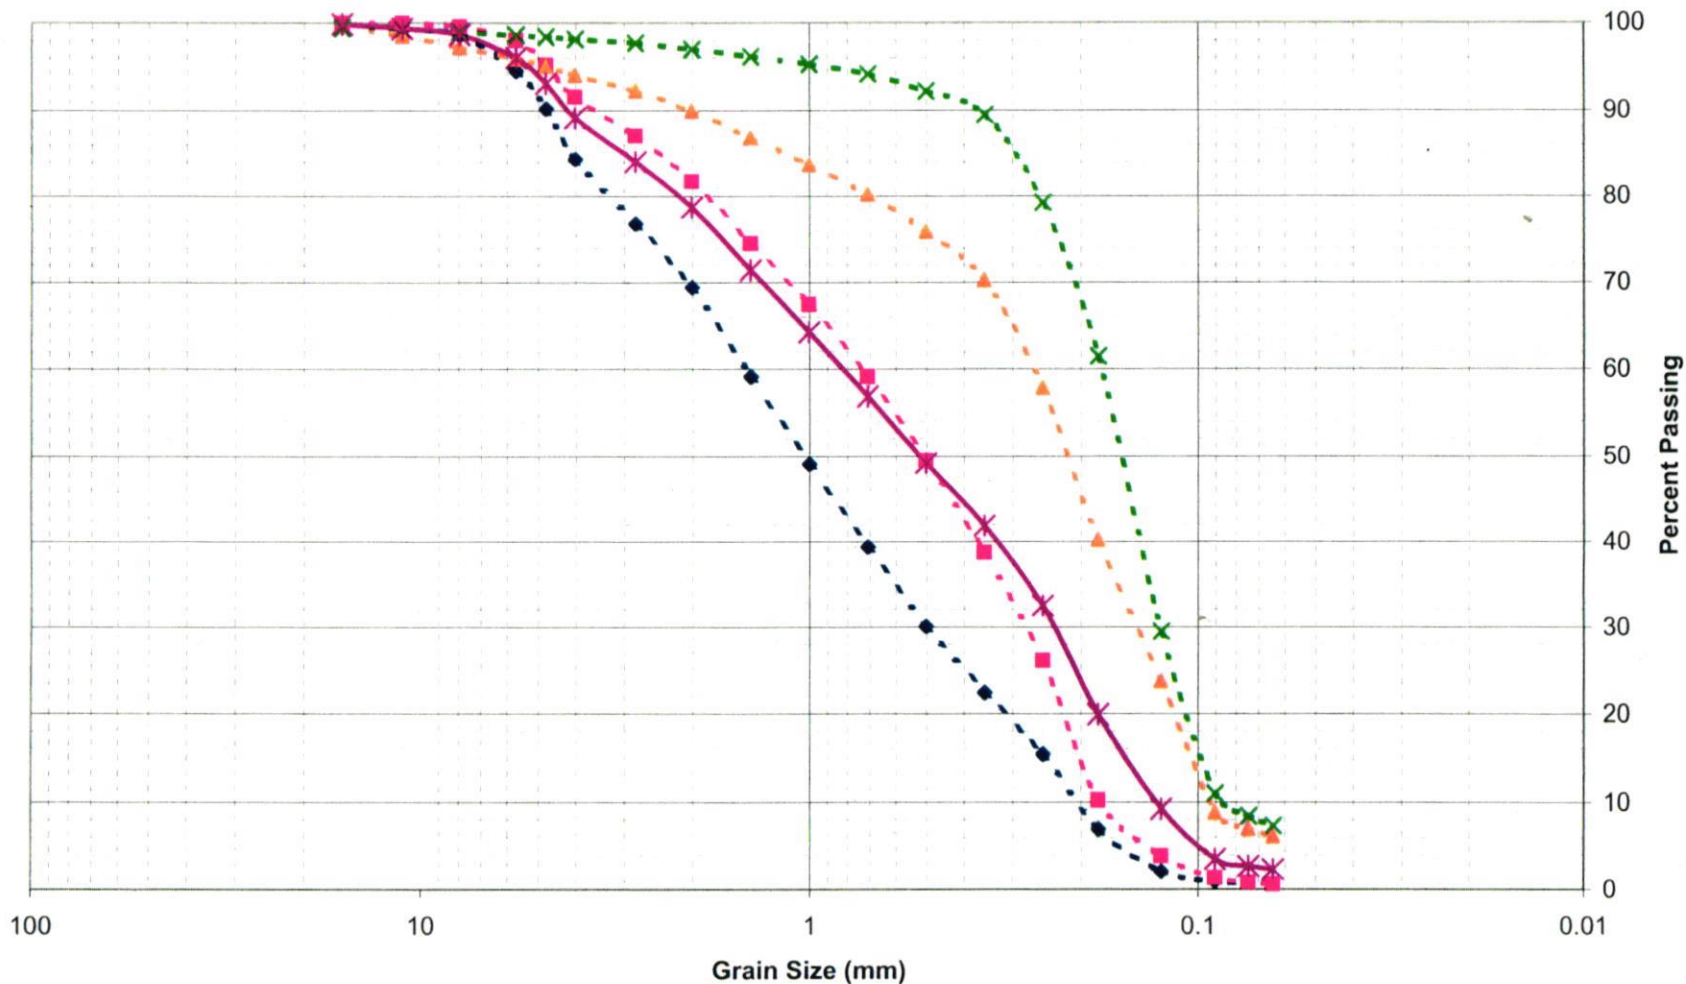
Figure 3-7 Alternative H Sub Area Composite  
Grain Size Distribution Curves

An estimated volume of 163,663 cubic yards (CY) of material will be excavated to form the Alternative H Alignment to restore Blind Pass (see Table 3.10). Composites of the material found in sub areas 1 and 2 resulted in less than 1 percent passing the 4 $\phi$  sieve. The material (approximately 119,000 CY) within these sub areas are highly beach compatible. Composites of approximately 21,200 CY of material within sub area 3 show approximately 6.2% fines or passing the 4 $\phi$  sieve. This indicates the deeper cut resulted in material composite that were not beach compatible. Overall composites of the material within sub area 4 resulted in 7.4% fines. Detailed sediment grain size distribution

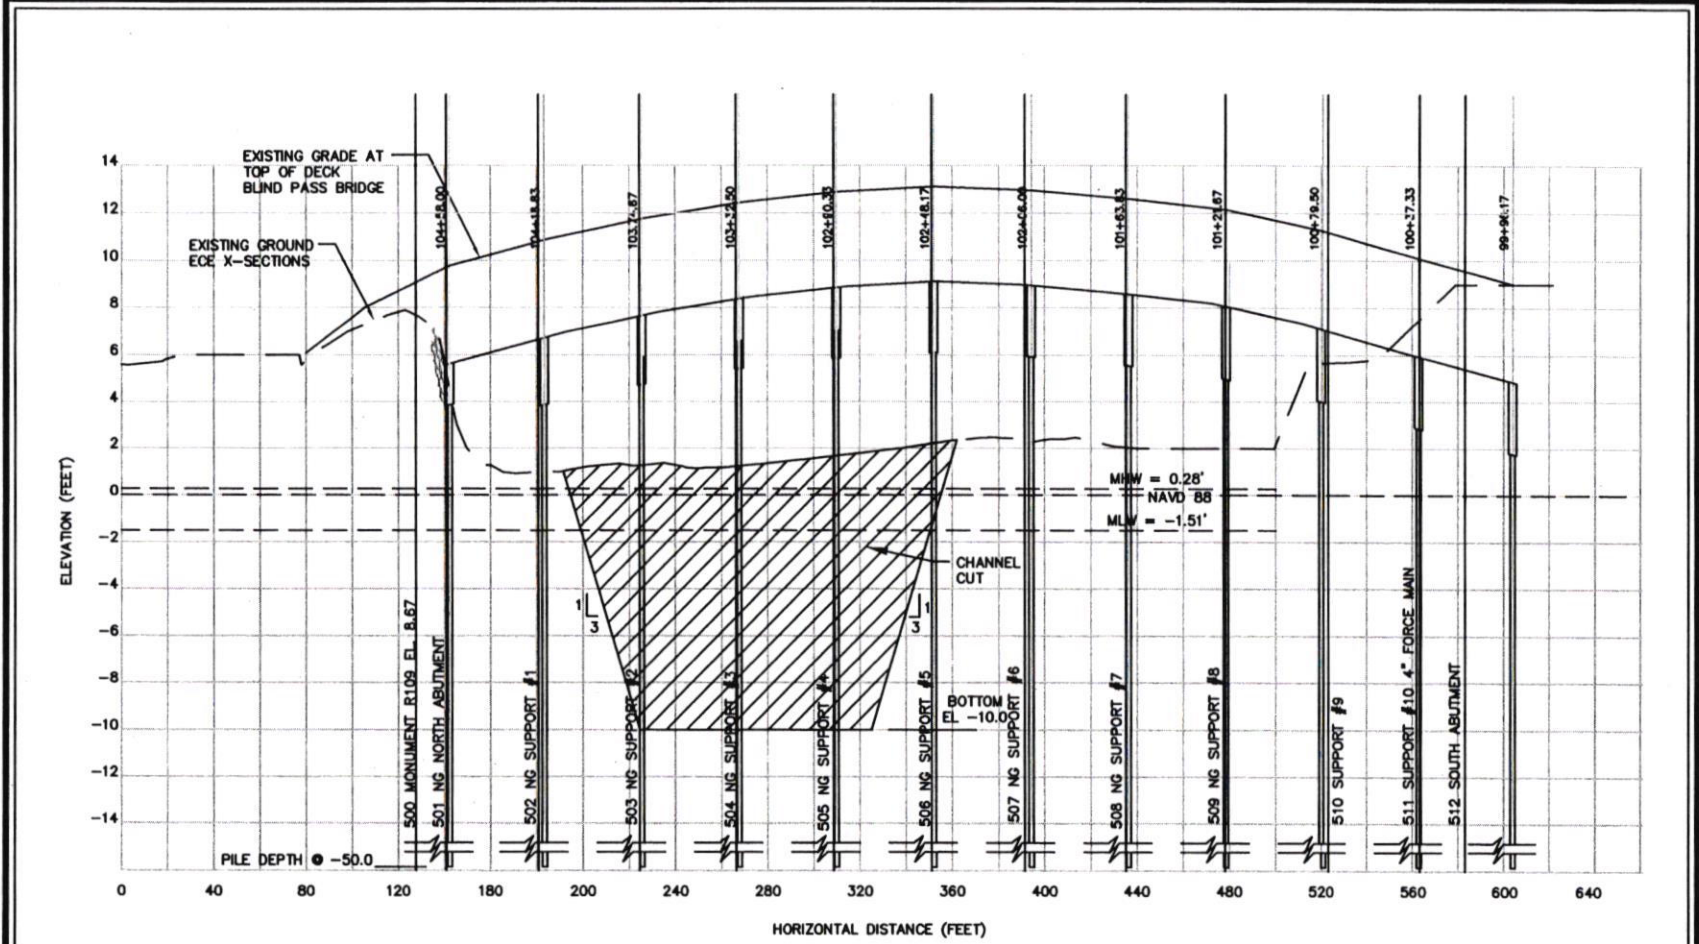
CHANNEL SECTION E-E' AT EXISTING BRIDGE  
 SCALE: HORIZ. 1"=80 FEET  
 VERT. 1"= 8 FEET

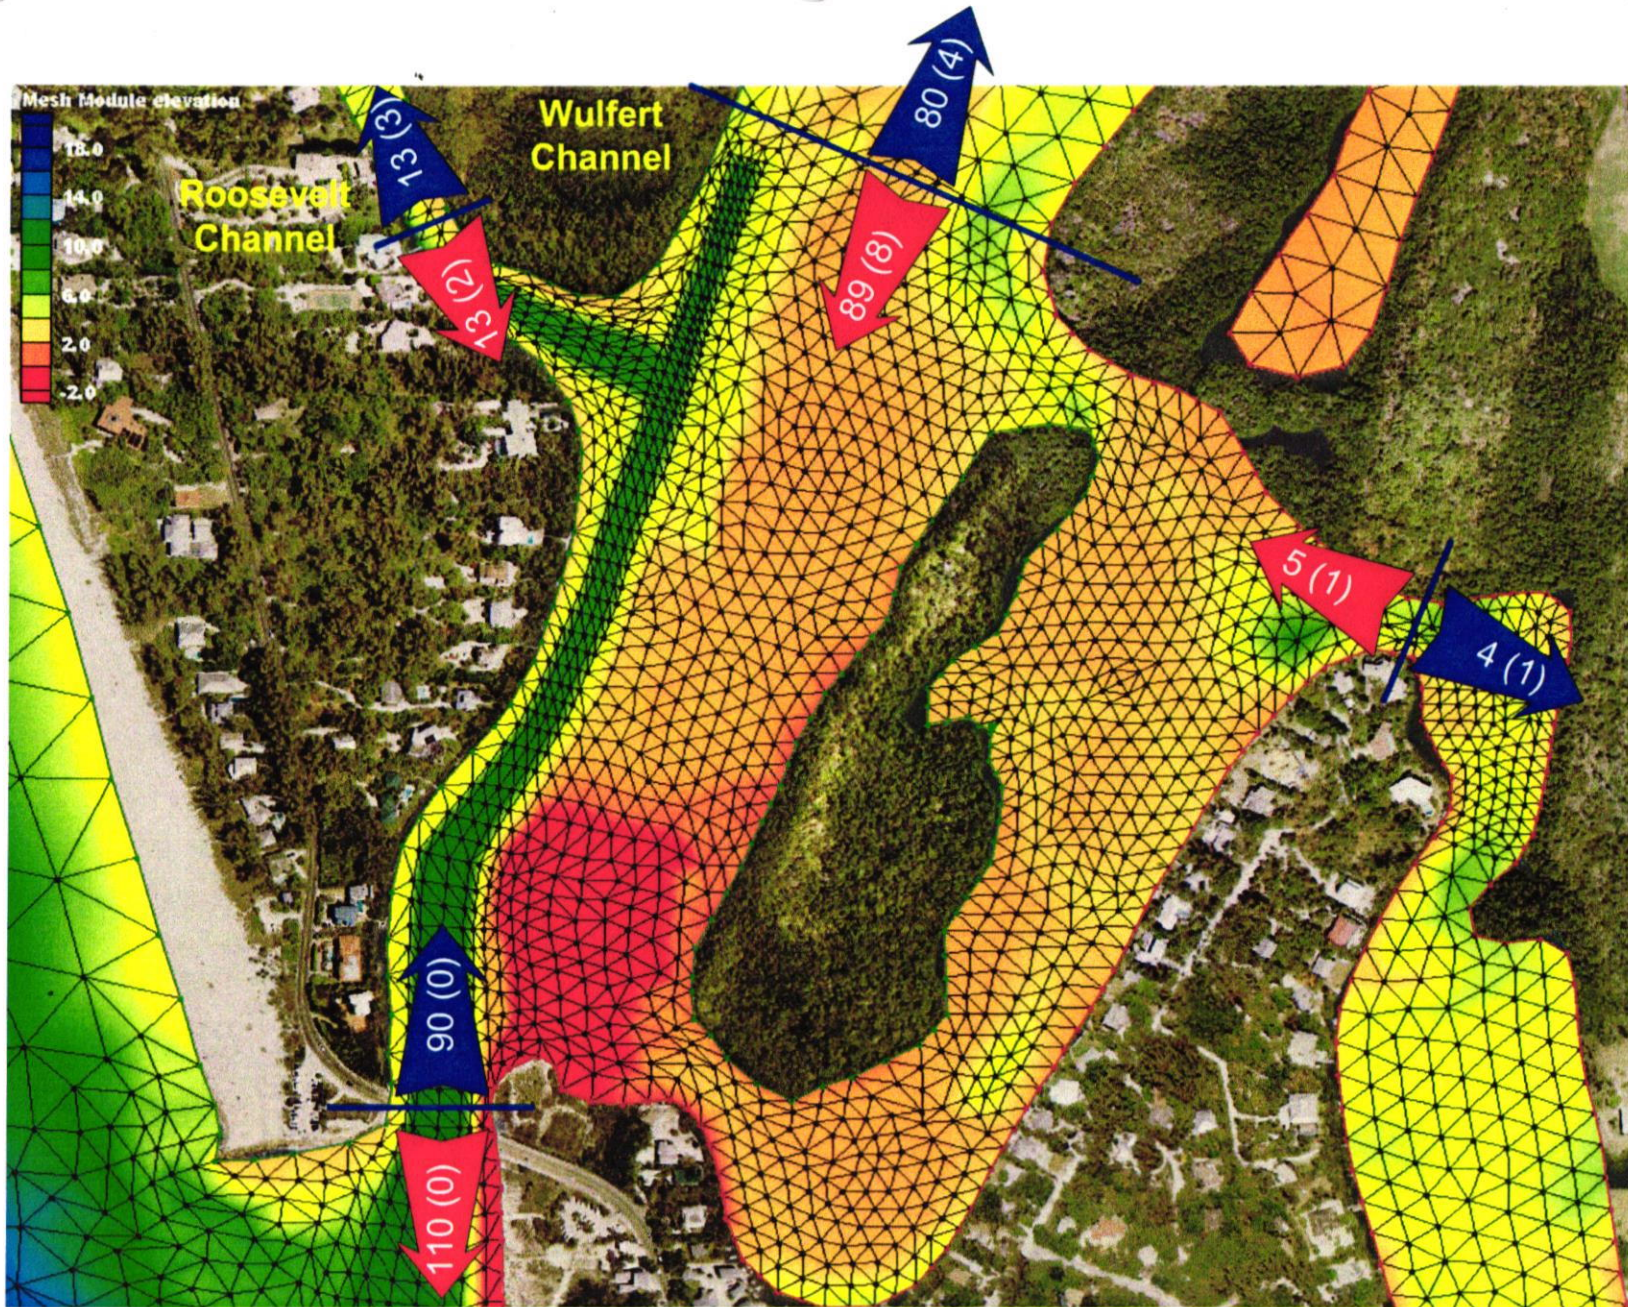
Figure 5-1 Tidal Prism Comparisons between Preferred Alternative and Existing Condition  
 (Tidal Prism: Preferred Alternative (Existing Condition), Unit:  $10^6 \text{ ft}^3$ )

A comparison of the simulated tidal prisms at the adjacent interior tidal channels and Blind Pass for the Preferred Alternative and the Existing Condition are summarized in Table 5-2. The model results show that the inlet will be ebb tide dominant and that the tidal prisms will be significantly increased through Wulfert Channel, Roosevelt Channel, and Dinkins Bayou by constructing the Blind Pass Restoration Project as proposed. At Wulfert Channel, the tidal prisms will increase approximately ten times during the ebb tide and twenty times during the flood tide phases of the tidal cycle. Also, tidal prisms will increase more than 4 to 6 times in Roosevelt Channel and Dinkins Bayou after the Pass is dredged. These model simulations show that Blind Pass will be an ebb dominant inlet, which significantly reduces the tendency for shoaling in the interior channels. Figure 5-1 compares tidal prisms at each channel resulting from the Blind Pass Restoration Project. Note that numbers shown in parentheses represent existing conditions. Significantly greater tidal prisms will improve the circulation and flushing in Wulfert Channel, Roosevelt Channel, and Dinkins Bayou.

Location	Tide	Tidal Prism ( $\times 10^6 \text{ ft}^3$ )		Percent Change
		Existing Condition	Preferred Alternative	
Blind Pass	Flood	0	90	
	Ebb	0	110	
Wulfert Channel	Flood	4	80	+1900%
	Ebb	8	90	+1013%
Roosevelt Channel	Flood	3	13	+333%
	Ebb	2	13	+550%
Dinkins Bayou	Flood	1	4	+300%
	Ebb	1	5	+400%
Redfish Pass	Flood	688	683	-0.7%
	Ebb	991	993	+0.2%

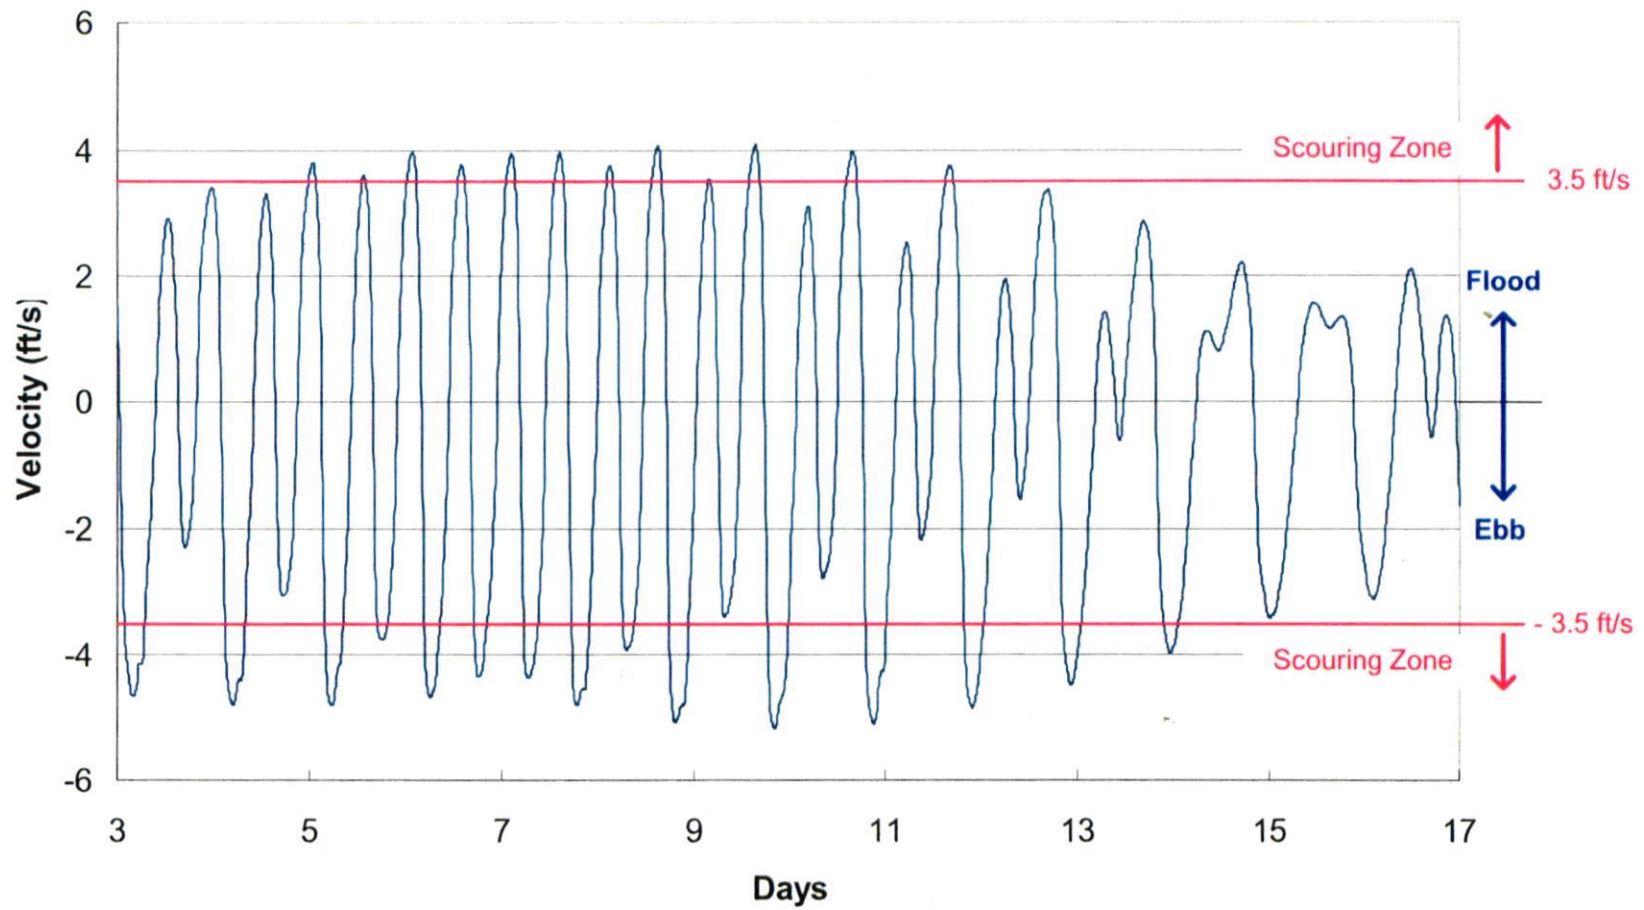
Figure 5-2 Current Velocity at Blind Pass after Dredging (Alternative Pass)

The peak current velocities at the throat of the restored Blind Pass are an important variable that affects the stability of the inlet. A minimum of 3.5 ft/s current velocity during peak velocity conditions are required to scour sediments out of the inlet throat and maintain a stable inlet cross-section. Figure 5-2 summarizes the simulated depth averaged current velocity at the throat of Blind

Pass for the Preferred Alternative. The averaged peak current velocities are 3.3 ft/s during flood tide and 4.3 ft/s during ebb tide. When the cross-section area at the pass throat is reduced by the sediment carried into the pass due to wave action and flood current flows during each tidal cycle, the ebb current velocity increases at the pass throat cause turbulence and initiation of sediment transport and hence results in stability of the inlet as scour moves the sediment seaward to the ebb shoal or downdrift beaches. The averaged peak ebb and flood velocities of 4.3 ft/s and 3.3 ft/s are expected to provide sufficient flow rate to maintain a stable pass cross-section under the immediate post-construction condition.

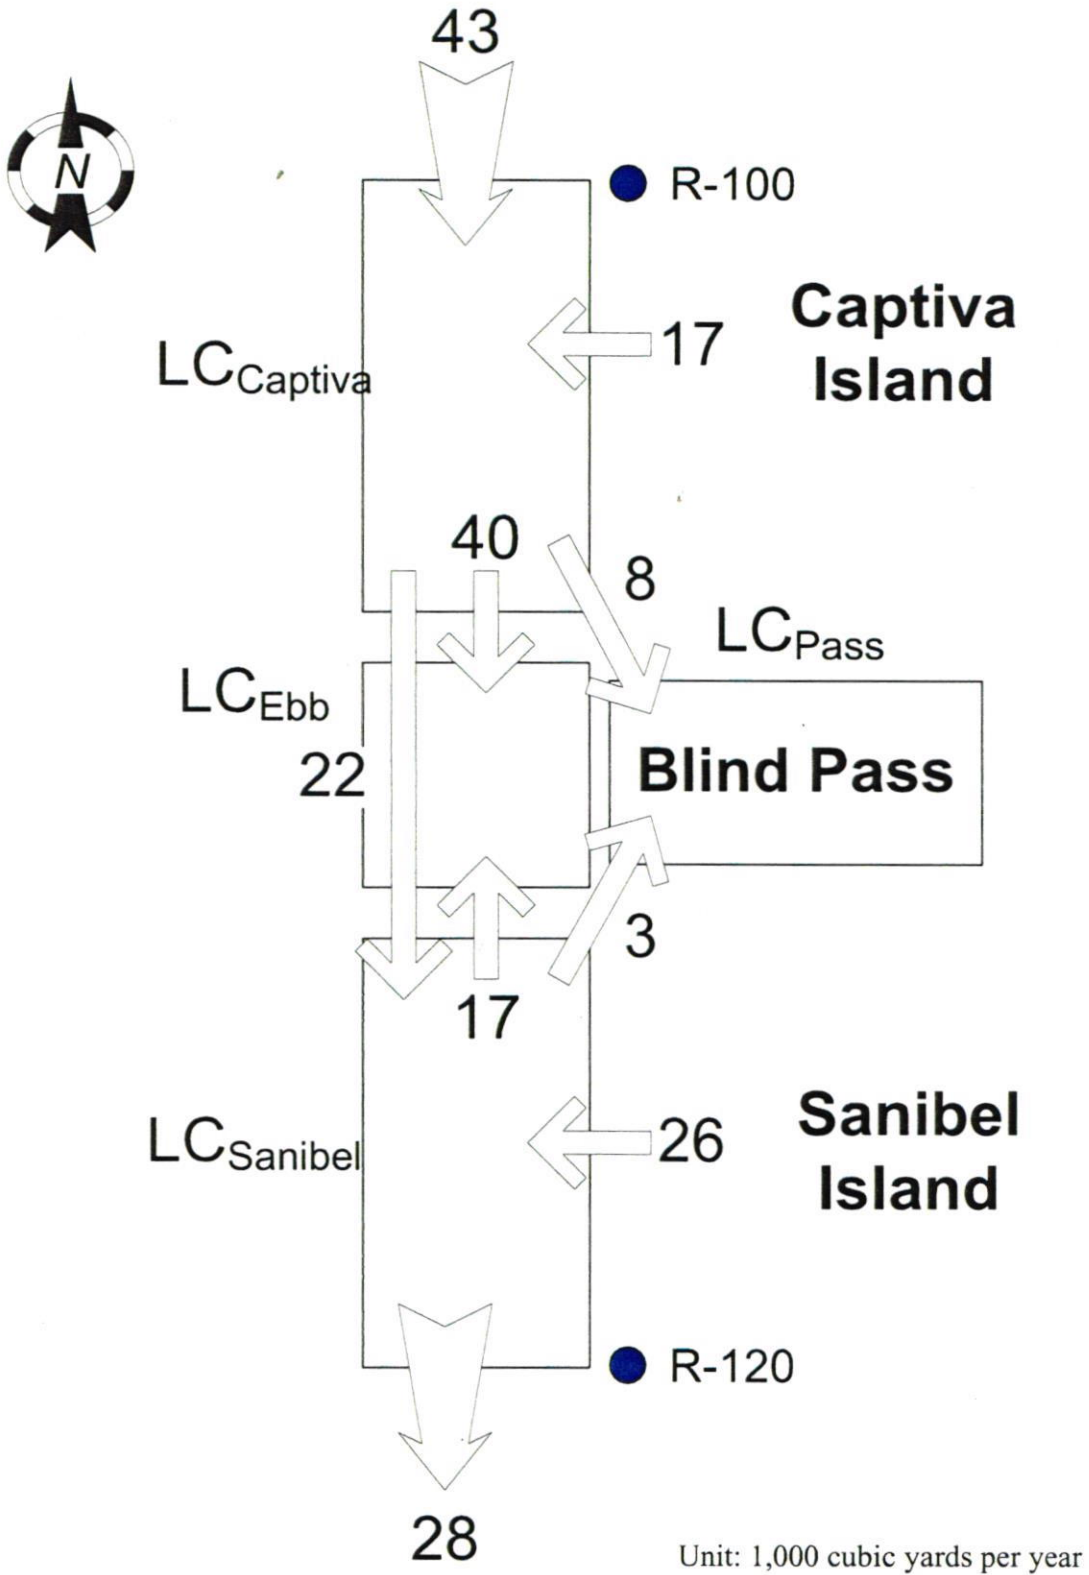
Figure 5-3 Conceptual Sediment Budget after Blind Pass Restoration Project

The conceptual sediment budget is based on the sediment volume change (as shown in Table 5.3) using observed beach profiles since the beach nourishment performed between 1988 and 1989 on Captiva Island and north Sanibel Island. These analyses are based on the historic beach profile data obtained by Florida DEP between 1989 and 2004. The north and south limits of this analysis extends from R-100 at the north, about 8,460 ft north of the Pass (Captiva Island) to R-120 at the south, about 10,300 ft to the south of the Pass (Sanibel Island).

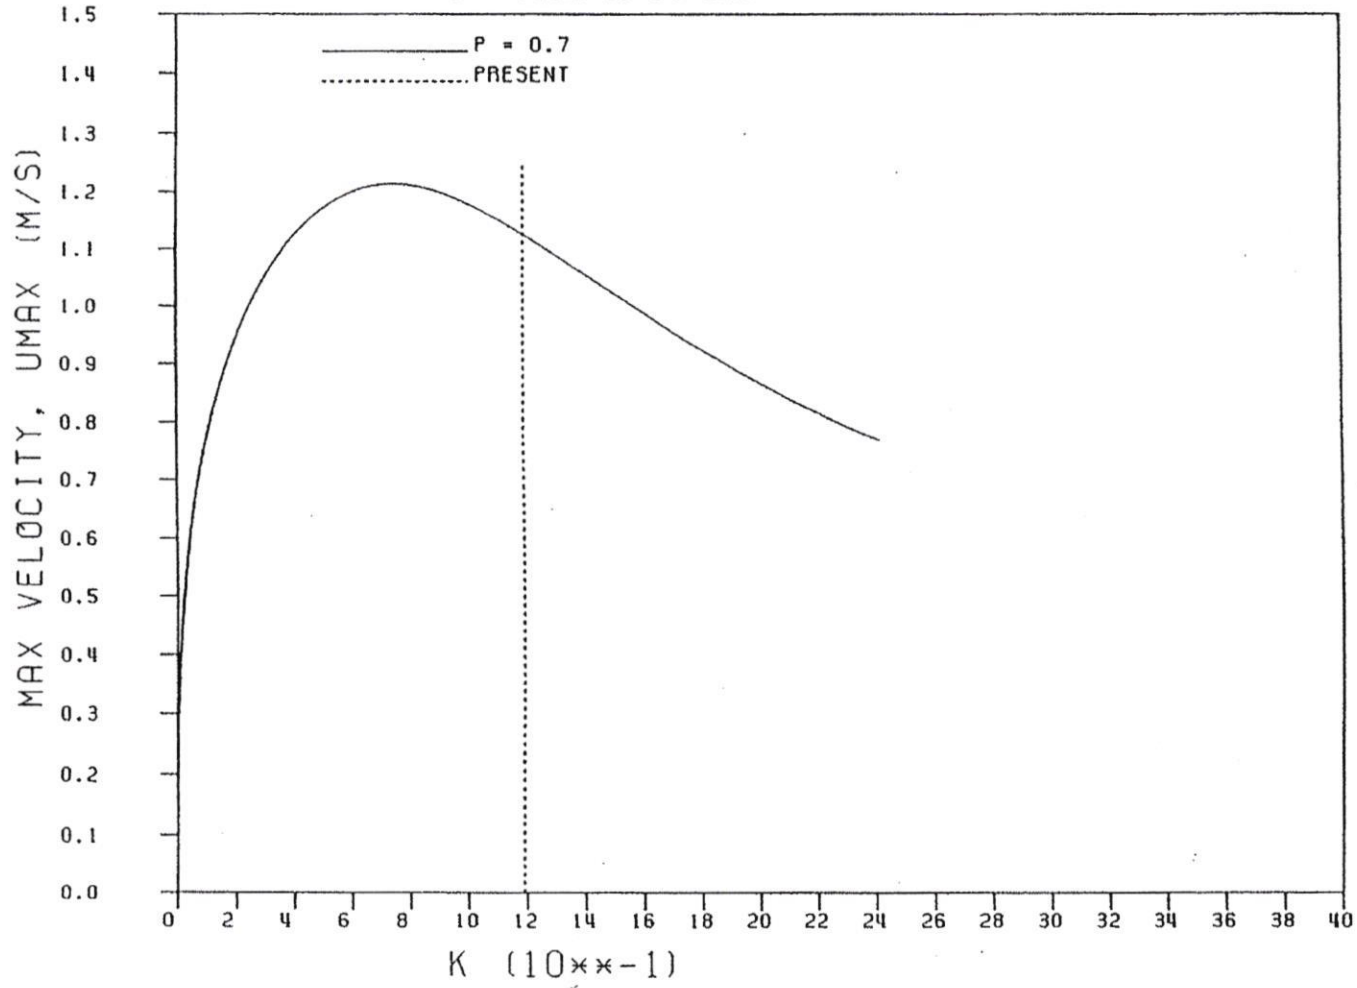
FIG.6.1: CRIT. K VALUE, BLIND P  
(MEAN TIDE CONDITION)

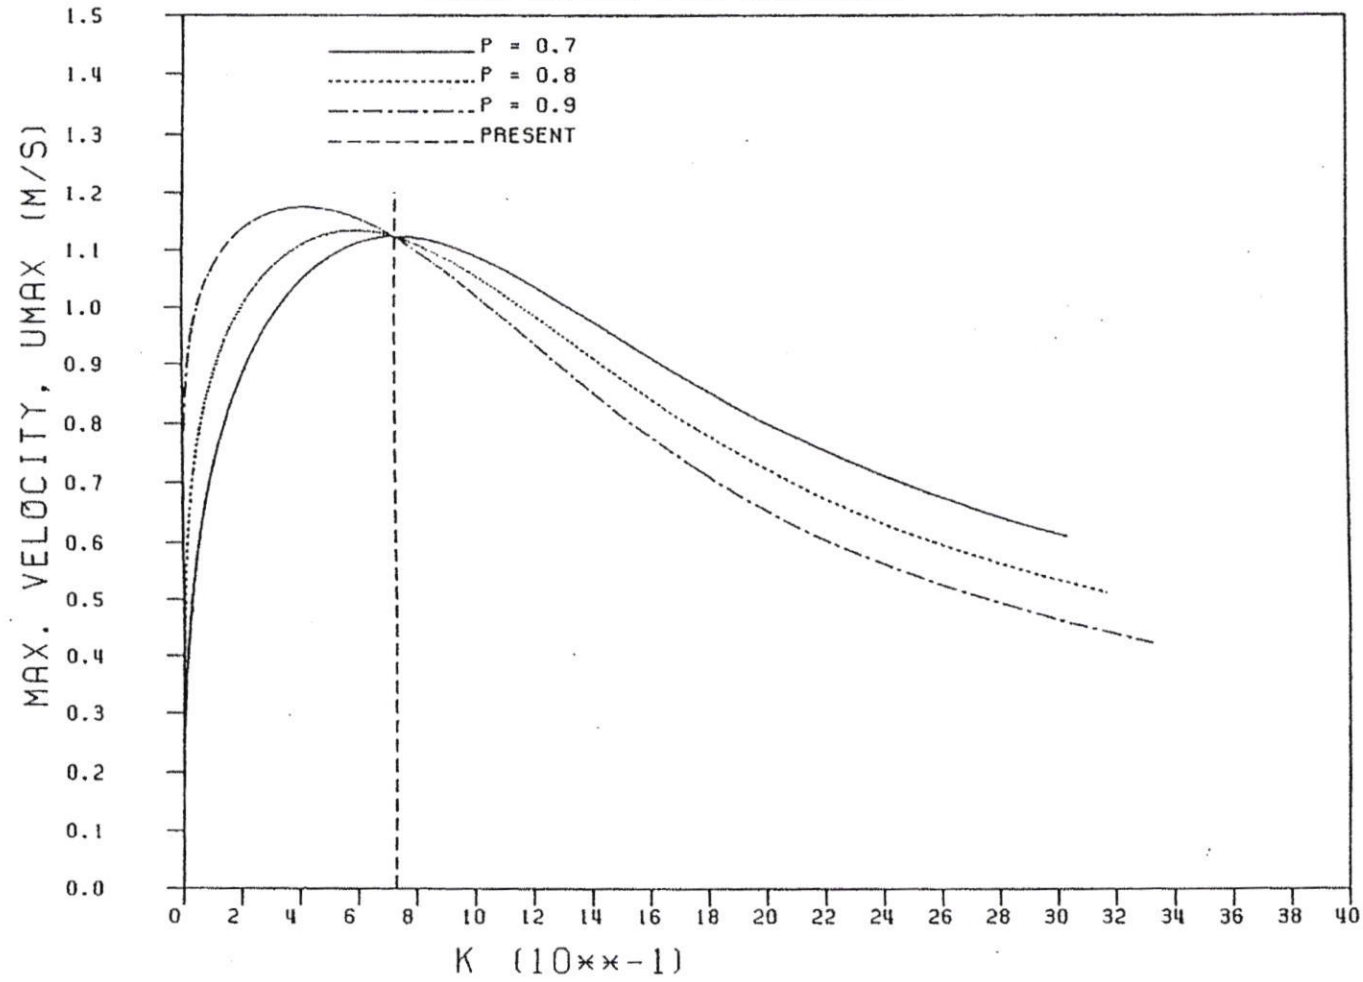
FIG.6.2:CRIT. REPLETION COEFF., BLIND P.  
(MEAN DIURNAL TIDE CONDITION)

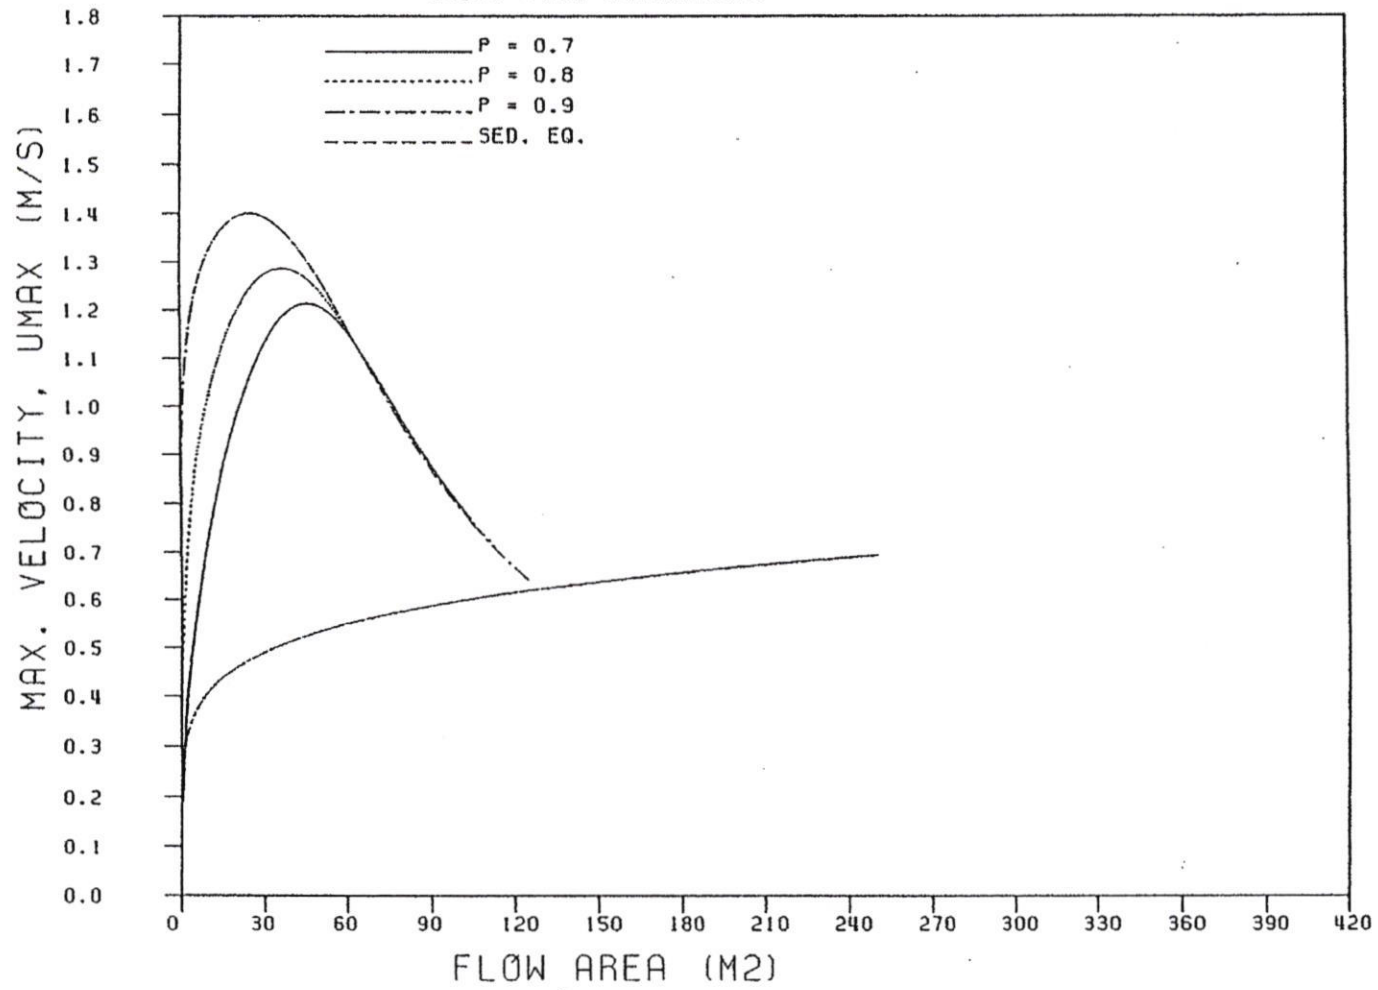
FIG. 6.3: STABILITY DIAGRAM, BLIND P.  
(MEAN TIDE CONDITION)

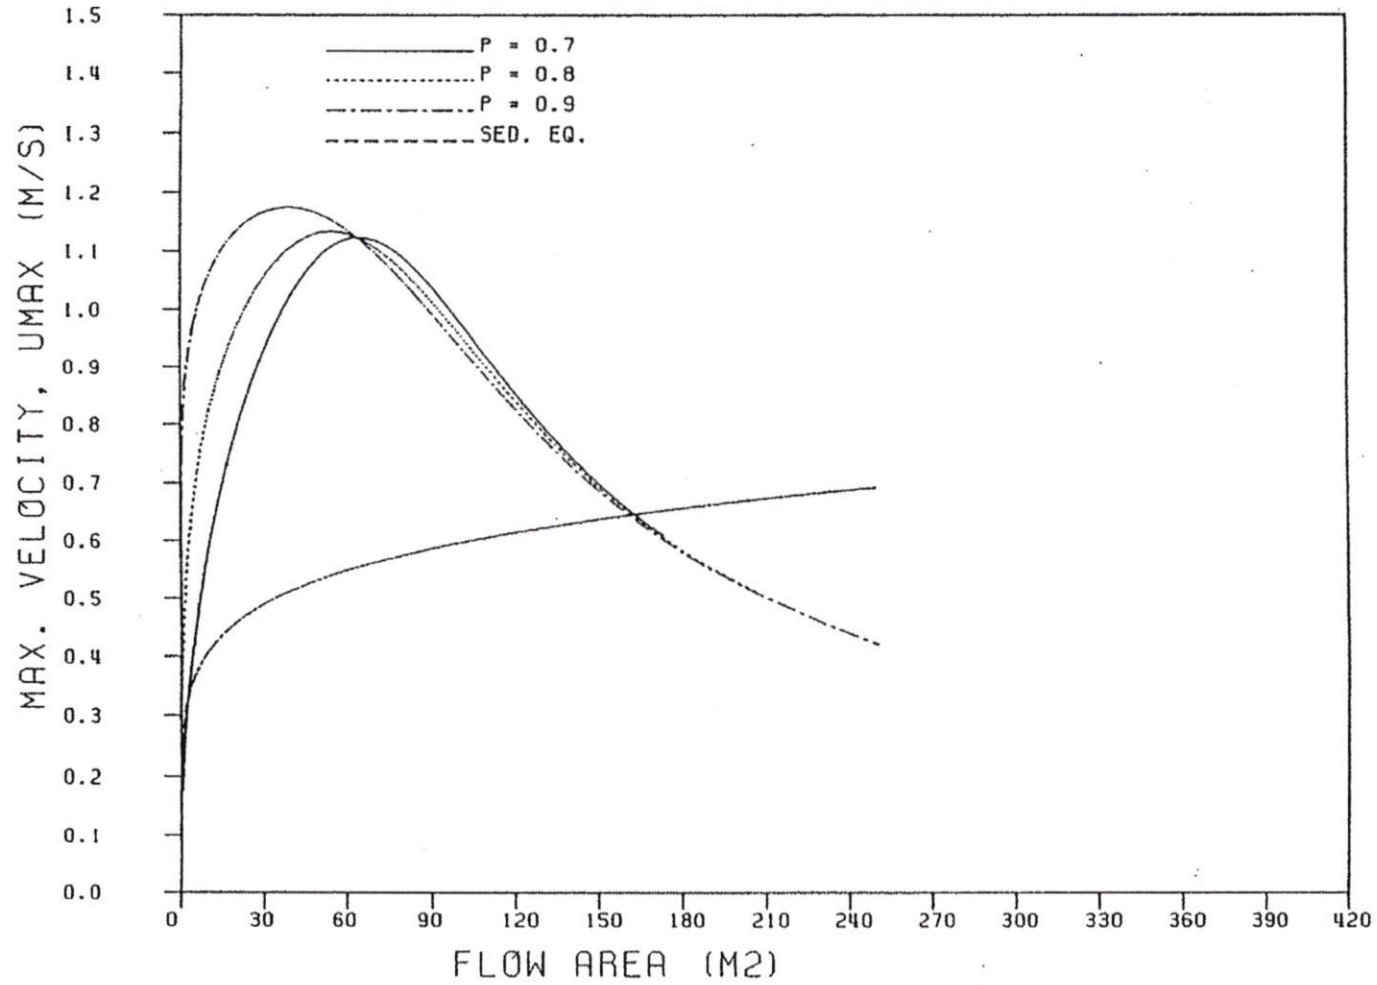
FIG.6.4: STABILITY DIAGRAM, BLIND P.  
(SAME PARAMETER INPUTS AS MODELS)
