# Blind Pass Restoration Project

**Design Report  
May 2006**

**ECE**  
Erickson Consulting Engineers

# **BLIND PASS RESTORATION PROJECT DESIGN REPORT**

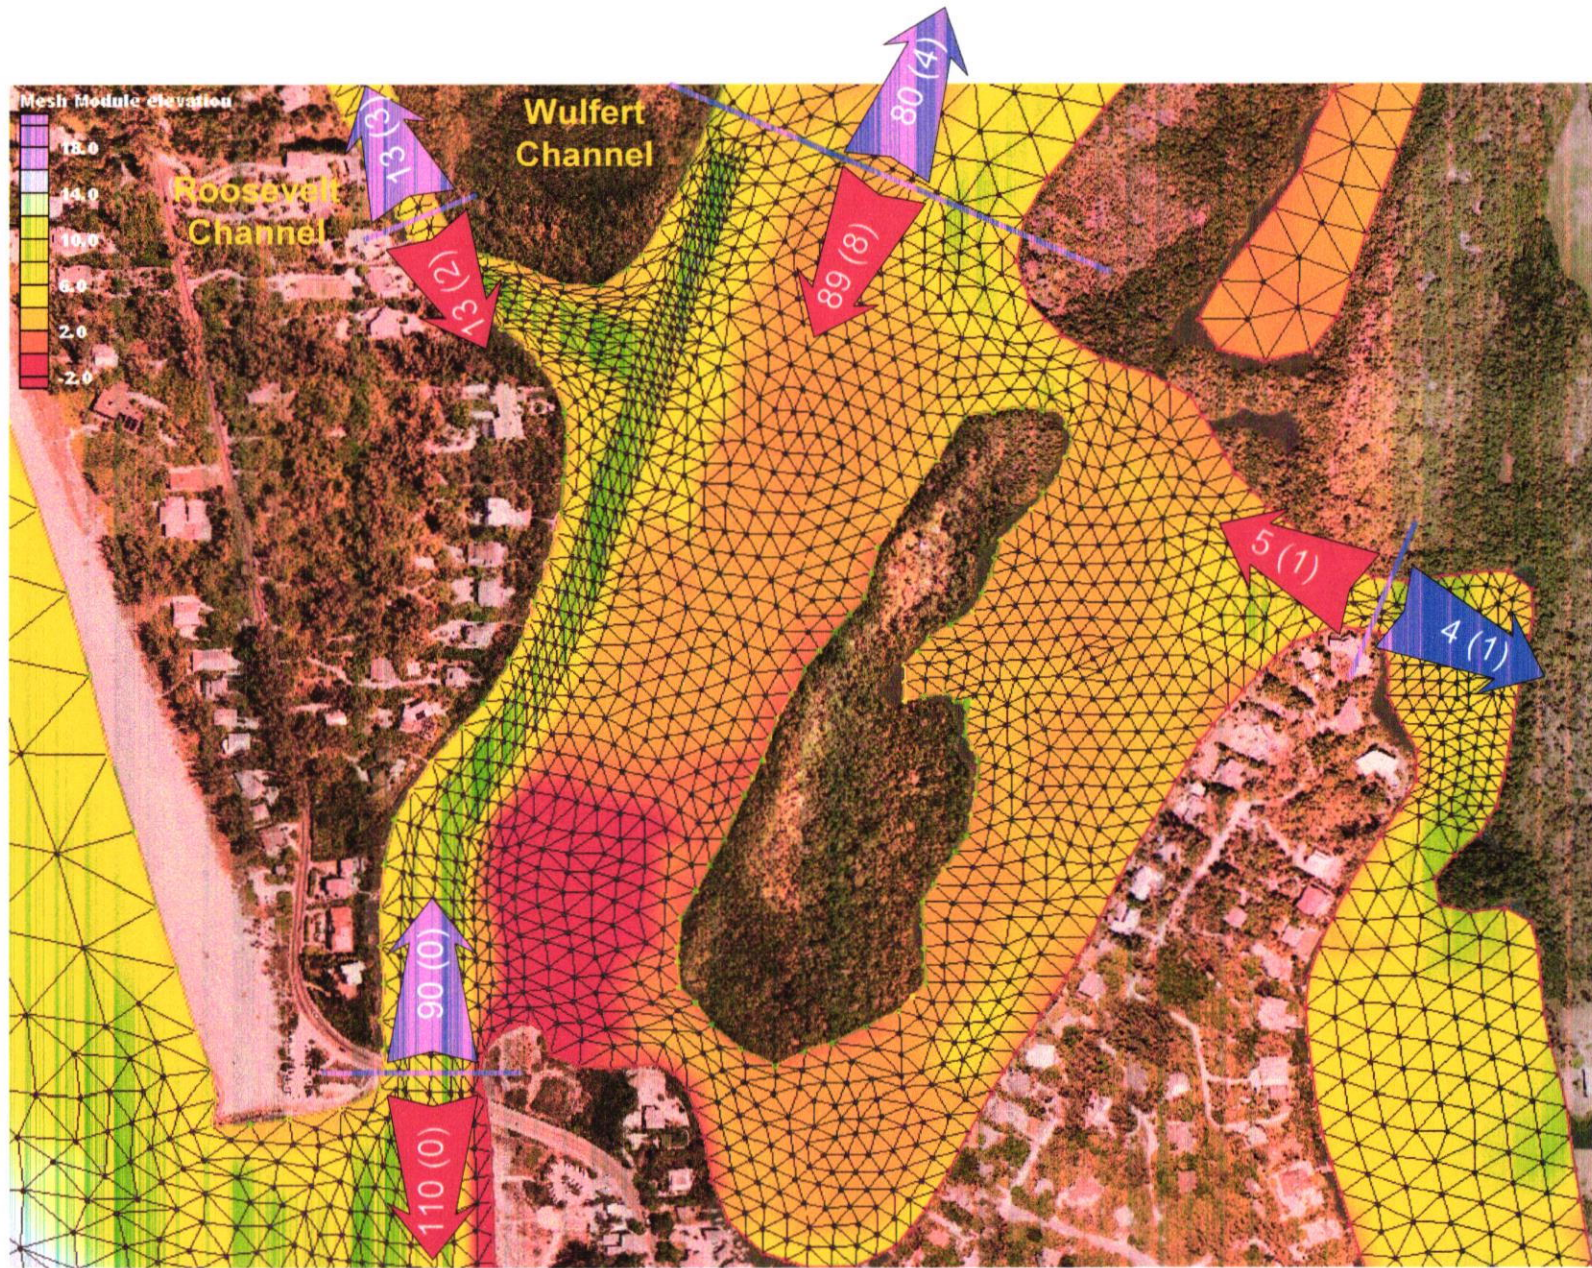
Figure 3 Tidal Prism Comparisons between Preferred Alternative and Existing Condition  
(Tidal Prism: Preferred Alternative (Existing Condition), Unit:  $10^6 \text{ ft}^3$ )

Note: Figure is a duplicate of Figure 5-1 from Design Report provided by ECE.

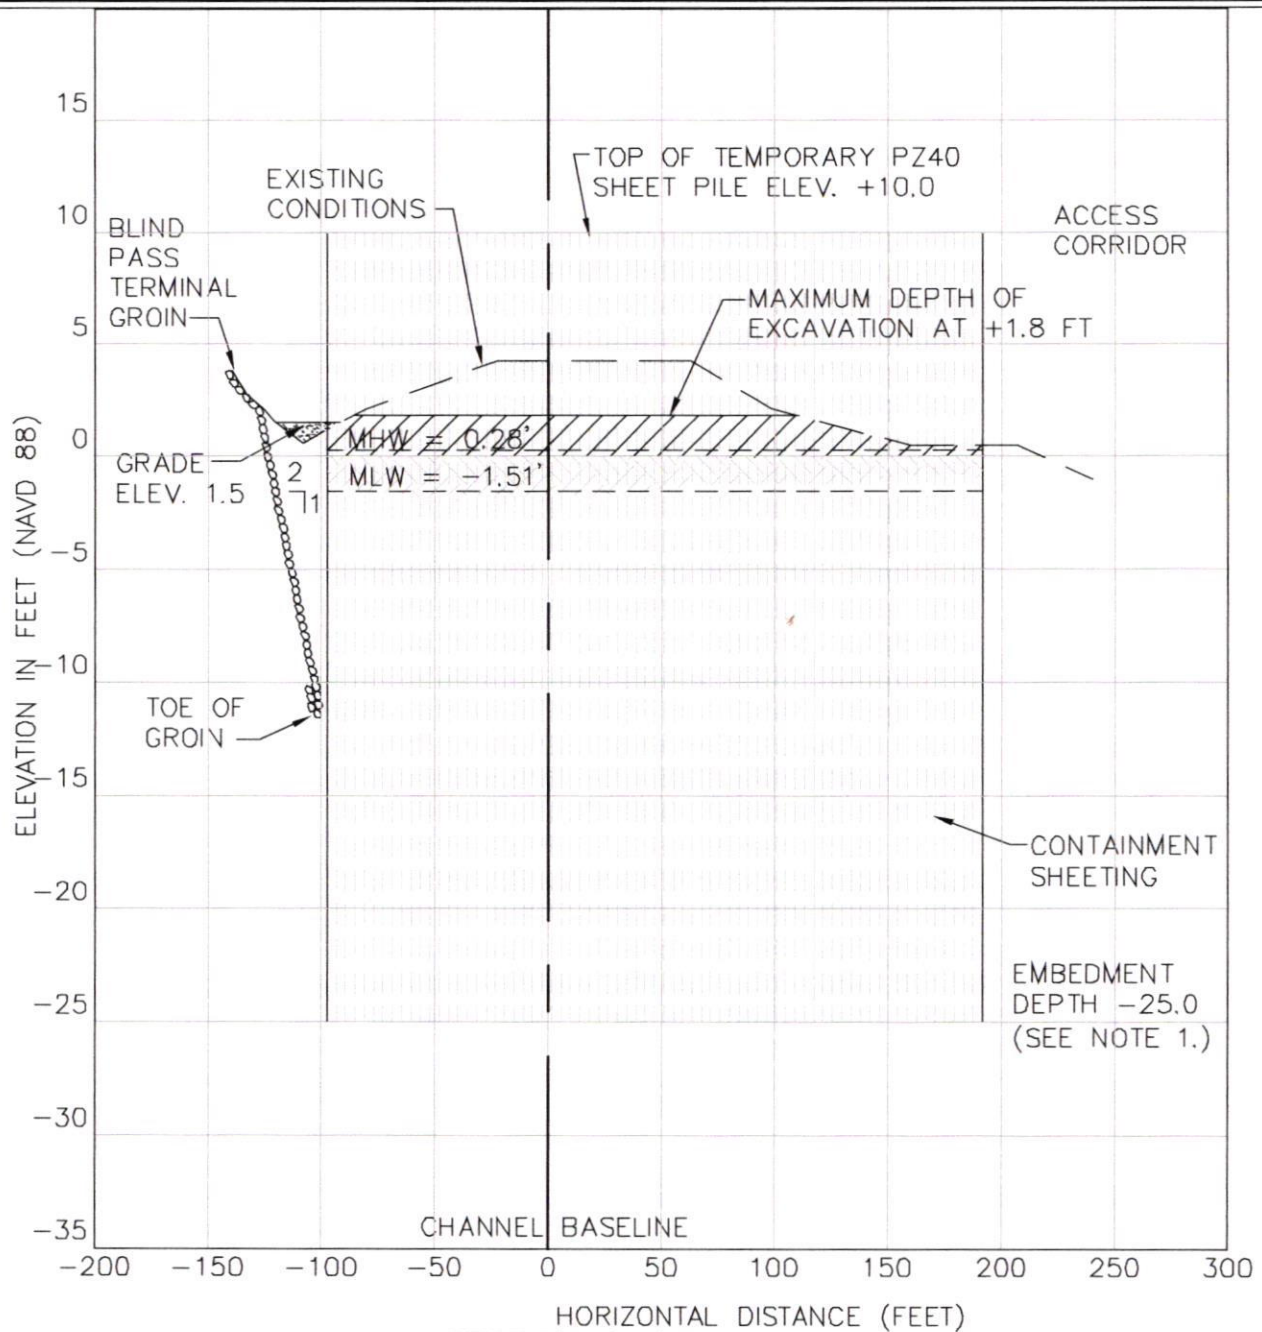
SECTION A-A  
 SAND CONTAINMENT CELL  
 SCALE: HORIZ. 1"=80 FEET  
 VERT. 1"= 8 FEET

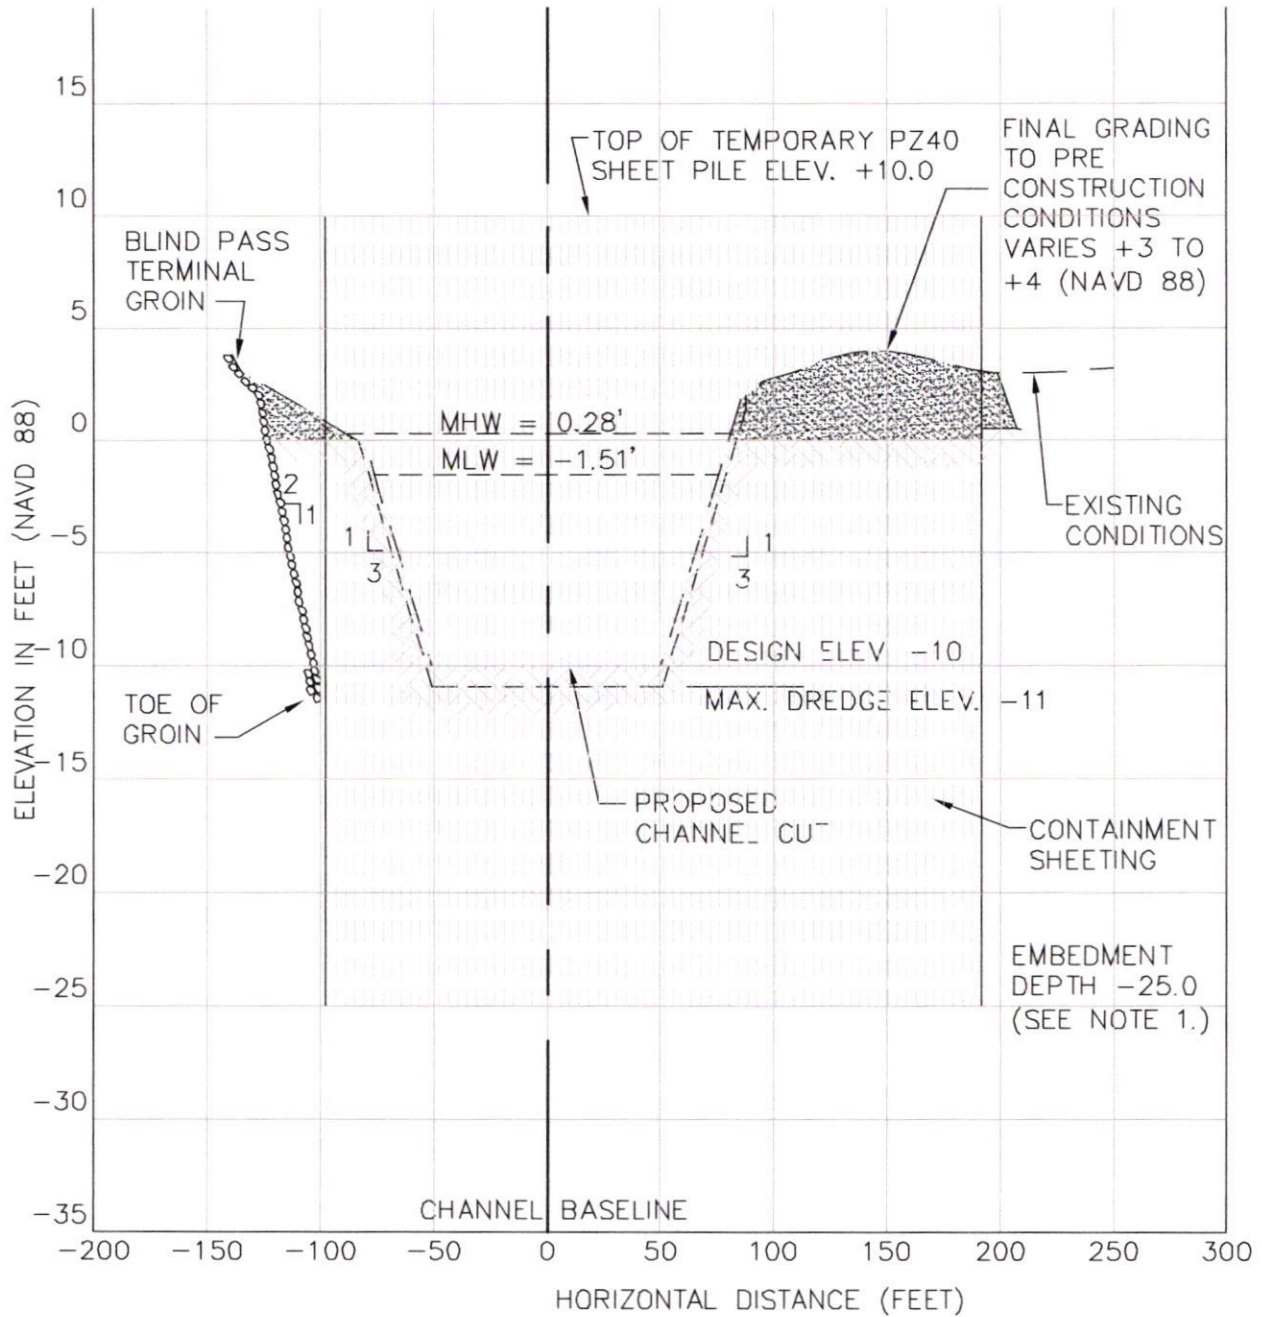
SECTION A-A PRIOR TO PASS OPENING  
 SAND CONTAINMENT CELL  
 SCALE: HORIZ. 1"=80 FEET  
 VERT. 1"= 8 FEET

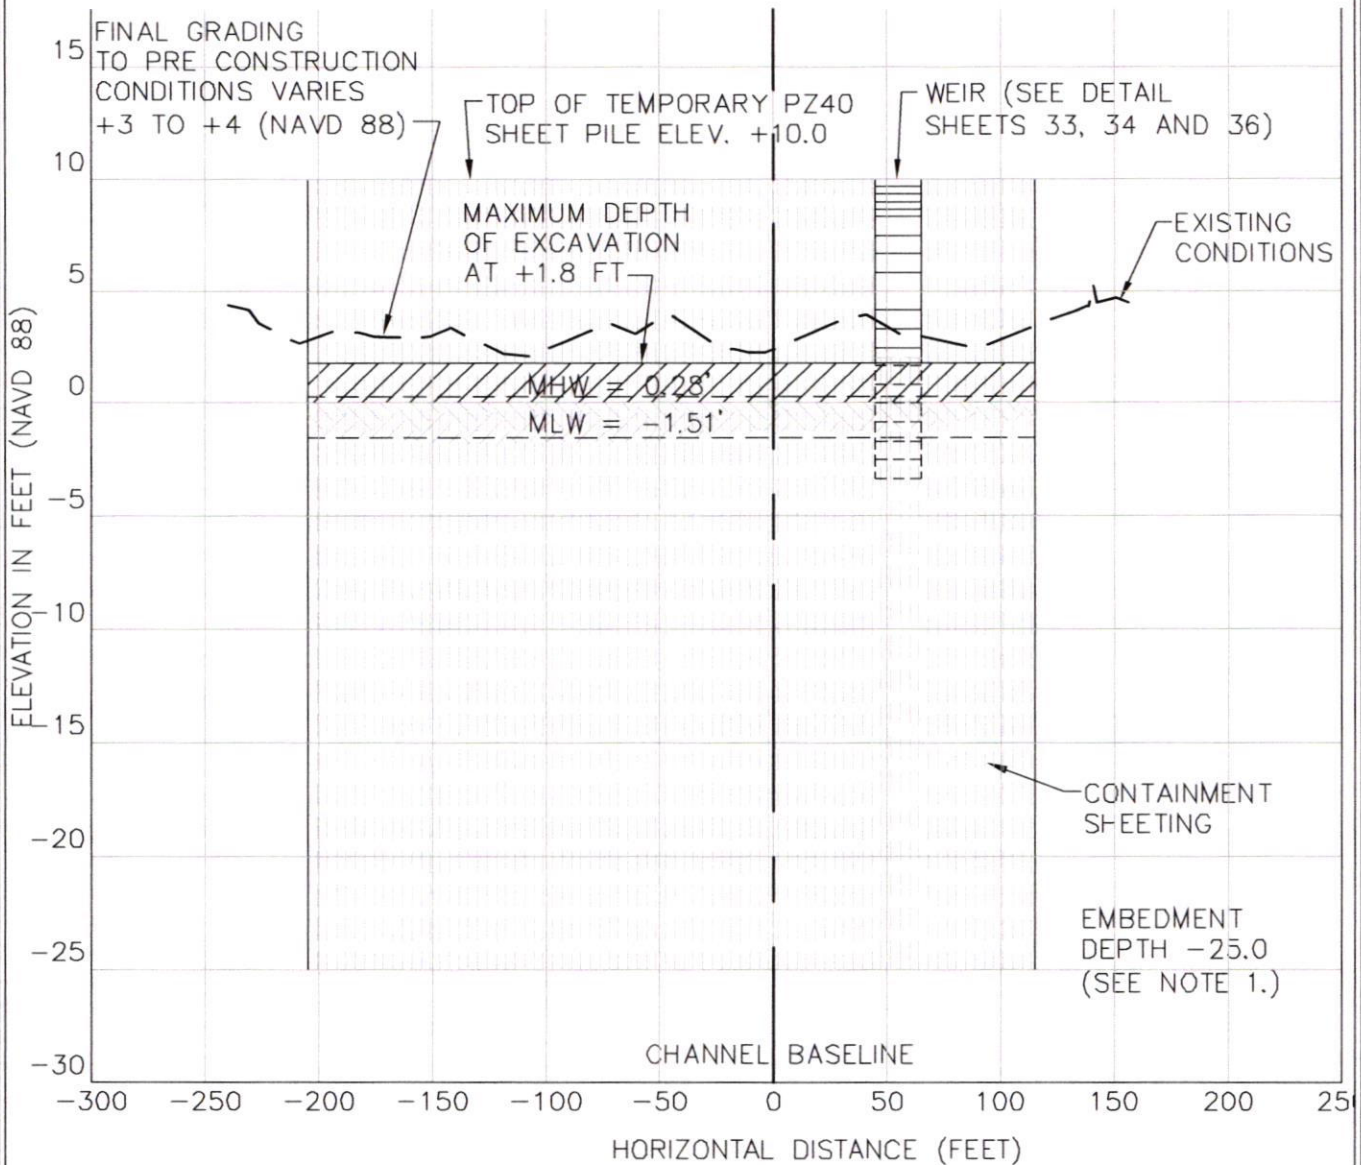
SECTION B-B  
SAND CONTAINMENT CELL  
SCALE: HORIZ. 1"=80 FEET  
VERT. 1"= 8 FEET

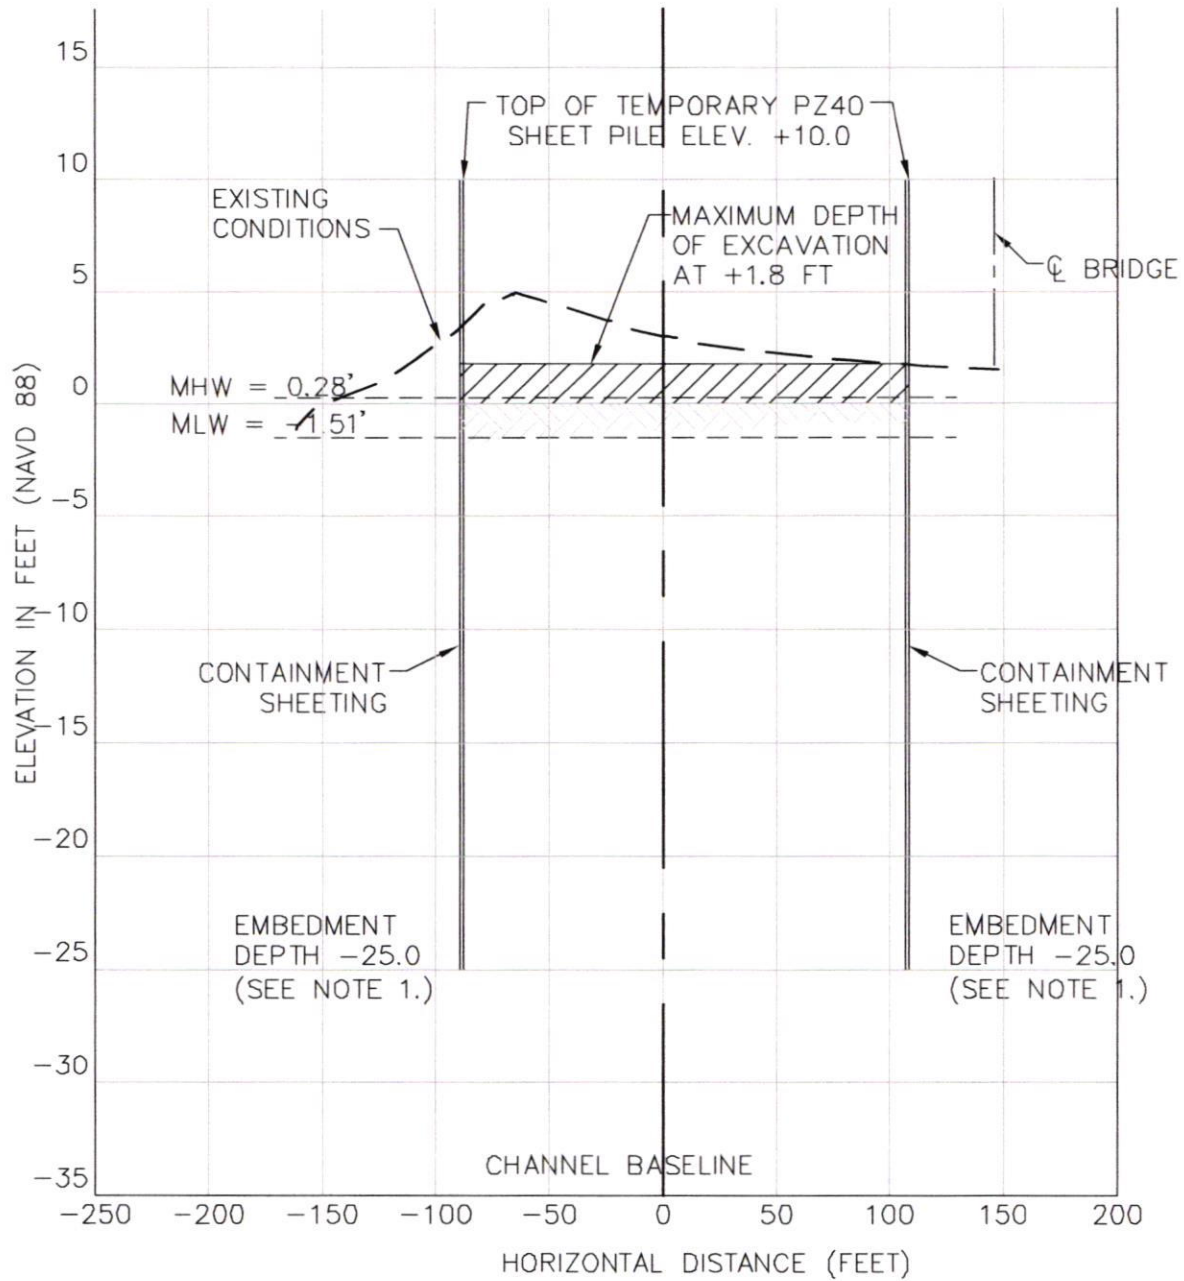
SECTION C-C  
SAND CONTAINMENT CELL  
SCALE: HORIZ. 1"=80 FEET  
VERT. 1"= 8 FEET

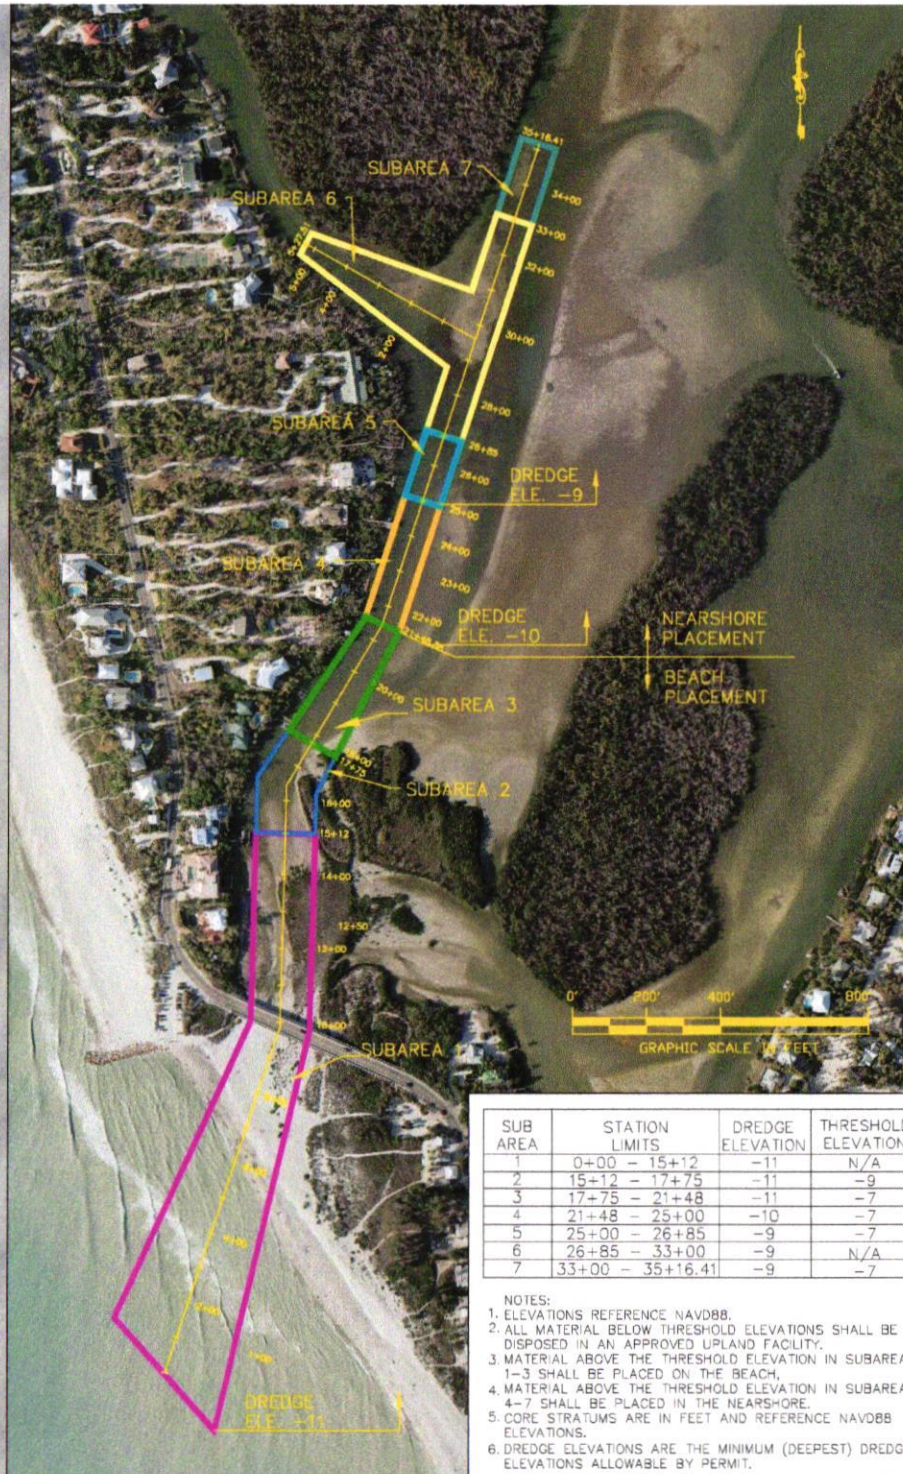
## Project Footprint

- Seven sub areas identified due to sediment concerns.
- 127,000 total cubic yards to be removed.
- 10,275 to be disposed upland.
- 32,359 to be placed in the nearshore zone.
- 80,039 to be placed directly on the beach.

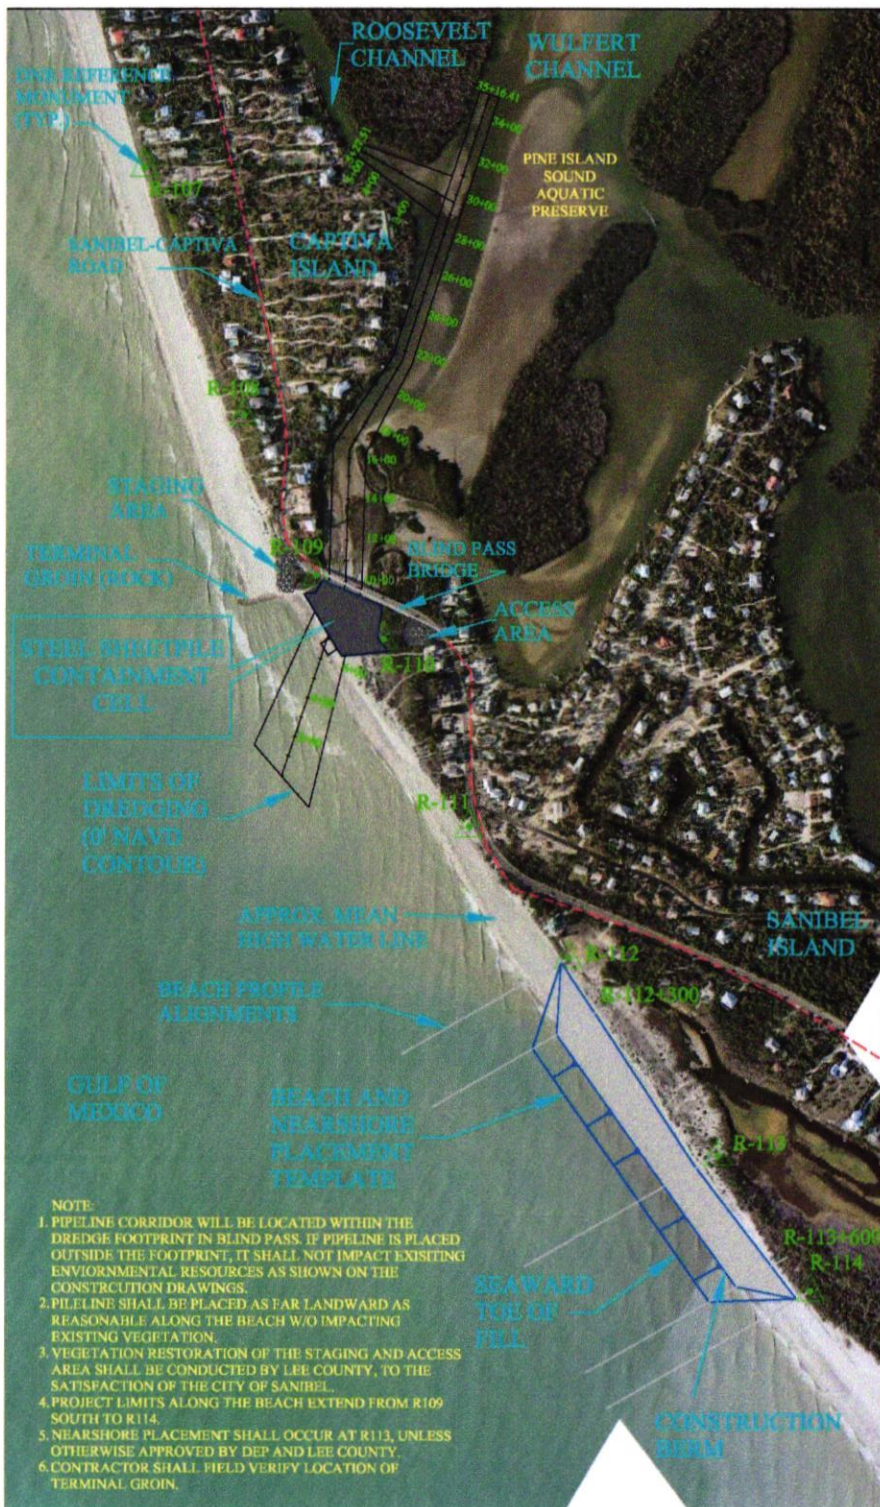
# Beach Fill Area

- Beach and Nearshore Placement will occur between R112 and R114.
- Average Shoreline Extension 100 ft.
- Approx. 500ft of beach will be closed to public at any one time.
