Sea Level Rise Vulnerability Analysis

PHASE 1 OCTOBER 2022

Captiva Erosion Prevention District (CEPD) 11513 Andy Rosse Lane Captiva, FL 33924

Aptim Coastal Planning & Engineering, LLC (APTIM) 6401 Congress Avenue, Suite 140 Boca Raton, FL 33487

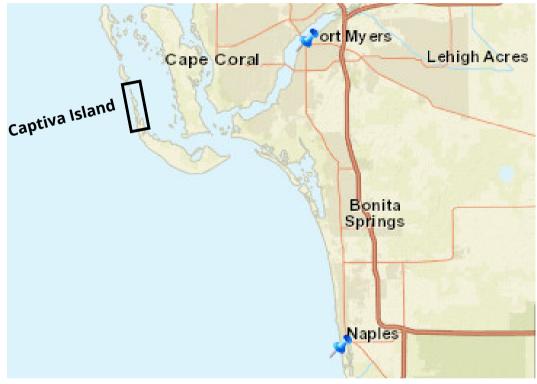
Figure 1. Tide Gauge Locations Near Captiva, FL

The Captiva Erosion Prevention District (CEPD) is located in close proximity to two tide gauges- station 8725520 in Fort Myers, FL and station 8725110 in Naples, FL (see Figure 1). Both gauges are operated and maintained by NOAA/NOS/CO-OPS, and published on NOAA's Tides & Currents website (http:\\tidesandcurrents.noaa.gov).

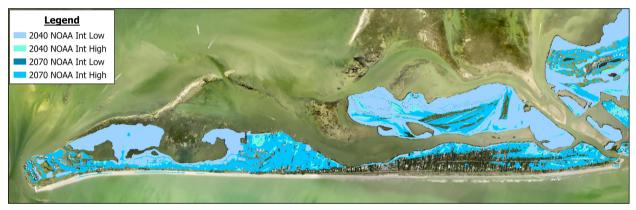
Figure 9. Island Inundation Comparison Map for NOAA Scenarios- 2040 NOAA Intermediate High and 2070 NOAA Intermediate Low

projections for the planning horizons of 2040 and 2070. As stated previously, due to the close proximity of water elevation levels, the 2040 NOAA Intermediate High (1.2 ft NAVD) and 2070 NOAA Intermediate Low (1.3 ft NAVD) do not represent significant differences in inundation extent or depth. Because of this the two scenarios were compared for the purpose of the sensitivity analysis. Figure 9 displays no difference between the scenarios' exposure analysis, which further validated the comparison.

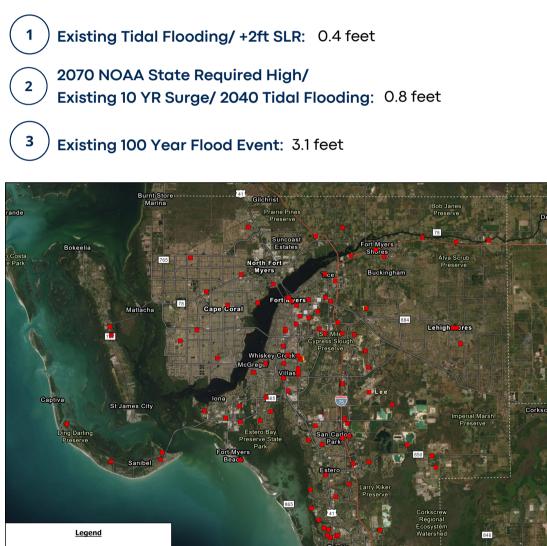
A Solid and Hazardous Waste Facility does not exist on Captiva Island. The nearest facility, the Sanctuary Golf Club was examined for the purpose of this assessment and is located one mile from Captiva's southern tip (Figure 29). The average depth of anticipated inundation under the three inundation tipping point scenarios are as follows:

Figure 29. Lee County Solid and Hazardous Waste Facilities

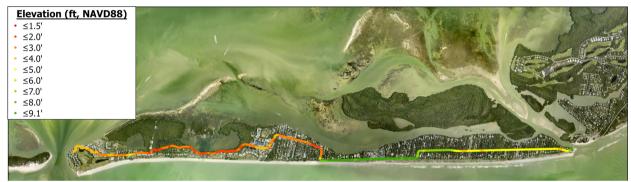
Captiva Drive serves as the island's evacuation route and its only connection to Sanibel. Inundation along this roadway could result in service interruptions, road closures, traffic delays, emergency service delays and overall loss of evacuation. The elevation of this roadway was assessed to determine the specific segments of the roadway at the lowest elevations, as these areas are most likely to flood first and to pose the greatest threat to service and evacuation interruptions. Figure 37 depicts the results of the initial elevation evaluation. Overall, the Northern portion of Captiva Island sits at a lower elevation than the remainder of the roadway and runs in close proximity to the bayside edge of the island with little to no buffer against the water body.

Figure 37. Captiva Evacuation Route Elevation

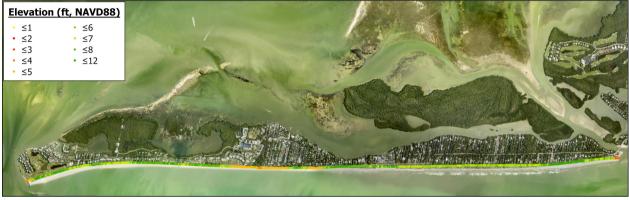
Figure 58. Shoreline Elevation Map.

To determine estimated shoreline inundation, the Erosion Control Line (ECL) was assessed under the relevant inundation scenarios. To determine estimated shoreline inundation, the Erosion Control Line (ECL) was assessed under the relevant inundation scenarios. Figure 58 highlights the elevation of Captiva's shoreline.

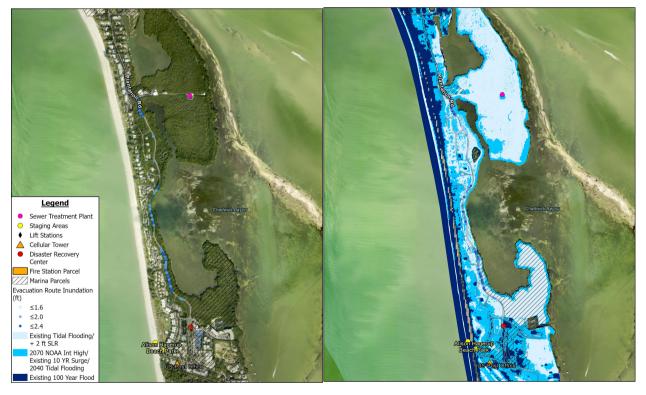
Figure 64. Chadwick Bayou AAA Map

The Chadwick Bayou AAA is the Northern most AAA identified on Captiva (Figure 64). This area contains various vulnerable critical facilities including a sewer treatment plant, a disaster recovery center, the Captiva post office, logistical staging areas, marinas, and low-lying evacuation route road segments. The flood risk for this area is along the bayside of the island, as little land buffers Captiva's roads and infrastructure from the Chadwick Bayou's waters. To create protection along this area, the following strategies can be implemented:

- Mangrove enhancement
- Connect mangroves or design something to allow flushing at high tide level that can be adapted over the years
- Sediment supply for mangroves coupled with shoreline protection (long term adaptation strategy)
- Enhance seagrass to stabilize the narrow island portion
- · Elevate or protect vulnerable low-lying road segments

Four geographic areas were noted as having concentrated vulnerabilities colocated with key critical assets within Captiva Island. These areas include properties and resources adjacent to Chadwick Bayou, Central Captiva, the Roosevelt Channel and Blind Pass. In addition, the bayside of the island was found to be more vulnerable to flooding than the oceanside. Short term, flooding of various types along the bay could lead to flood trespassing across bayfront shorelines. Addressing the vulnerabilities in these areas through policy and strategy will be a primary focus of the next phase of effort, the resilience plan.

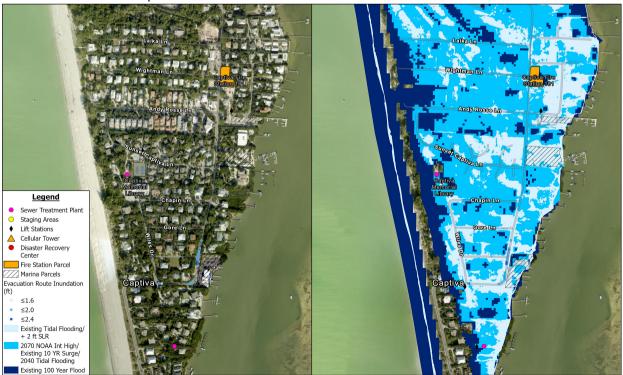
Figure 66. Central Captiva AAA Map

Predicted future inundation for the Central Captiva AAA is also predicted mostly along the bayside of the island (Figure 66). More specifically, a few areas of sea level rise flooding along the bayside of Captiva serve as entry points for inland flooding, allowing water to move towards and threaten critical infrastructure. Such infrastructure includes the Captiva Fire Station, Captiva Memorial Library, two treatment plants, four lift stations, marinas, and low-lying evacuation route road segments. Initial adaptation strategies could include:

- Introduce sill or encourage seagrass between sandbars depicted in Figure 65 to reduce surge, wave action, and erosion at the narrowest point of the island on the backside
- Seal up vulnerable bayside area with seawalls or berms to prevent flow across property onto main road (policy)
- Harden fire station and tide valves
- Establish sill to slow surge around this area

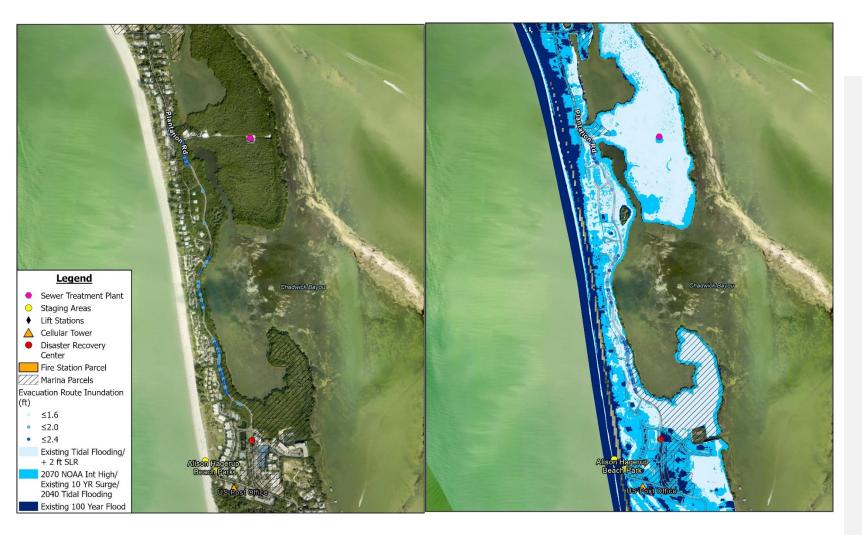
CHADWICK BAYOU AAA

- Mangrove enhancement area
 - Sediment supply for mangroves coupled with shoreline protection (long term adaptation strategy)
- Connect mangroves or design something to allow flushing at high tide level that can be adapted over the years
- Enhance seagrass to stabilize the narrow island portion
- Elevate or protect vulnerable lowlying road segments

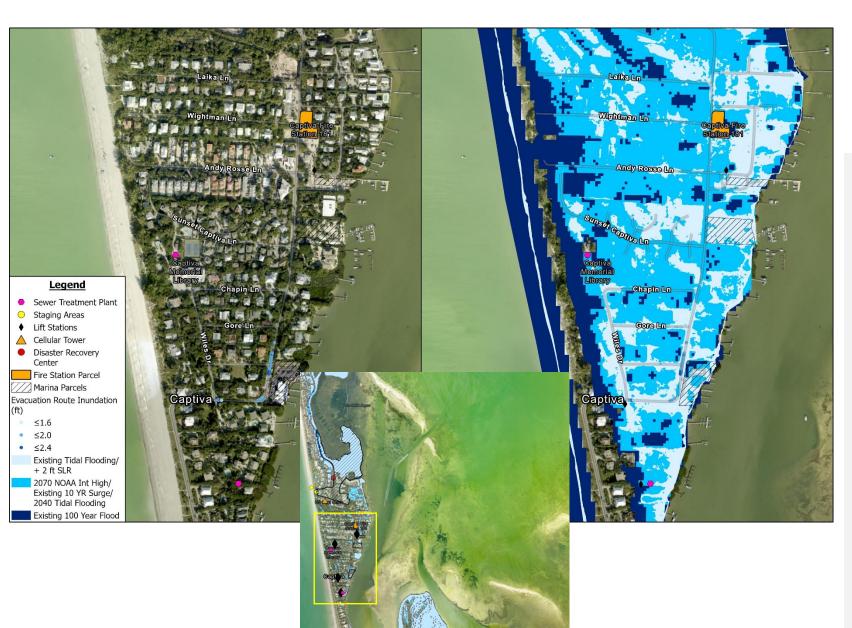
CENTRAL CAPTIVA AAA

- Introduce sill or encourage seagrass between sandbars to reduce surge, wave action, and erosion at the narrowest point of the island on the backside
- Seal up vulnerable bayside area with seawalls or berms to prevent flow across property onto main road (policy)
- Harden fire station and tide valves
- Establish sill to slow surge around this area

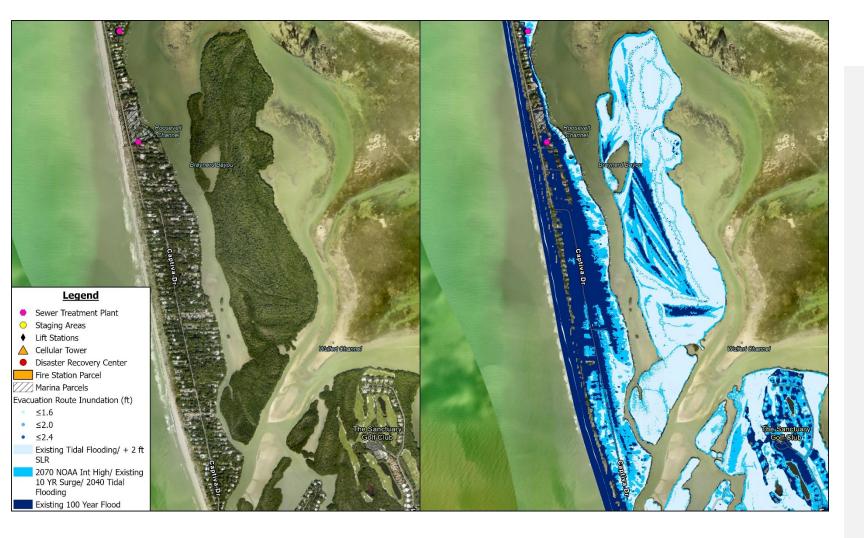
ROOSEVELT CHANNEL AAA

- Install flood gates at North and South end of channel or focus on flood
- Elevate buildings along shoreline
- Seawalls (policy)

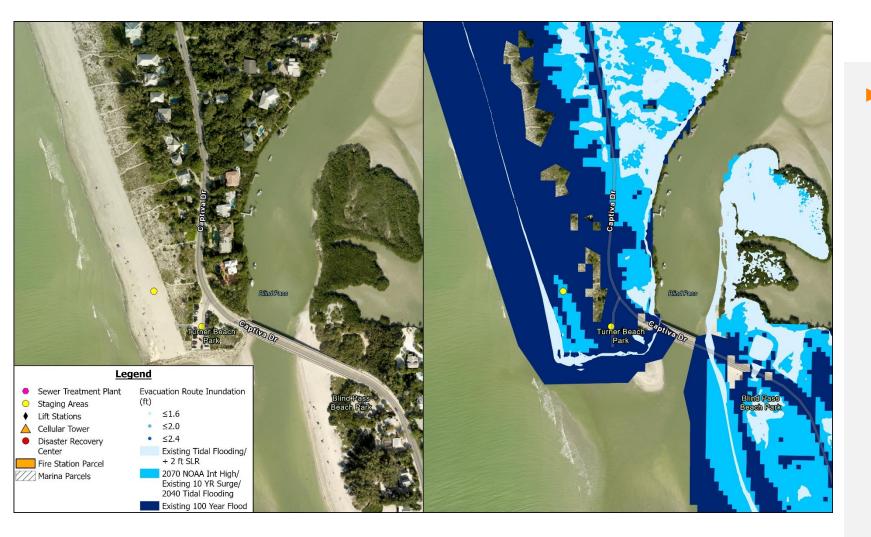
BLIND PASS AAA

Seal up vulnerable bayside area with seawalls or berms to prevent flow across property onto main road (policy)
