## CAPTIVA EROSION PREVENTION DISTRICT RESOLUTION 2023-02

A RESOLUTION OF THE CAPTIVA EROSION PREVENTION DISTRICT APPROVING THE VULNERABILITY ANALYSIS; AND PROVIDING AN EFFECTIVE DATE.

Approve the Vulnerability Analysis as provided by APTIM in Exhibit A

PHASE 1

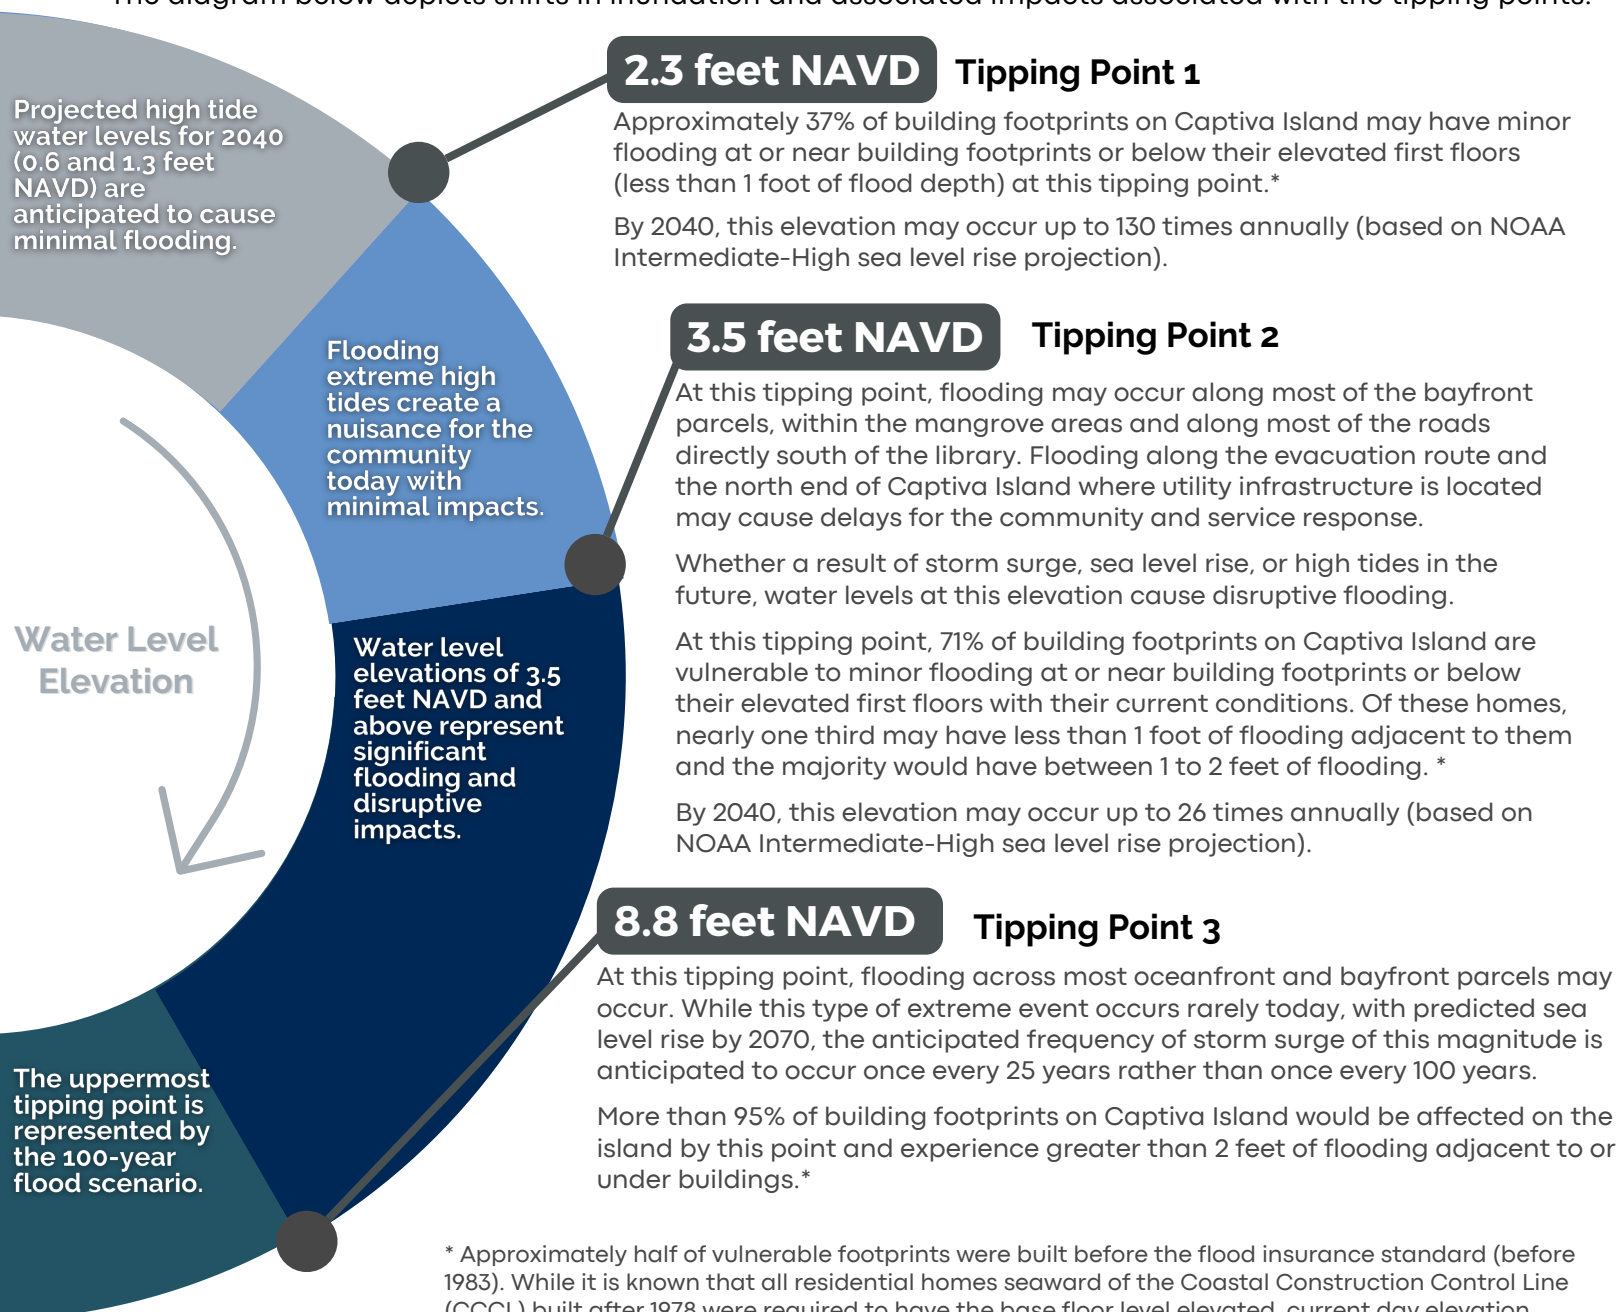
- The elevation of 2.3 feet NAVD occurred or was exceeded 6 times in the past 10 years.
  - The elevation of 3.5 feet NAVD occurred once in the past 10 years.

- The elevation of 8.8 feet NAVD may have occurred at least once (based on high water data from Hurricane Ian (SCCF, 2022).
- The diagram below depicts shifts in inundation and associated impacts associated with the tipping points.

\* Approximately half of vulnerable footprints were built before the flood insurance standard (before 1983). While it is known that all residential homes seaward of the Coastal Construction Control Line (CCCL) built after 1978 were required to have the base floor level elevated, current day elevation certificates were unavailable, and thus, this analysis solely serves as a first order assessment.

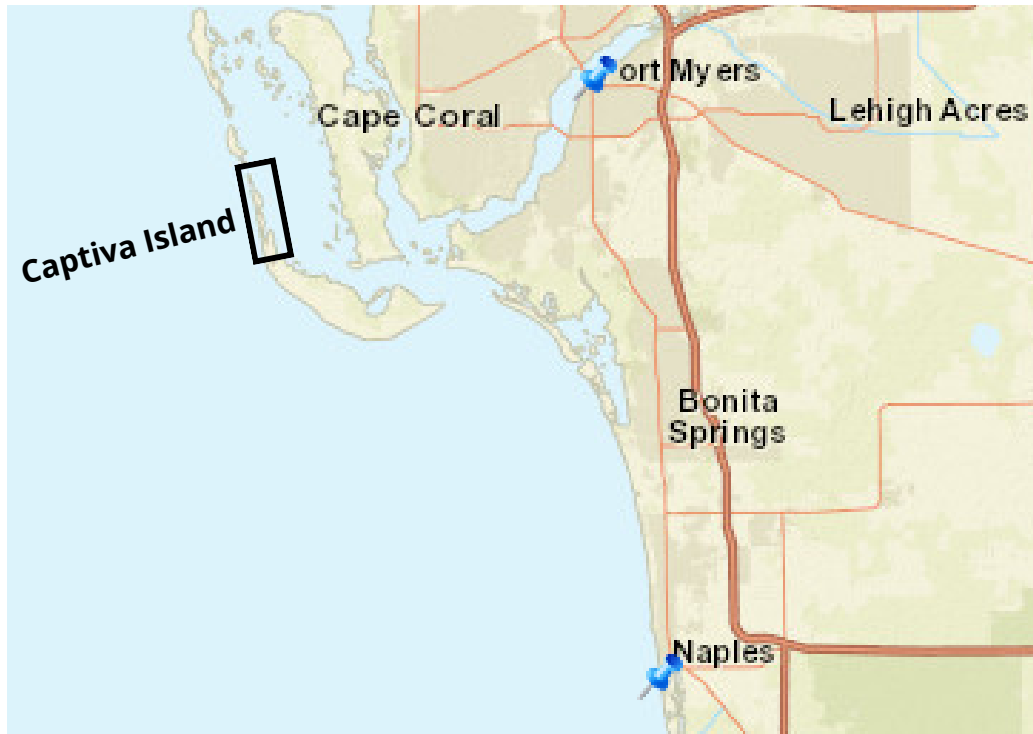
Figure 1. Tide Gauge Locations Near Captiva, FL

The Captiva Erosion Prevention District (CEPD) is located in close proximity to two tide gauges- station 8725520 in Fort Myers, FL and station 8725110 in Naples, FL (see **Figure 1**). Both gauges are operated and maintained by NOAA/NOS/CO-OPS, and published on NOAA's Tides & Currents website (<http://tidesandcurrents.noaa.gov>).

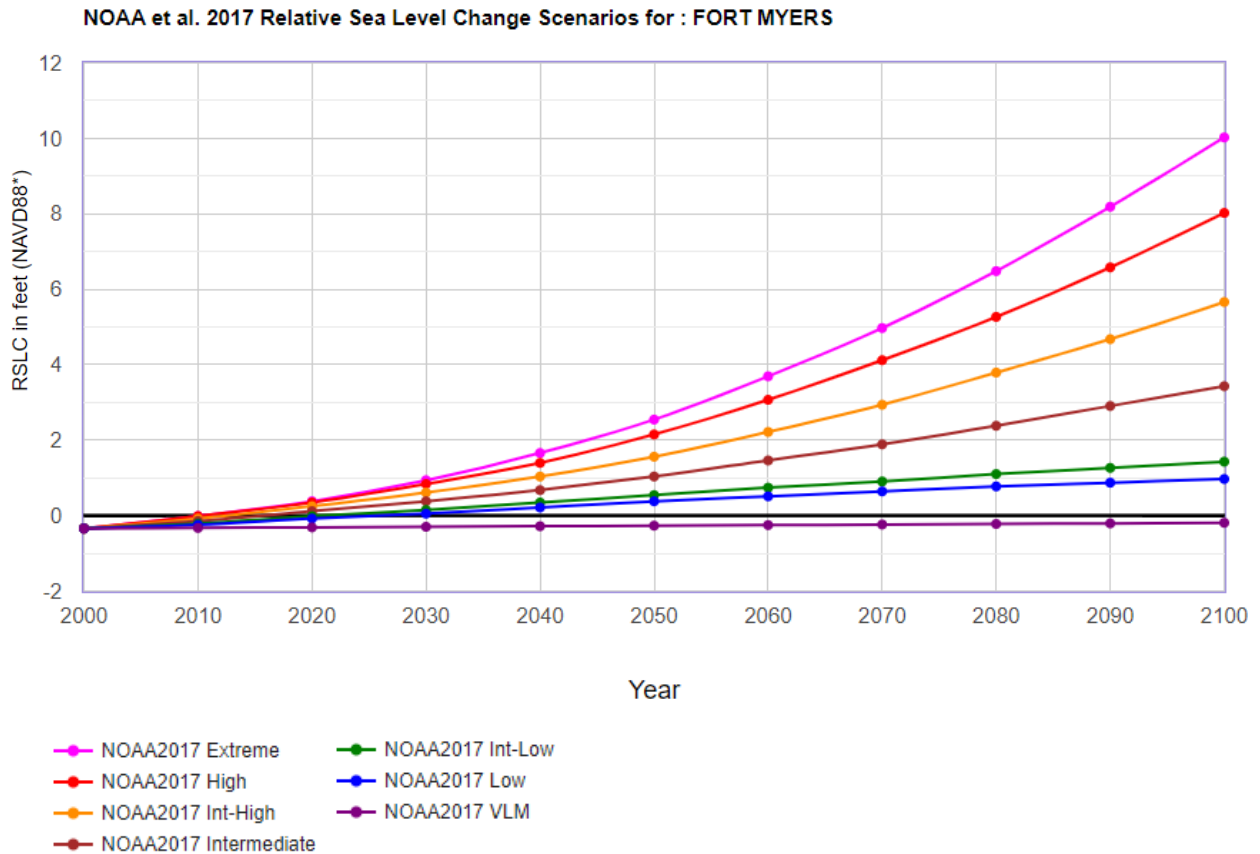
Figure 2. NOAA 2017 Relative Sea Level Change Scenarios for Fort Myers, FL

**Sea level rise projections** utilized for mapping purposes in this assessment were retrieved from the Fort Myers station as it is the closest gauge with the highest mean sea level (-0.41 NAVD, compared to -0.62 MSL at the Naples, FL gauge). State guidance for vulnerability assessments suggests the closest gauge with the highest mean sea level be used. It is noted that the gauge is located inland and may be an underestimate of actual individual high tide events on Captiva Island. Relative to the current Mean Higher High Water (MHHW) level at the Fort Myers gauge, the sea level change scenarios for Fort Myers indicate a water level of 0.63 feet NAVD according to the 2040 Intermediate-Low scenario, a water level of 1.31 feet NAVD according to the 2040 Intermediate-High scenario and a water level of 3.2 feet NAVD according to the 2070 Intermediate-High scenario. These projections were selected based on state guidance. **Figure 2** depicts the NOAA 2017 relative sea level rise change scenarios for Fort Myers.

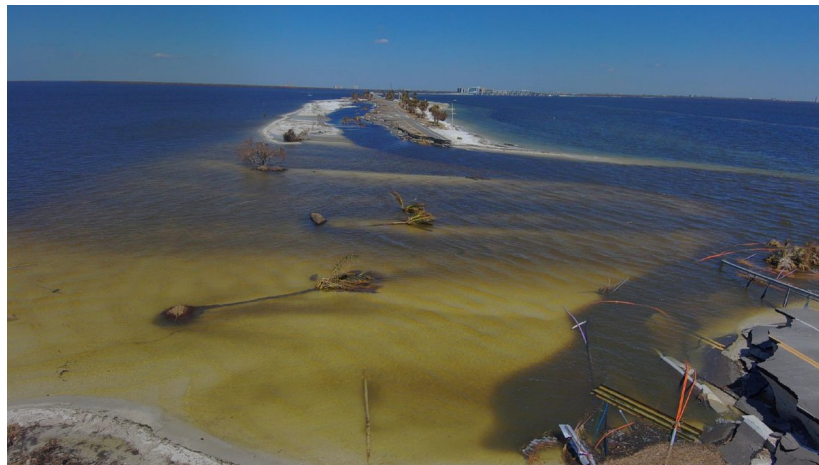
Figure 7. Hurricane Ian Damage to Sanibel Causeway (FDOT, 2022)

The bayside of Captiva Island experienced a high degree of flooding, which resulted in impacts to communication facilities and roadways. According to FPL's Power Tracker (electric utility), 85% of Lee County FPL customers were without power the morning after the storm. Much of Captiva's key infrastructure such as water treatment plants, and evacuation route were all impacted by inundation. **Figure 7** highlights an example of infrastructure damage in the aftermath of Ian. Of significance was the collapse of approximately 50 to 65 feet of the Sanibel Causeway bridge, which resulted from the storm's aggressive storm surge and powerful winds. This bridge serves as the only vehicle connection from Captiva and Sanibel to the mainland of Florida, and thus its destruction served as a significant hinderance to Captiva Island residents as they were unable to access resources and aid.

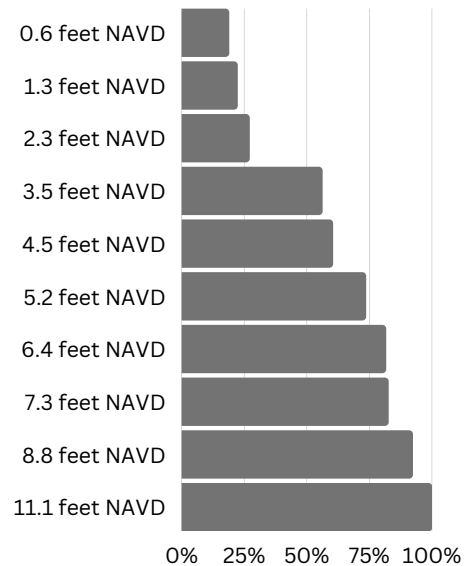
Figure 8. Percentage of Captiva Inundated Under All Flood Scenarios

To provide a comprehensive view of inundation, it is important to review the exposure predictions of Captiva Island under all relevant scenarios and planning horizons mentioned. By doing so, various inundation depths and spatial extents can be compared to each other and in relation to the depths utilized in the 2020 Captiva Island Resiliency Assessment and more incremental flooding can be visualized (Figures 9-12). Figure 8 compares the overall percentage of island inundation for each of the scenario water level elevations. Table 3 can be referenced to identify the associated scenarios represented by each of the water level elevations depicted in Figure 8.

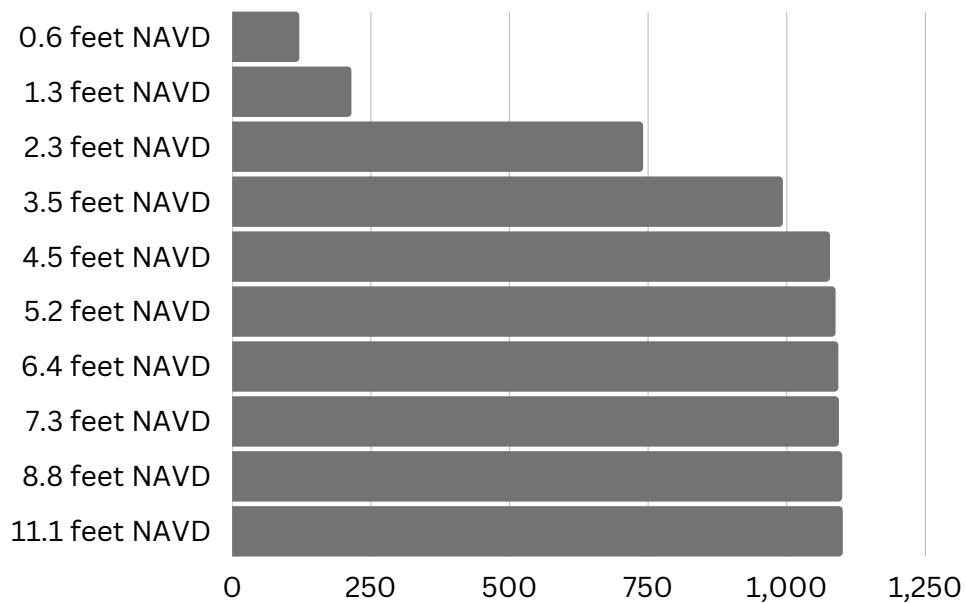
Figure 13. Predicted Number of Impacted Parcels Across All Flood Scenarios

Parcel data was obtained from the Florida Department of Revenue (FDOR) and analyzed for inundation impact from the various flood scenarios. A total of 1,105 parcels exists within Captiva Island. **Figure 13** depicts the number of parcels likely to experience flooding per scenario.

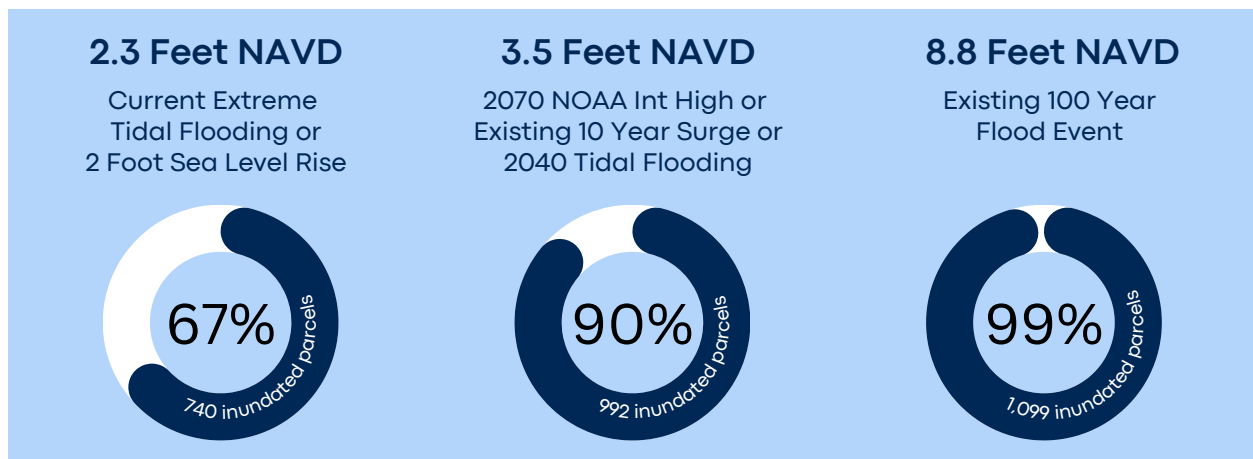
Figure 14. Percentage of Parcel Inundation Under Inundation Tipping Point Scenarios

**Figure 14** displays the number and percentage of inundated parcels for each of the three inundation tipping point scenarios. **Figure 15** depicts a spatial view of the results of this analysis.

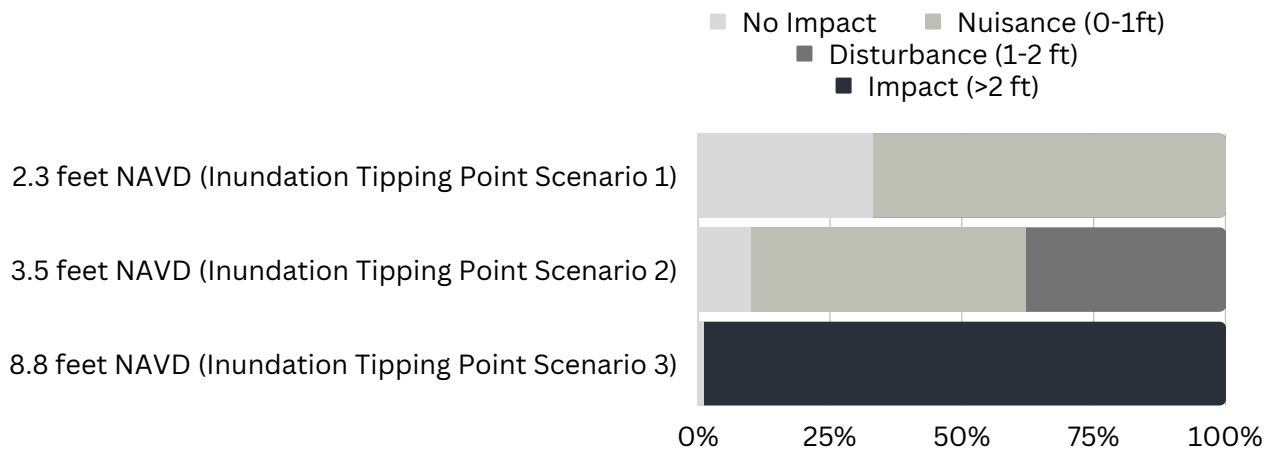
Figure 16. Parcel Inundation Depth Under Inundation Tipping Point Scenarios

Further analysis included estimating the average inundation depth of parcels per flood scenario. The overall results of the inundation depth analysis for the three inundation tipping point scenarios can be seen in **Figure 16**. The further analysis also involved estimating the value of impacted parcels by totaling the value of relevant building footprints within each parcel.

Under the Inundation Tipping Point Scenario 1 (2.3 feet NAVD), 67% of all parcels on Captiva Island will experience nuisance flooding of a depth of below one foot. The market value of affected parcels is \$1.1 billion; however, damage costs of nuisance flooding would be anticipated to be minimal or null.

Under Inundation Tipping Point Scenario 2 (3.5 feet NAVD), 52% of island parcels are subject to nuisance flooding and 38% of all parcels are subject to flooding >1 foot of depth. The inundation from this scenario is projected to impact parcels totaled at a value of \$1.3 billion. Under the Inundation Tipping Point Scenario 3 (8.8 feet NAVD), 99% of island parcels will experience flooding at a depth greater than 2 ft. The value of the parcels impacted equates to \$1.6 billion.

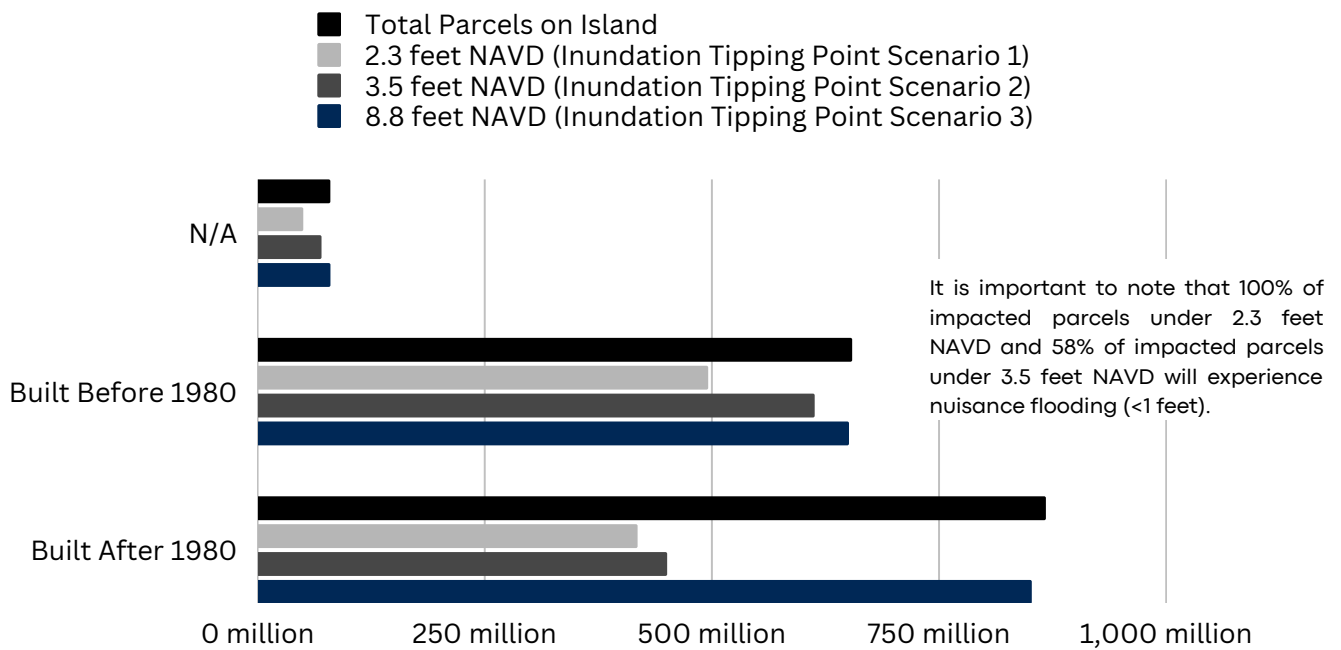
Figure 17. Impacted Parcels by Decade Built and Parcel Value

The age of the structures built were reviewed in relation to the 1983 FEMA base flood elevation standard (**Figure 17**). For presentation purposes, structure ages were grouped by decade and compared to 1980 rather than 1983. Specifically, under the Inundation Tipping Point Scenario 1 (2.3 feet NAVD), 60% of vulnerable parcels were built before 1980, with an estimated present market value of \$500 million. Under the Inundation Tipping Point Scenario 2 (3.5 feet NAVD), 64% of the total vulnerable parcels were built before 1980, with an estimated present market value of \$610 million. According to the Inundation Tipping Point Scenario 3 (8.8 feet NAVD), 60% of impacted parcels were built before 1980, and 40% were built after. The impacted parcels have an estimated present market value of \$650 million. For the purpose of this evaluation, those parcels without a designated built year (labeled "N/A"), were not included in the total parcel count as it is unclear if these parcels were built before or after the implementation of the 1983 FEMA base flood elevation standard.

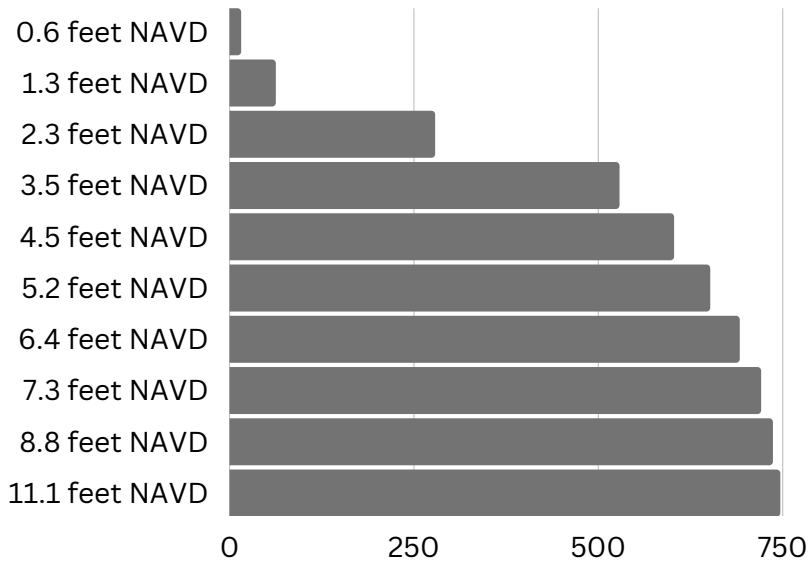
Figure 18. Building Footprint Inundation Across All Flood Scenarios

Seven hundred and forty-seven buildings are located on Captiva. The building footprints for Captiva Island were obtained from Lee County and analyzed for initial inundation impact under the various flood scenarios. **Figure 18** displays the number of building footprints that may experience flooding if their elevations is at ground level. **This analysis does not account for elevation certificates or actual structure first floor elevations. An elevated building will not be inundated.**

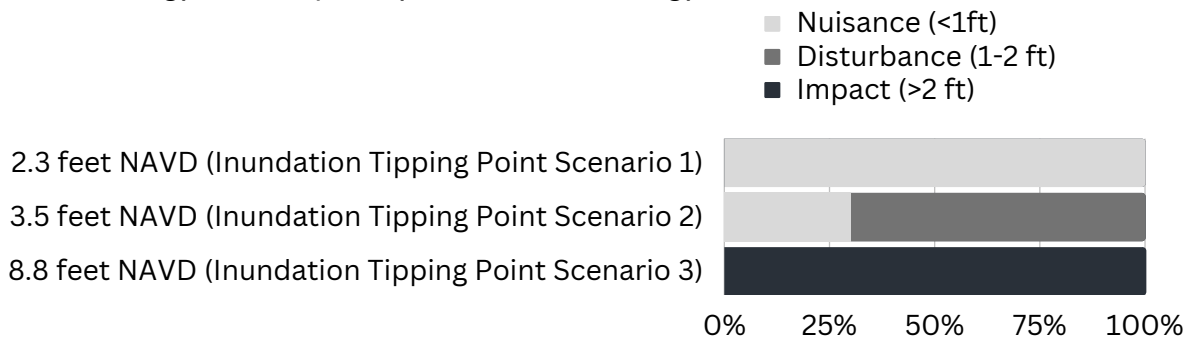
Figure 21. Building Footprint Inundation Depth Under Inundation Tipping Point Scenarios

A more thorough analysis of building footprint inundation included estimating average building footprint inundation depth, classifying the building footprint data by decade built, and estimating building value per scenario. The methodology used here is the same as that used to complete the parcel inundation analysis. Average depth is represented by the center of the grid of inundation. Thus, the total number of impacted building footprints is reduced as not every footprint that intersects the inundation polygons has its center point fall within the inundation grid. **Figure 21** details building sensitivity per scenario and the associated flooding type- nuisance (< 1 foot of flooding), disturbance (1 to 2 feet of flooding), and impact (> 2 feet of flooding).

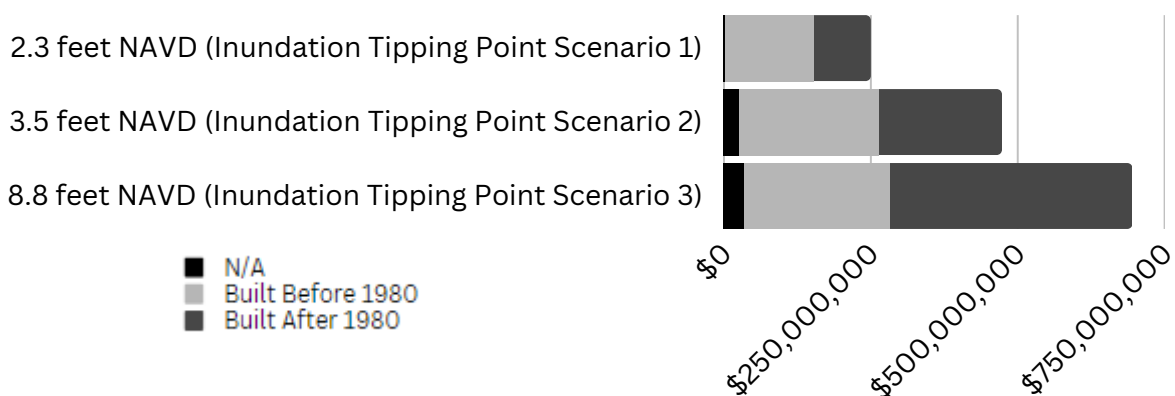
Figure 22 Impacted Building Footprints by Decade Built and Property Value

When reviewing the distribution of the predicted inundated building footprints and their associated estimated value over the decades (**Figure 22**), it is clear that the approximately half of the vulnerable footprints were built before the flood insurance standard (before 1983). Again, it is important to note that this analysis does not take into account the current base floor elevations of the buildings. While it is known that all residential homes seaward of the Coastal Construction Control Line (CCCL) built after 1978 were required to have the base floor level elevated, current day elevation certificates were unavailable, and thus, this analysis solely serves as a first order assessment. In general, the findings of this analysis depict the building footprints that are predicted to have flooding at the ground level adjacent to the building.

Under the 2.3 feet NAVD water level elevation, 36% of the buildings experiencing inundation will have been built before 1980. These buildings have a combine estimated value of \$150 millionllars. According the 3.5 feet NAVD water level elevation, 49% of the buildings predicted to be inundated are buildings built before 1980, with a total estimated value of 240 million. Under the 8.8 feet NAVD water level elevation, 46% of effected buildings were built before 1980, with an estimated value of 250 million. As stated previously, parcels without a designated built year were not included in the total parcel count.

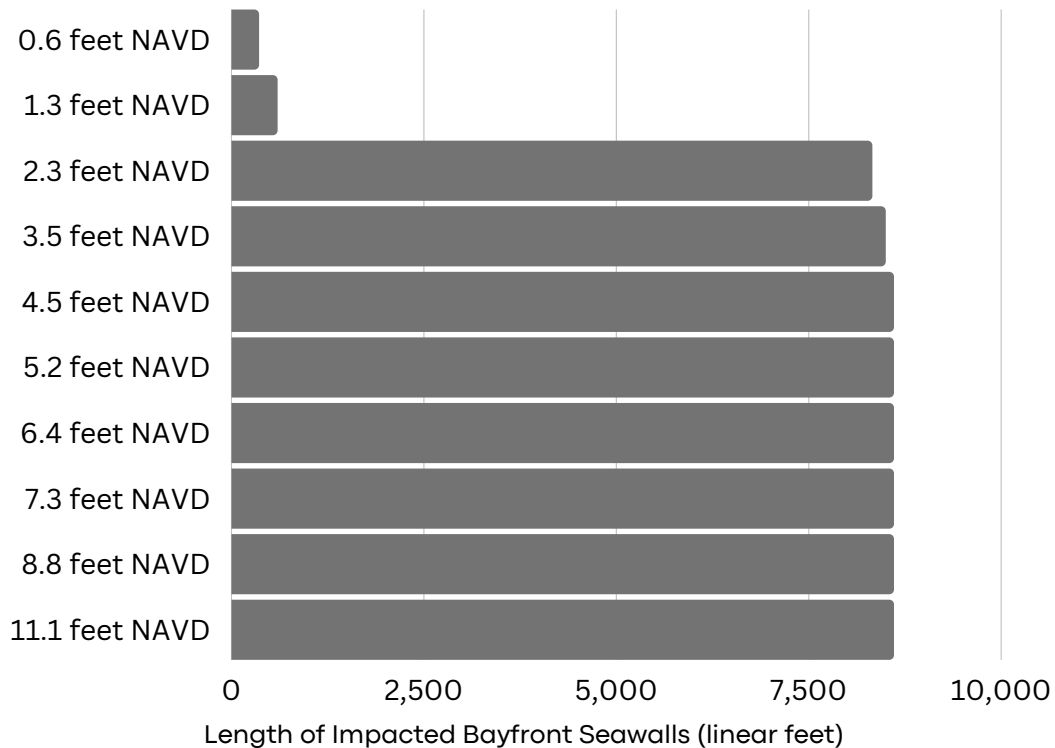
Figure 23. Length of Seawalls Inundated for Each Flood Scenario (Linear Feet of Seawall)

As-built survey data was not available for the analysis of seawall height, so an alternative method to represent seawalls in the analysis was performed using available ground elevation data for parcels. The predicted exposure (in linear feet) of seawalls per scenario is depicted in **Figure 23**. All seawalls are expected to be exposed under all water level elevations 4.5 feet NAVD and above.

- Flooding across the bayfront shorelines may cause critical infrastructure to be vulnerable in the near term (prior to 2040). **Approximately 97% of bayfront seawalls are currently vulnerable, the majority of which are in the central part of the island.**

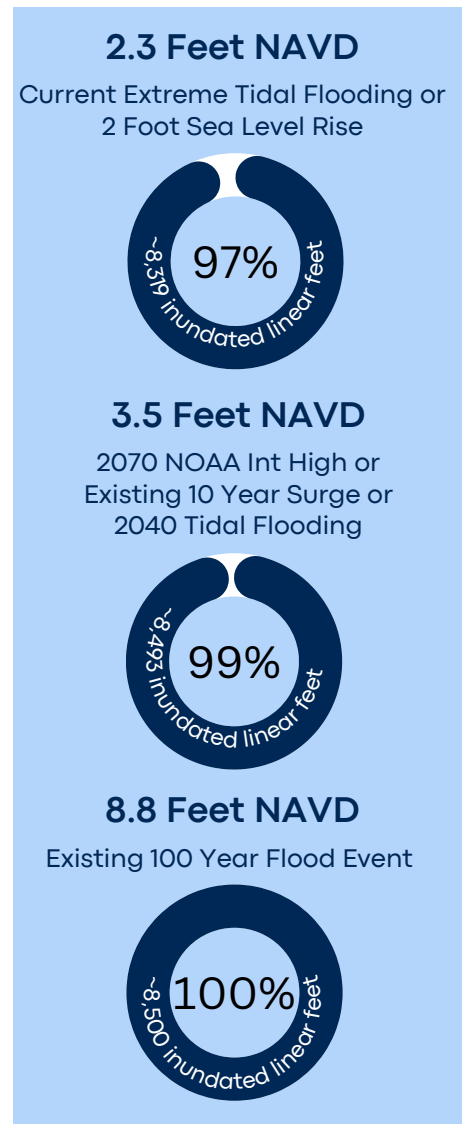
The majority (>97%) of bayfront seawalls are expected to experience flooding under all flood scenarios. Approximately 8,319 linear feet of seawalls are expected to be exposed under the first inundation tipping point scenario (2.3 feet NAVD). Seawall inundation increases to 8,493 linear feet under the 3.5 feet NAVD water level elevation. Under tipping point scenario 3 at 8.8 feet NAVD, all of Captiva's seawalls will experience flooding. The locations and extents of inundated seawalls per tipping point scenario can be viewed in **Figure 25**.

Figure 24. Percentage of Seawall Exposure Under Inundation Tipping Point Scenarios

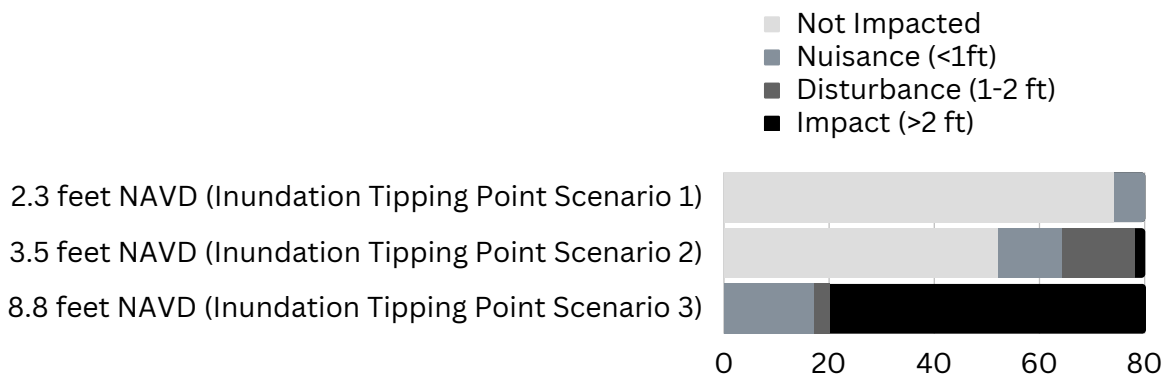
Figure 30. Electrical Transformers and Utility Boxes Inundation Depth Under Inundation Tipping Point Scenarios

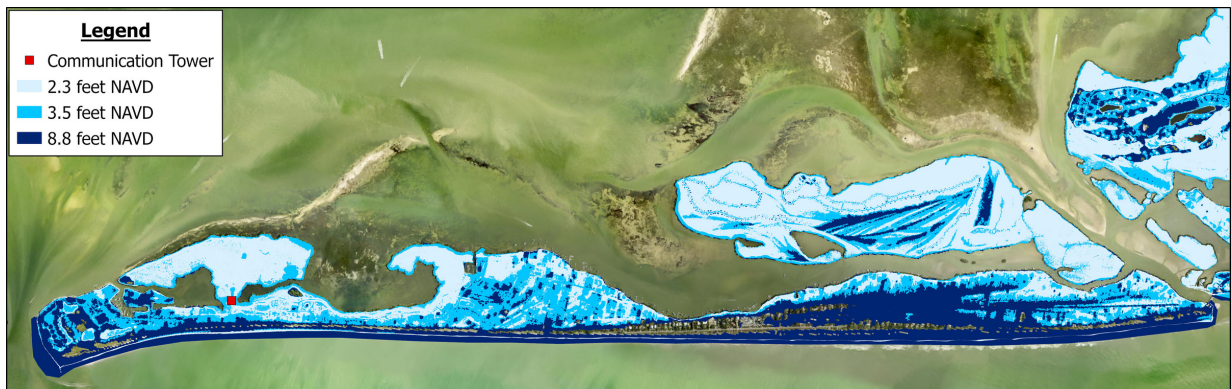
Individuals rely on communication facilities to relay information, connect with others, call for help, etc. If a communication tower is flooded and inoperable, it could result in nearby residents and facilities being unable to reach or receive calls which can be dangerous, especially because the local Emergency Medical Services (EMS) facility is located on Captiva Island. **Figure 31** depicts the communication facility on Captiva Island located directly west of the South Seas Wastewater Treatment Plant. The South Seas tower was identified in the 2020 Captiva Island Resiliency Assessment produced by Integral consulting. Additional communication facilities across Lee County can be viewed in Appendix I.

Figure 31. Communications Facilities Inundation Map for Inundation Tipping Point Scenarios

The closest inundation point was utilized to predict potential flood impacts to the communication tower. The results of this analysis predict that under the 2.3 feet NAVD water level elevation, the communication tower will not experience flooding. According to the Inundation Tipping Point Scenario 2 (3.5 feet NAVD), the South Seas Tower will experience inundation with an average depth of 0.8 feet. The flooding threat to the tower increases under the 8.8 feet NAVD water level elevation, with an average projected flood depth of six feet.

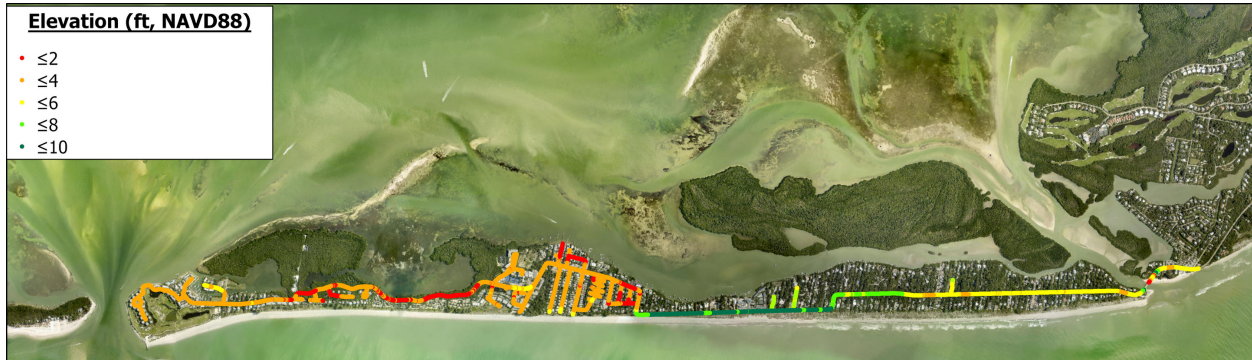
**Figure 35** depicts road elevation for all roads on Captiva, which helps to visualize low lying areas and road segments that would be the first to flood. It is evident that the majority of roads on the northern half of the island are at lower elevations than roads on the southern half of the island.

Figure 35. Captiva Roads Elevation Map

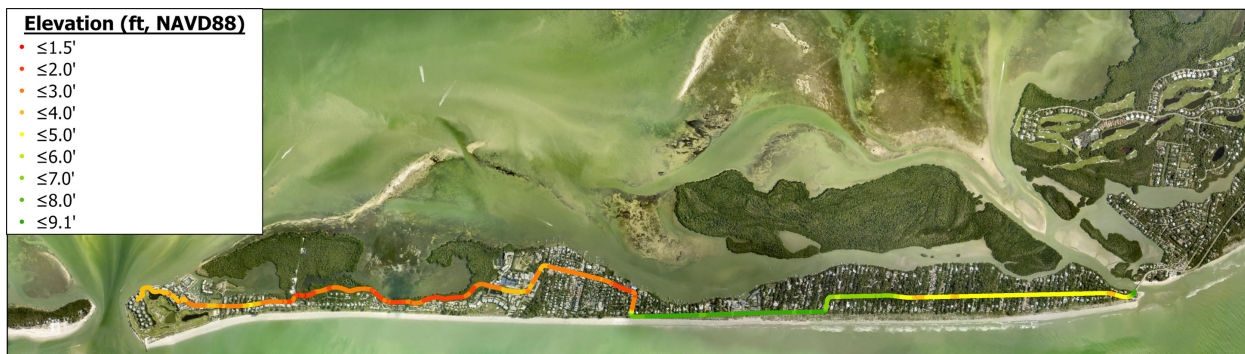
Captiva Drive serves as the island's evacuation route and its only connection to Sanibel. Inundation along this roadway could result in service interruptions, road closures, traffic delays, emergency service delays and overall loss of evacuation. The elevation of this roadway was assessed to determine the specific segments of the roadway at the lowest elevations, as these areas are most likely to flood first and to pose threat to service and evacuation interruptions. **Figure 38** depicts the results of the initial elevation evaluation. Overall, the northern portion of Captiva Island sits at a lower elevation than the remainder of the roadway and runs in close proximity to the bayside edge of Captiva Island with little to no buffer against the water body. It is important to note that Captiva Island is within evacuation zone A, and thus, it is expected that during storm surge events, the island will be evacuated, and roadway accessibility will not be required. However, flooding from tidal conditions, sea level rise, and compounded sources, pose inundation threats to the evacuation route, which residents would rely on to leave the island if circumstances necessitated.

Figure 38. Captiva Evacuation Route Elevation

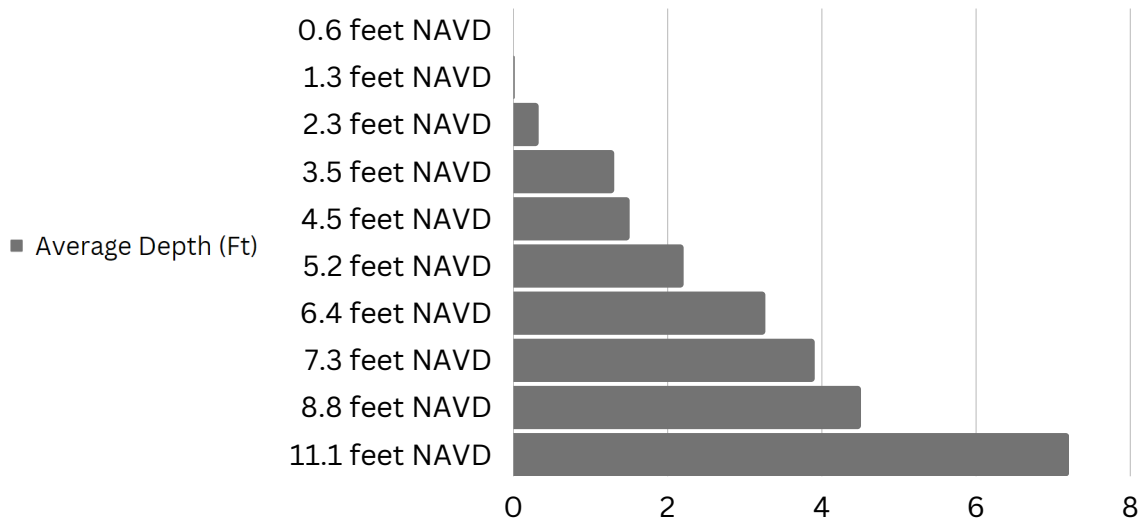
Utilizing the approximate centerline of Captiva Drive, road segments were then assessed to determine specific locations and magnitudes of inundation per scenario. The average inundation depth in feet for the evacuation route per scenario is outlined in **Figure 39**.

Figure 39. Captiva Evacuation Route Average Inundation Depth Across All Flood Scenarios

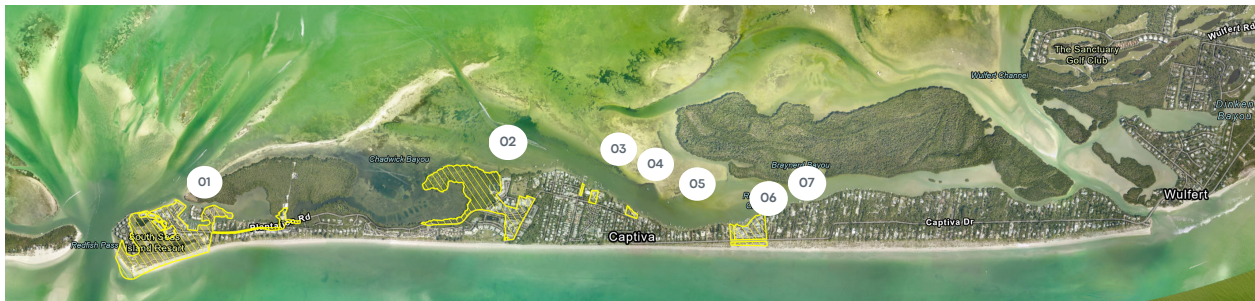
Seven marinas exist on Captiva Island (**Figure 41**). The associated parcel for each marina coordinate point was utilized to estimate inundation under the ten flooding scenarios.

Figure 41. Captiva Marinas

All scenarios cause flooding to all seven marinas, except for the scenarios with the two lowest water level elevations (0.6 feet NAVD and 1.3 feet NAVD), which impact four and six marinas respectively. To better understand the magnitude of this inundation, inundation depth was estimated for each marina, under each flood scenario. The results of this analysis for the three inundation tipping point scenarios are summarized in the subsequent pages, in **Figures 42-48** and **Table 12** and **Table 13**.

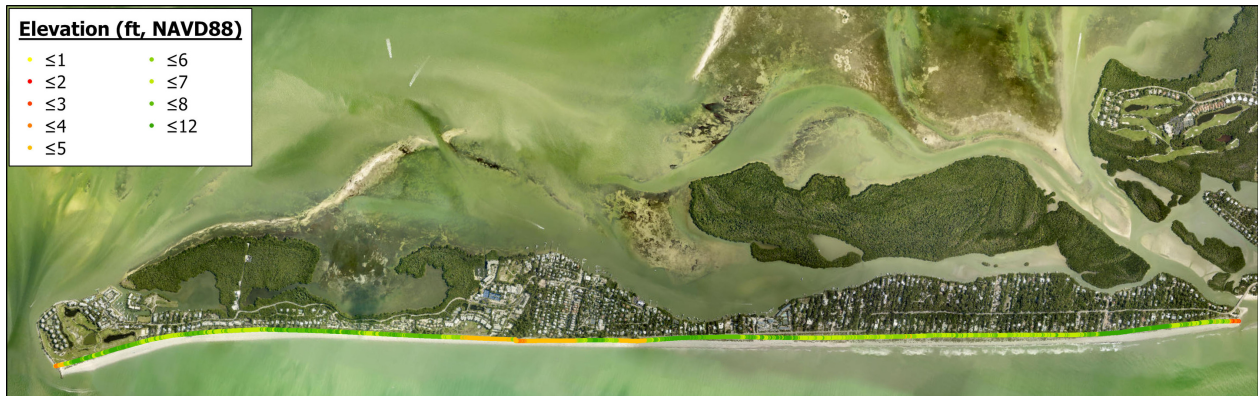
Figure 56. Shoreline Elevation Map.

To determine estimated gulf-front shoreline inundation, the 1982 and 1983 Erosion Control Lines (ECL) were assessed under the relevant inundation scenarios. The ECLs cover the island's beach front running from the groin at South Seas to the groin at Turner Beach. Beach profiles were not utilized to estimate inundation. **Figure 56** highlights the elevation of Captiva's shoreline.

**Figure 56.** Shoreline Elevation Map.....72

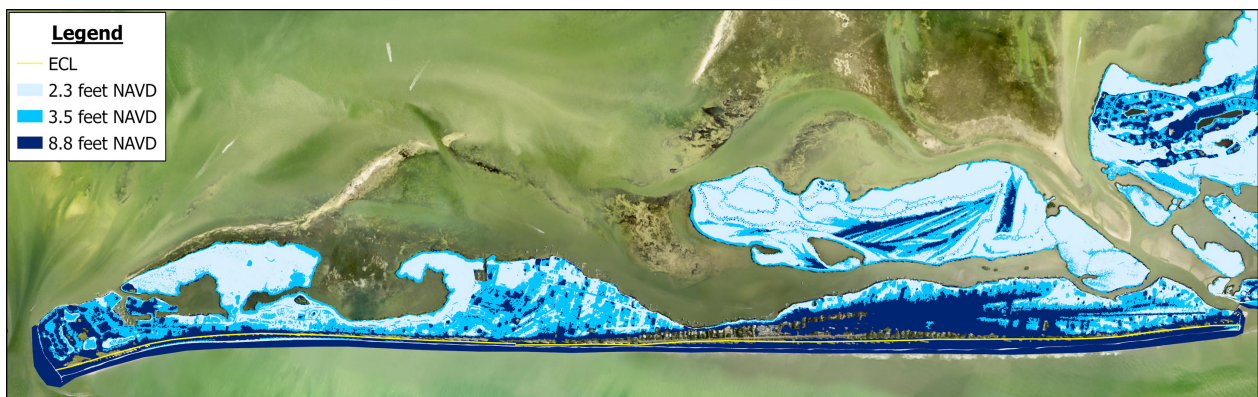
Figure 57. Shoreline Inundation Map for Inundation Tipping Point Scenarios.

Captiva Island possesses 25,823 linear feet of gulf-front shoreline and under 2.3 feet NAVD (Inundation Tipping Point 1), 0% of the shoreline will experience inundation. The degree of shoreline inundation increases to only 1% according to the 3.5 feet NAVD water level elevation (Inundation Tipping Point 2). Gulf-front shoreline inundation increases drastically under the 8.8 feet NAVD water level elevation (Inundation Tipping Point 3), which anticipates that 60% of shorelines will be impacted by flooding (**Figure 57**).

**Figure 57.** Shoreline Inundation Map for Inundation Tipping Point Scenarios.....72
