April 2023 Board Meeting

MARCH 2023, REVISED

SEA LEVEL RISE VULNERABILITY ANALYSIS

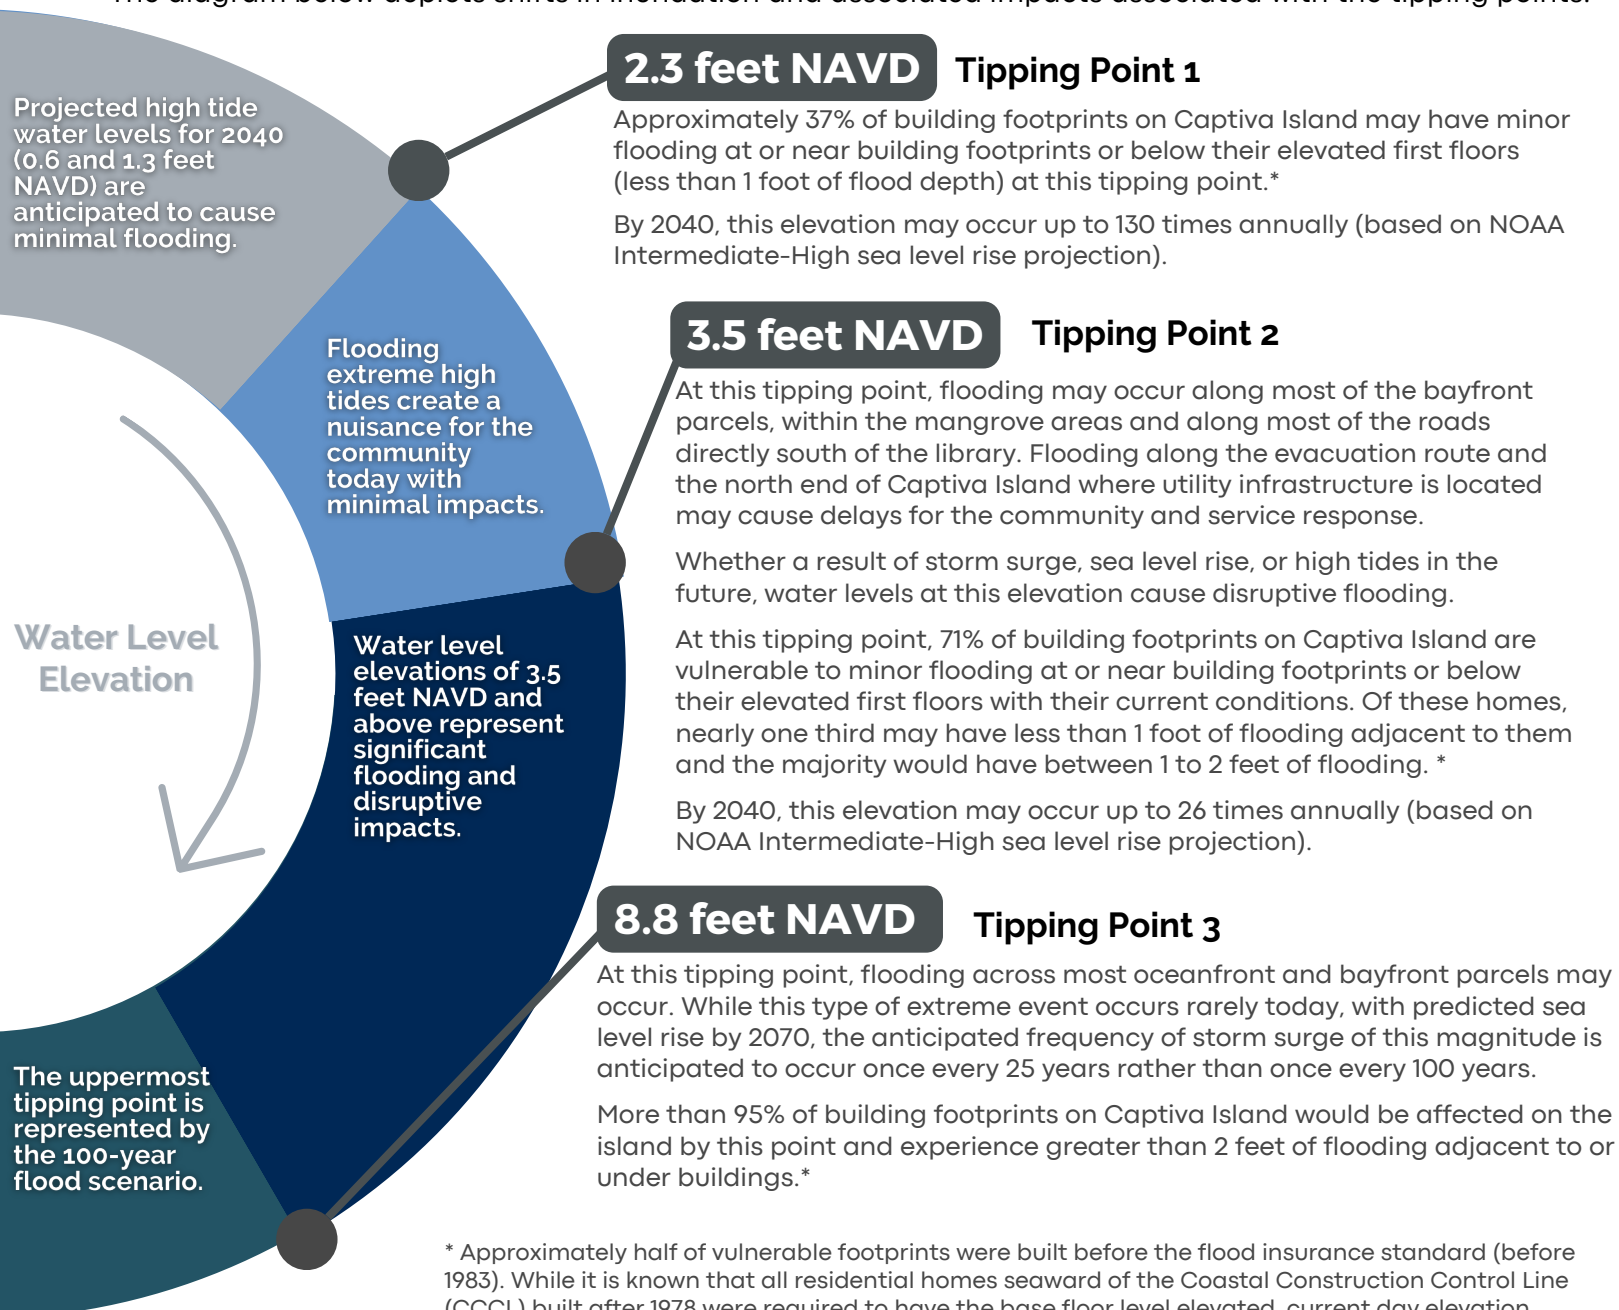
- The elevation of 8.8 feet NAVD may have occurred at least once (based on high water data from Hurricane Ian (SCCF, 2022).
- The diagram below depicts shifts in inundation and associated impacts associated with the tipping points.

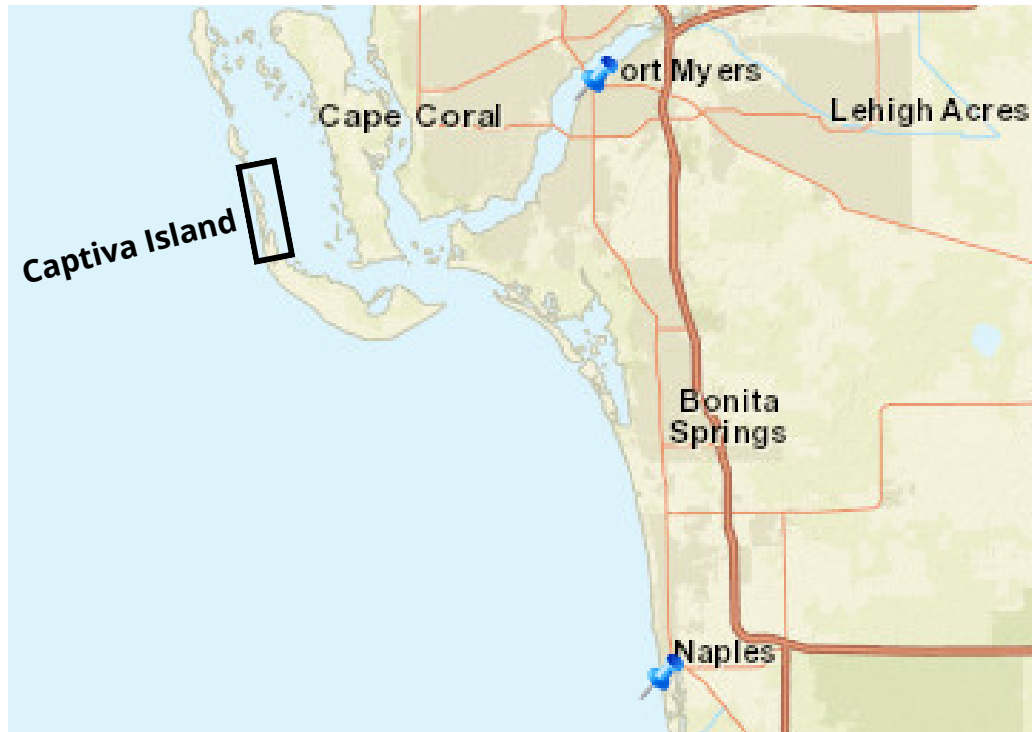
Figure 1. Tide Gauge Locations Near Captiva, FL

The Captiva Erosion Prevention District (CEPD) is located in close proximity to two tide gauges- station 8725520 in Fort Myers, FL and station 8725110 in Naples, FL (see **Figure 1**). Both gauges are operated and maintained by NOAA/NOS/CO-OPS, and published on NOAA's Tides & Currents website (<http://tidesandcurrents.noaa.gov>).

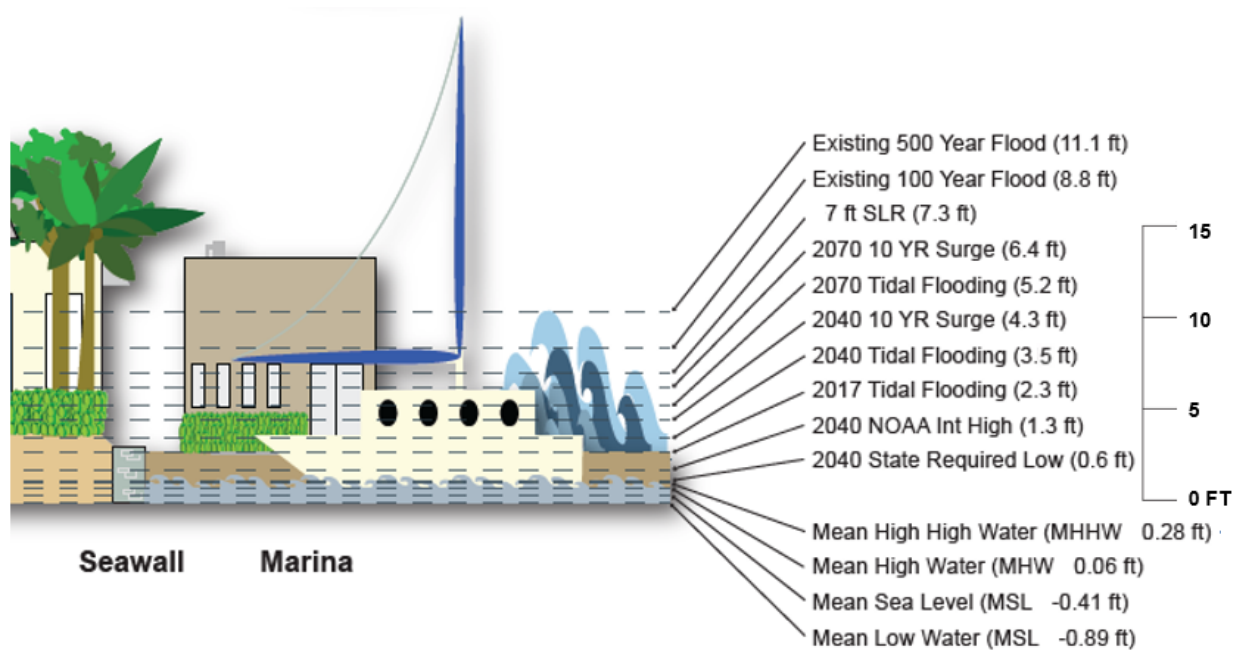
Figure 3. Comparison of Local Tidal Datum Elevations and Flood Elevations

Figure 3 depicts the Fort Myers water elevations for relevant tidal datums in comparison to the flood scenarios outlined in **Table 2**. The purpose of this comparison is to help visualize the water level discrepancy and incrementation between the mean local elevations and the predicted flood elevations. All levels are in feet NAVD88. These water level elevations were utilized to determine the depth of flooding experienced by Captiva assets and areas throughout this report. As an example, under current extreme tidal flooding conditions (2.3 feet NAVD), an asset with an elevation of 2 feet NAVD would experience inundation with a depth of 0.3 feet or approximately 4 inches.

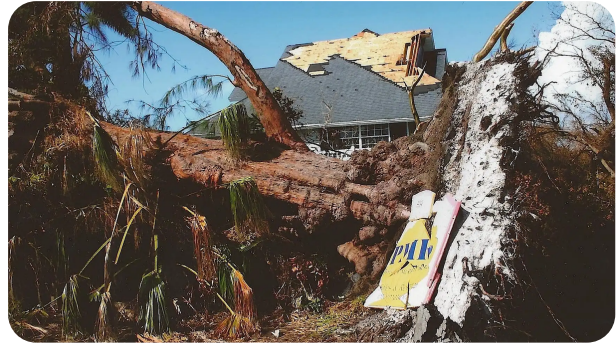
Figure 4. Hurricane Damage on Captiva Island

The geomorphic composition of the island is actually the result of a 1921 hurricane which separated Captiva into two islands (now Captiva and North Captiva) at Redfish Pass. Two intense hurricanes that impacted the Island since 1990, include Hurricane Charley (2004) and Hurricane Ian (2022). Both storms resulted in power outages, disruption to communications and water treatment plants, and destruction and inundation to major roadways.

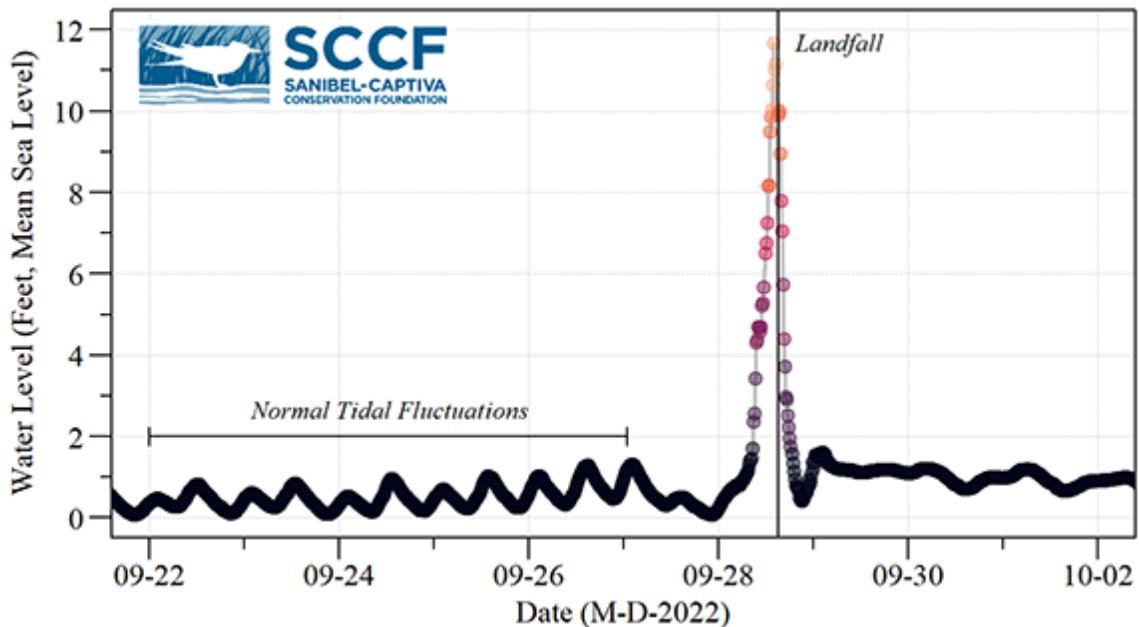
Figure 5. Hurricane Ian Water Elevation Data near Sanibel, FL

The SCCF team also noted a significant decrease in beach elevation relative to mean sea level across Sanibel and Captiva after Hurricane Ian. The average elevation of Captiva's sea turtle nest sites was of 7.2 feet before the storm and decreased to 3.6 feet after the storm.

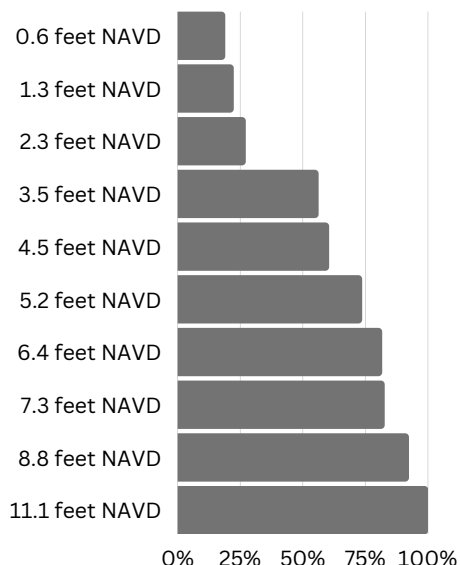
Figure 8. Percentage of Captiva Inundated Under All Flood Scenarios

To provide a comprehensive view of inundation, it is important to review the exposure predictions of Captiva Island under all relevant scenarios and planning horizons mentioned. By doing so, various inundation depths and spatial extents can be compared to each other and in relation to the depths utilized in the 2020 Captiva Island Resiliency Assessment and more incremental flooding can be visualized (Figures 9-12). Figure 8 compares the overall percentage of island inundation for each of the scenario water level elevations. Table 3 can be referenced to identify the associated scenarios represented by each of the water level elevations depicted in Figure 8.

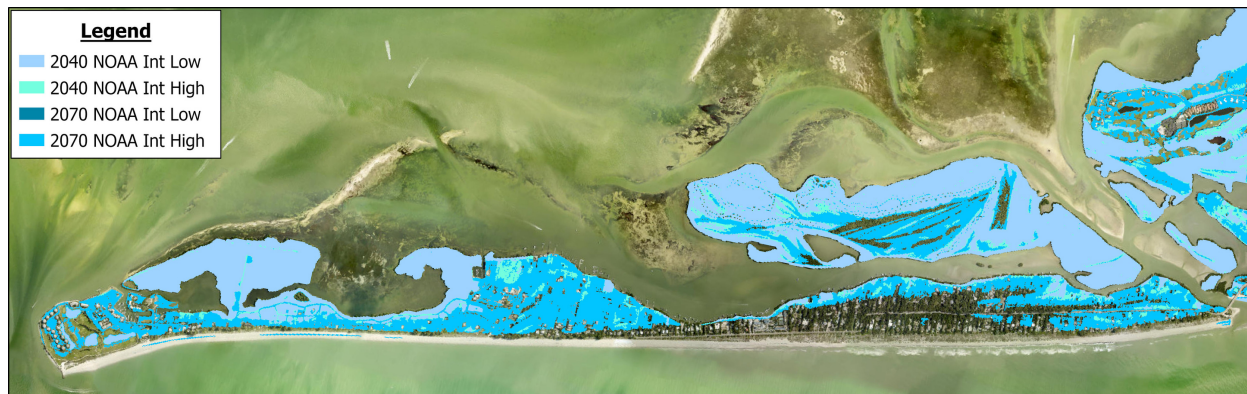
Figure 9. Island Inundation Comparison Map for NOAA Scenarios- 2040 NOAA Intermediate-High and 2070 NOAA Intermediate-Low

The state guidance for vulnerability assessments requests the use of the NOAA intermediate-low and intermediate-high sea level rise projections (published in 2017) for the planning horizons of 2040 and 2070. As stated previously, due to the close proximity of water elevation levels, the 2040 NOAA Intermediate-High (1.2 feet NAVD) and 2070 NOAA Intermediate-Low (1.3 feet NAVD) do not represent significant differences in inundation extent or depth. To confirm there is no critical difference between the inundation extents of these two elevations, the results of both were compared (**Figure 9**). The lack of difference further validates the consolidation of similar water levels into one scenario. **It is important to note that while Buck Key is included within figures, it was not included in inundation percentages or key metrics presented within this report.**

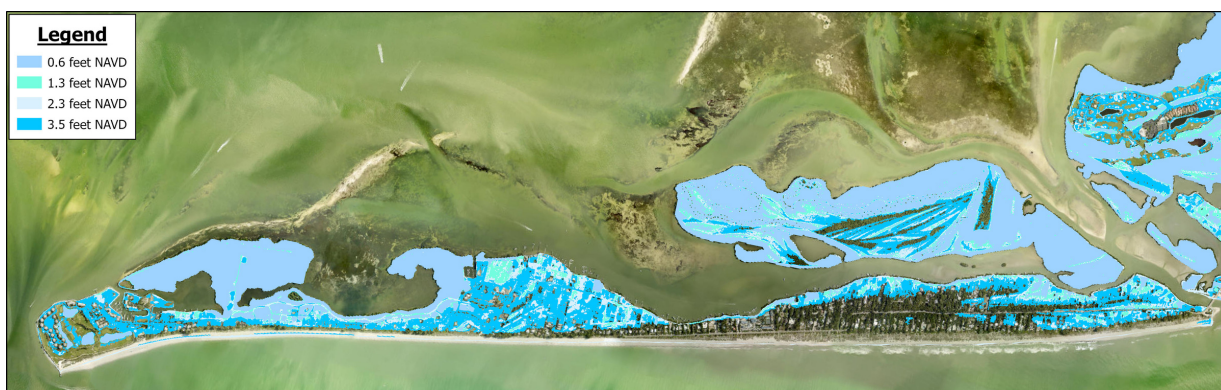
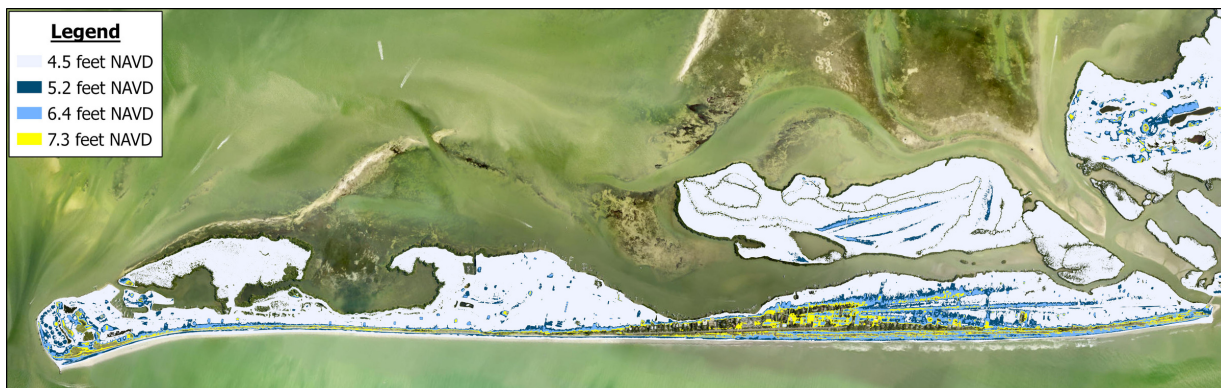
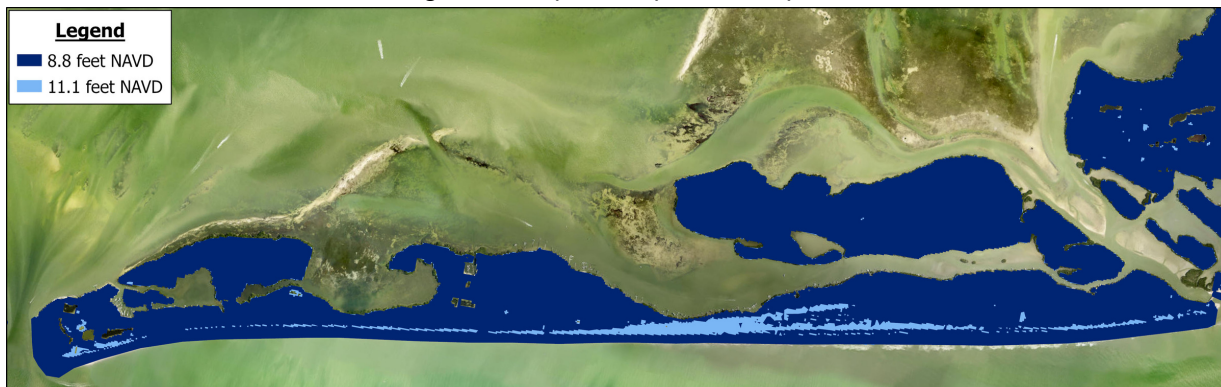
The results of the exposure analysis for the ten scenarios outlined in **Table 3** are represented in **Figures 10-12**. Scenarios were layered and mapped in order of increasing water level elevation to show incremental inundation change across the island. The ten scenarios were mapped across three figures in order to show relative change within specific water elevation level increments and to prevent visual confusion.

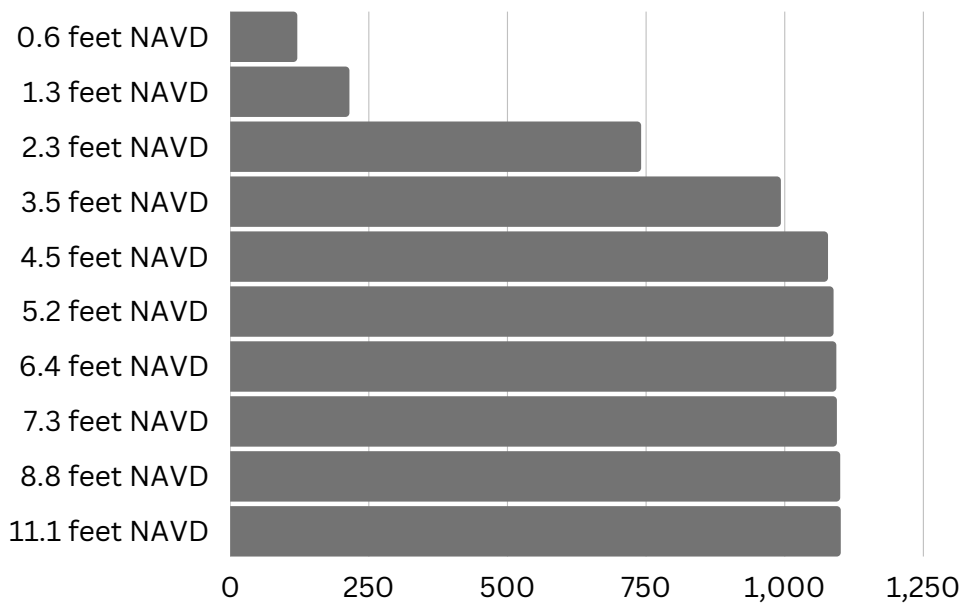
Figure 13. Predicted Number of Impacted Parcels Across All Flood Scenarios

Parcel data was obtained from the Florida Department of Revenue (FDOR) and analyzed for inundation impact from the various flood scenarios. A total of 1,105 parcels exists within Captiva Island. **Figure 13** depicts the number of parcels likely to experience flooding per scenario.

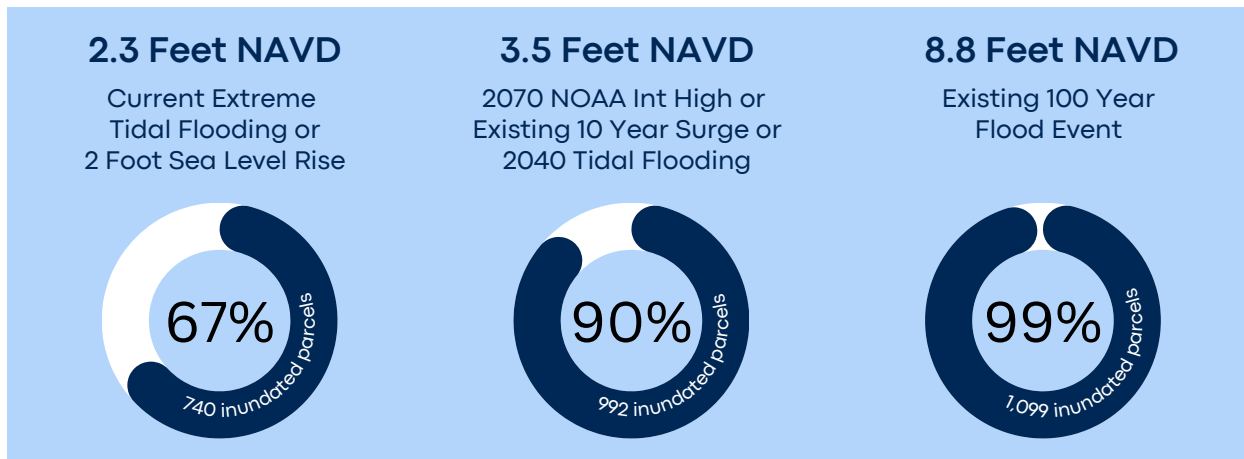
Figure 14. Percentage of Parcel Inundation Under Inundation Tipping Point Scenarios

Figure 14 displays the number and percentage of inundated parcels for each of the three inundation tipping point scenarios. **Figure 15** depicts a spatial view of the results of this analysis.

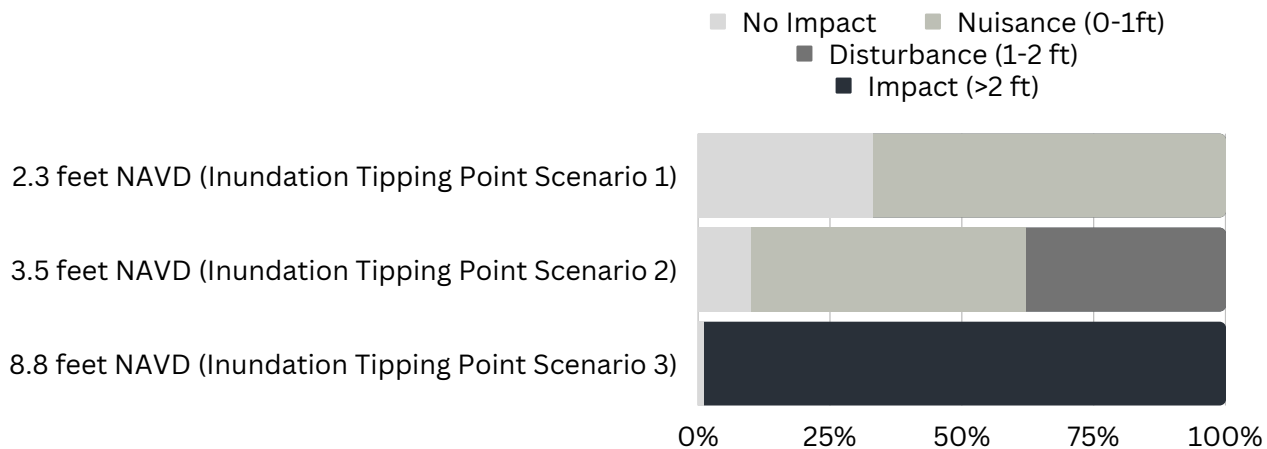
Figure 16. Parcel Inundation Depth Under Inundation Tipping Point Scenarios

Further analysis included estimating the average inundation depth of parcels per flood scenario. The overall results of the inundation depth analysis for the three inundation tipping point scenarios can be seen in **Figure 16**. The further analysis also involved estimating the value of impacted parcels by totaling the value of relevant building footprints within each parcel.

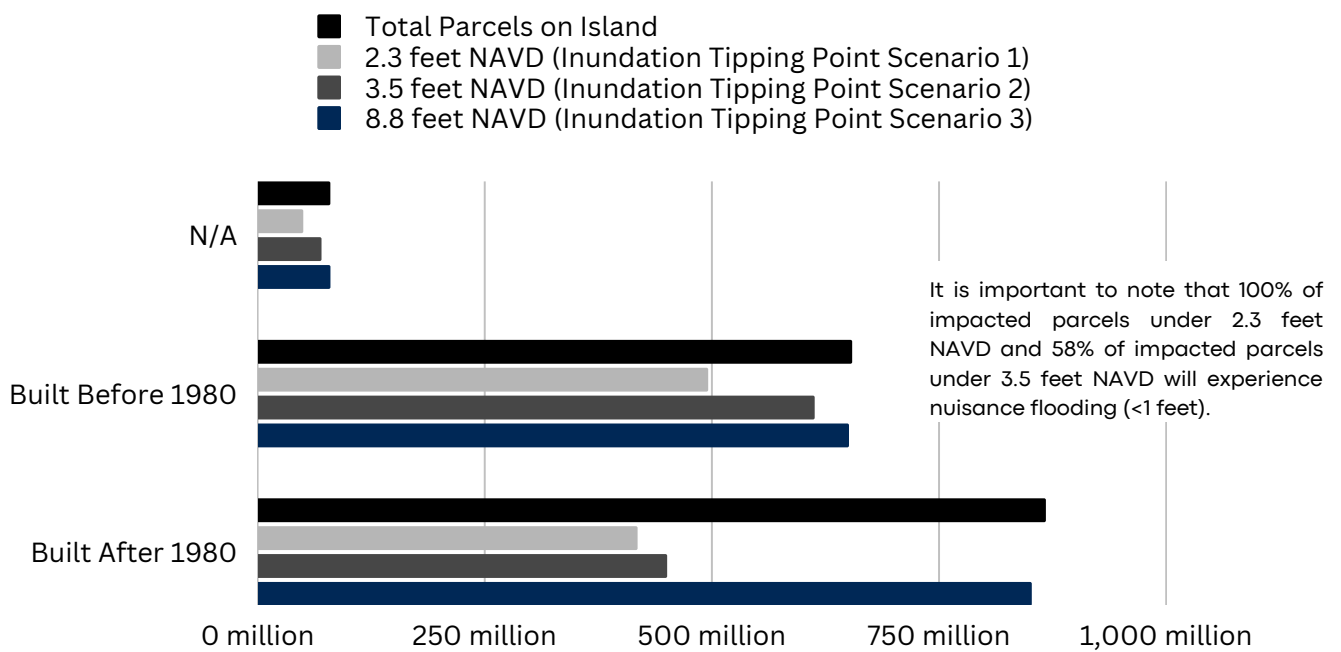
Figure 17. Impacted Parcels by Decade Built and Parcel Value

The age of the structures built were reviewed in relation to the 1983 FEMA base flood elevation standard (**Figure 17**). For presentation purposes, structure ages were grouped by decade and compared to 1980 rather than 1983. Specifically, under the Inundation Tipping Point Scenario 1 (2.3 feet NAVD), 60% of vulnerable parcels were built before 1980, with an estimated present market value of \$500 million. Under the Inundation Tipping Point Scenario 2 (3.5 feet NAVD), 64% of the total vulnerable parcels were built before 1980, with an estimated present market value of \$610 million. According to the Inundation Tipping Point Scenario 3 (8.8 feet NAVD), 60% of impacted parcels were built before 1980, and 40% were built after. The impacted parcels have an estimated present market value of \$650 million. For the purpose of this evaluation, those parcels without a designated built year (labeled "N/A"), were not included in the total parcel count as it is unclear if these parcels were built before or after the implementation of the 1983 FEMA base flood elevation standard.

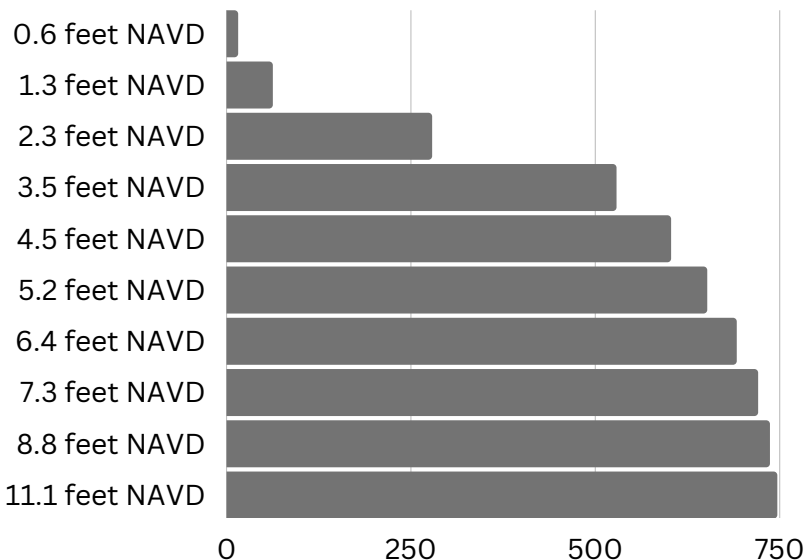
Figure 18. Building Footprint Inundation Across All Flood Scenarios

Seven hundred and forty-seven buildings are located on Captiva. The building footprints for Captiva Island were obtained from Lee County and analyzed for initial inundation impact under the various flood scenarios. **Figure 18** displays the number of building footprints that may experience flooding if their elevations is at ground level. **This analysis does not account for elevation certificates or actual structure first floor elevations. An elevated building will not be inundated.**

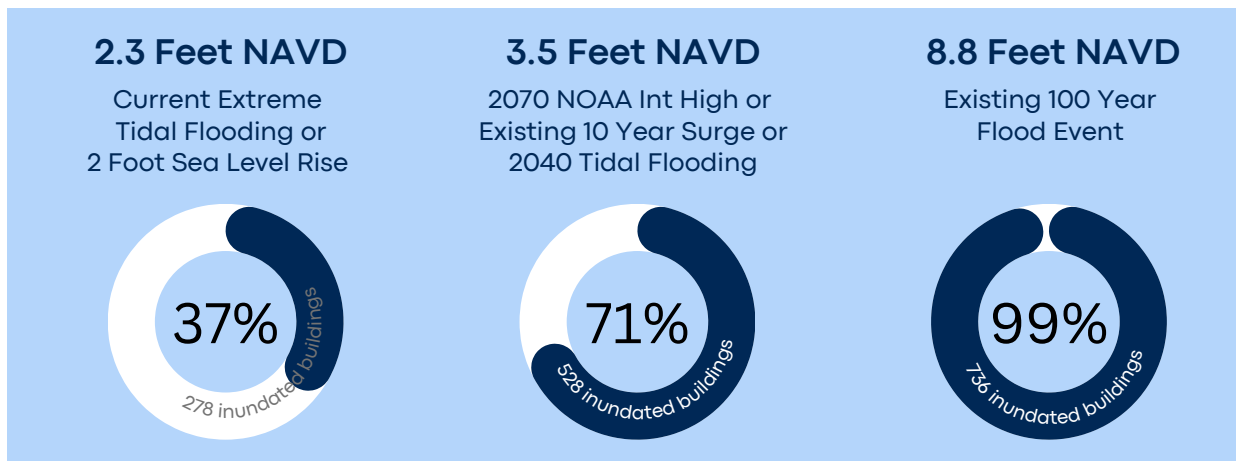
Figure 19. Percentage of Building Footprint Inundation Under Inundation Tipping Point Scenarios

Figure 19 displays the number and percentage of inundated building footprints for each of the three inundation tipping point scenarios. The location and extent of building impact per scenario can be seen in **Figure 20**.

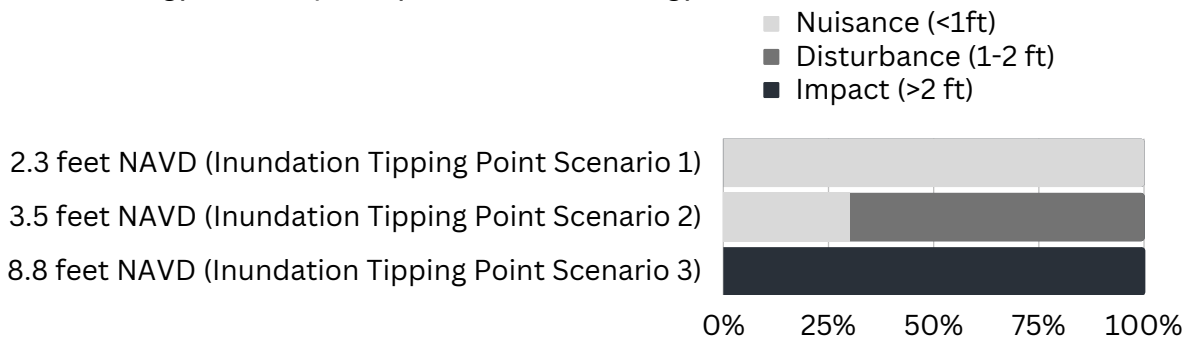
Figure 21. Building Footprint Inundation Depth Under Inundation Tipping Point Scenarios

A more thorough analysis of building footprint inundation included estimating average building footprint inundation depth, classifying the building footprint data by decade built, and estimating building value per scenario. The methodology used here is the same as that used to complete the parcel inundation analysis. Average depth is represented by the center of the grid of inundation. Thus, the total number of impacted building footprints is reduced as not every footprint that intersects the inundation polygons has its center point fall within the inundation grid. **Figure 21** details building sensitivity per scenario and the associated flooding type- nuisance (< 1 foot of flooding), disturbance (1 to 2 feet of flooding), and impact (> 2 feet of flooding).

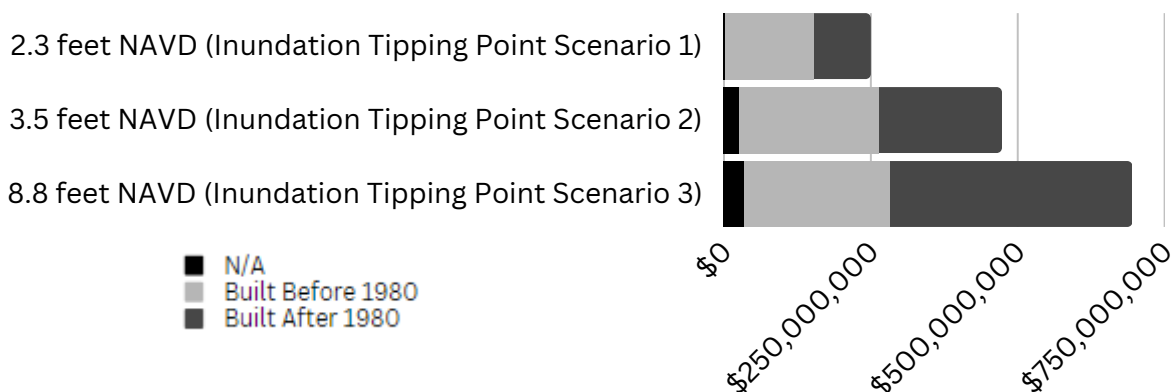
Figure 22 Impacted Building Footprints by Decade Built and Property Value

Under the 2.3 feet NAVD water level elevation, 36% of the buildings experiencing inundation will have been built before 1980. These buildings have a combine estimated value of \$150 millionllars. According the 3.5 feet NAVD water level elevation, 49% of the buildings predicted to be inundated are buildings built before 1980, with a total estimated value of 240 million. Under the 8.8 feet NAVD water level elevation, 46% of effected buildings were built before 1980, with an estimated value of 250 million. As stated previously, parcels without a designated built year were not included in the total parcel count.

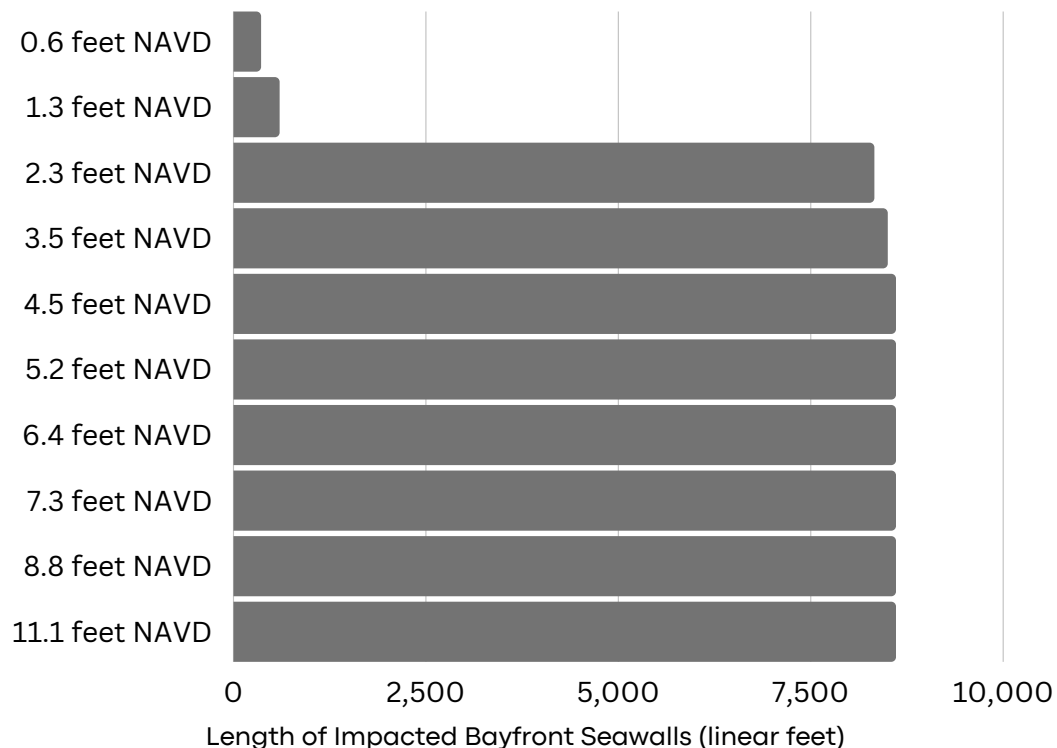
Figure 23. Length of Seawalls Inundated for Each Flood Scenario (Linear Feet of Seawall)

As-built survey data was not available for the analysis of seawall height, so an alternative method to represent seawalls in the analysis was performed using available ground elevation data for parcels. The predicted exposure (in linear feet) of seawalls per scenario is depicted in **Figure 23**. All seawalls are expected to be exposed under all water level elevations 4.5 feet NAVD and above.

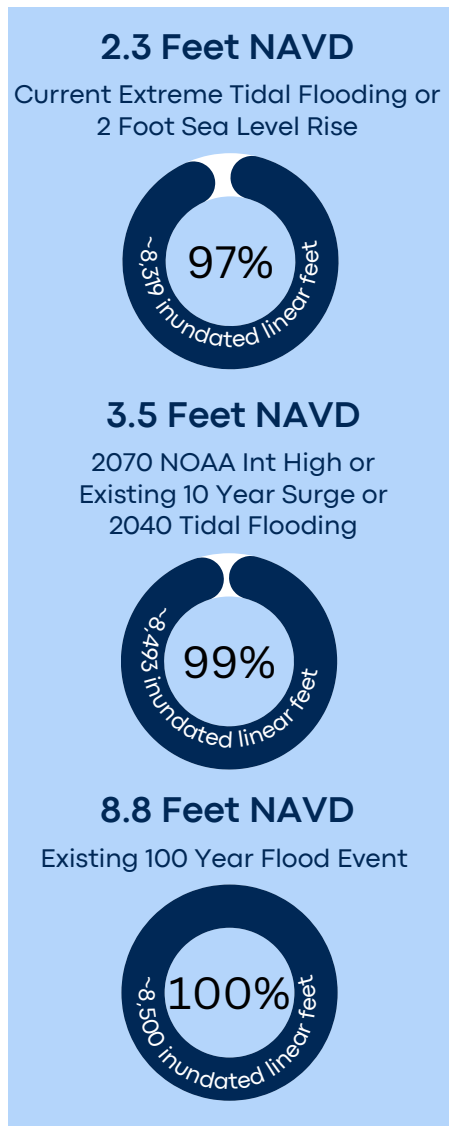
Figure 24. Percentage of Seawall Exposure Under Inundation Tipping Point Scenarios

The majority (>97%) of bayfront seawalls are expected to experience flooding under all flood scenarios. Approximately 8,319 linear feet of seawalls are expected to be exposed under the first inundation tipping point scenario (2.3 feet NAVD). Seawall inundation increases to 8,493 linear feet under the 3.5 feet NAVD water level elevation. Under tipping point scenario 3 at 8.8 feet NAVD, all of Captiva's seawalls will experience flooding. The locations and extents of inundated seawalls per tipping point scenario can be viewed in **Figure 25**.

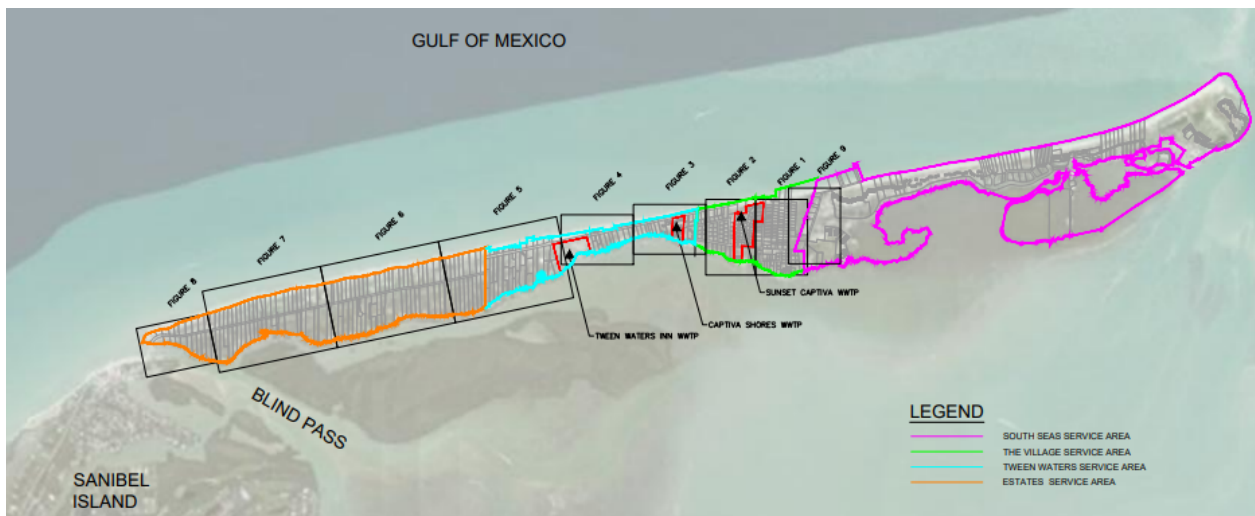
Figure 26. July 2021 Kimley-Horn Study - Unsewered Service Areas of Captiva

In July 2021, Kimley-Horn completed an engineering study to determine the best ways a central sewer system can fit within Captiva's landscape. The firm prepared a conceptual layout for a wastewater collection and conveyance system for the unsewered portion of Captiva Island that consists of the areas outside the South Seas Resort, which has its own system. More specifically, this includes three areas currently serviced by package Wastewater Treatment plants- the Village Service Area, the Tween Waters Service Area, and the Estates Service Area (**Figure 26**).

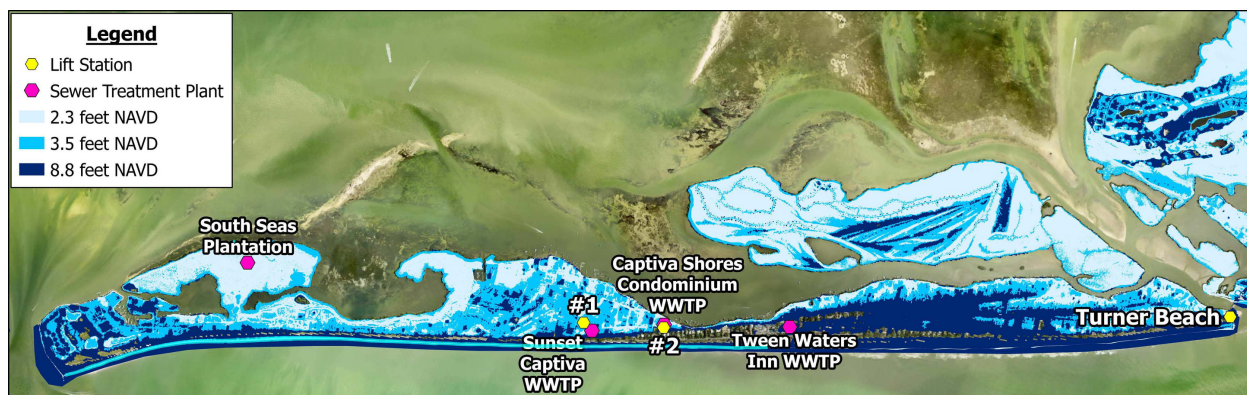
Figure 27. Wastewater Treatment Plant and Lift Station Inundation Map for Inundation Tipping Point Scenarios

Three lift stations are located on the island of Captiva- one at each of the package plant stations and one City of Sanibel lift station at Turner Beach that serves the Lee County Park. The locations of the lift stations were identified by Kimley Horn (2021) and were approximated for the purposes of this assessment. **Figure 27** highlights the locations of the lift stations, and the wastewater treatment plants on Captiva Island.

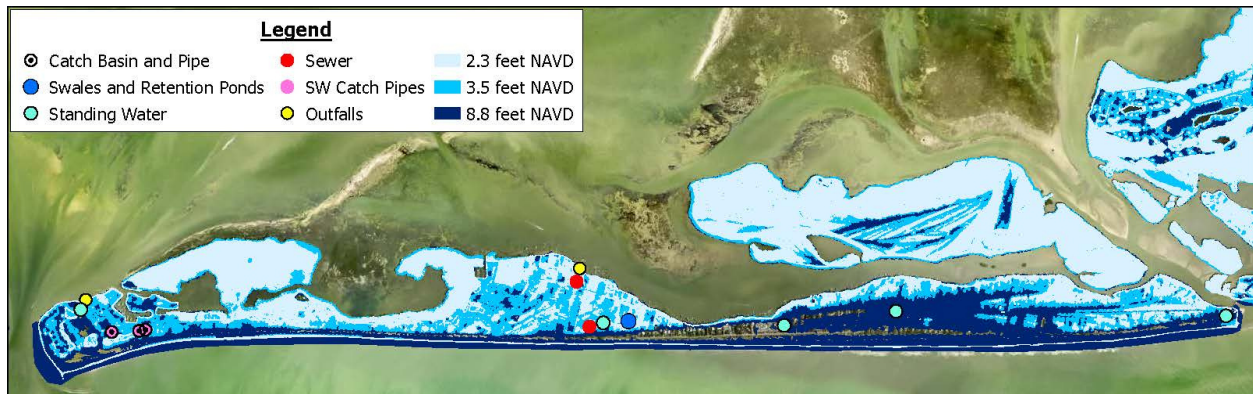
Figure 28. Stormwater Infrastructure Inundation Map for Inundation Tipping Point Scenarios

Comprehensive stormwater data for Captiva Island was not available for the purpose of this assessment. Instead, limited longitudinal data was extracted from the 2011 Captiva Water Quality Assessment Project Final Report prepared by the SCCF Marine Laboratory in Sanibel, FL. This report was generated for the Lee County Tourist Development Council (TDC) and the Captiva Community Panel (CCP), and its overall purpose was to investigate the conditions of Captiva's nearshore waters and the potential problems contributing to local water quality. Included within the data collection was a list of all water quality sites established for the project, which included site types related to stormwater infrastructure and storm water occurrences. Specifically, longitudinal data for Captiva catch basins and pipes, swales and retention ponds, standing water, sewer, and outfalls from the report were plotted and assessed for inundation impacts (**Figure 28**).

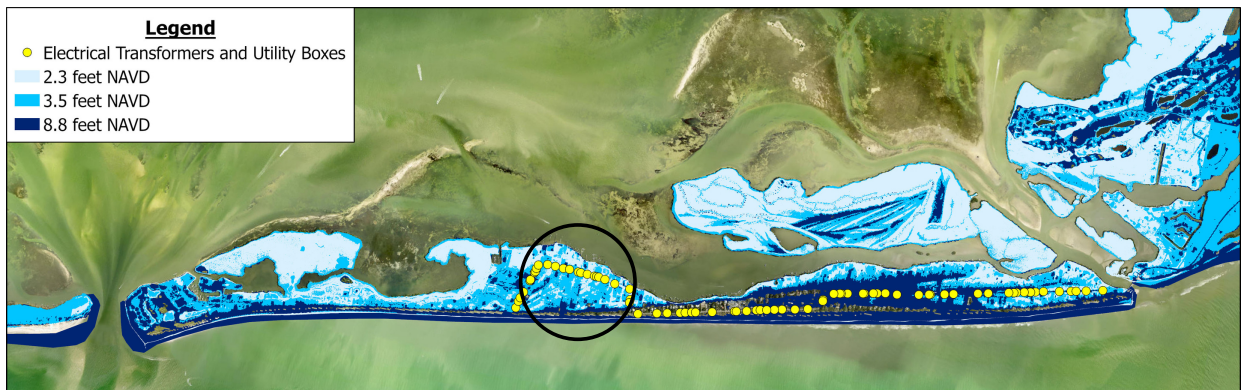
Figure 29. Electrical Transformers and Utility Boxes Location & Inundation Map for Inundation Tipping Point Scenarios.

Official electrical data was not available for Captiva Island, so to account for the electrical transformers and utility boxes on Captiva, the street view of Google maps was used to map their locations along Captiva Drive. This exercise was conducted for assets on Captiva Island, outside the South Seas Island Resort area. A total of eighty transformers and utility boxes were surveyed and accounted for the purpose of this analysis, the locations of which are depicted in **Figure 29**. A portion of the utility boxes mapped may represent communication boxes, but additional site visits would need to be conducted in order to verify. Under Inundation Tipping Point Scenario 1, 8% of the assets will be affected by flooding, under Inundation Tipping Point Scenario 2, 35% will be affected, and under Inundation Tipping Point Scenario 3, 100% will be affected. The depth of flooding anticipated for the eighty assets, under each scenario are summarized in **Figure 30**. The sixteen electrical transformers and utility boxes projected to experience tidal flooding at a depth of >1 foot by 2040 are located in the area denoted by a circle within **Figure 29**.

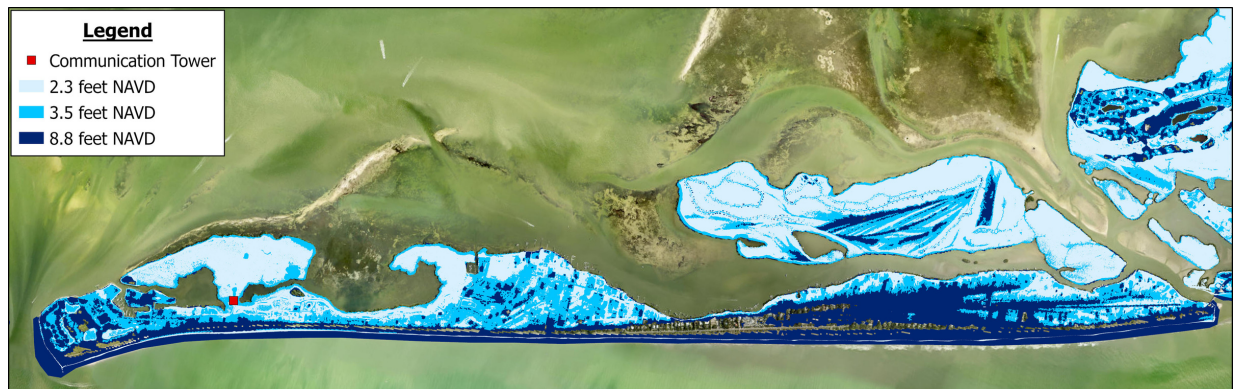
Figure 31. Communications Facilities Inundation Map for Inundation Tipping Point Scenarios

Individuals rely on communication facilities to relay information, connect with others, call for help, etc. If a communication tower is flooded and inoperable, it could result in nearby residents and facilities being unable to reach or receive calls which can be dangerous, especially because the local Emergency Medical Services (EMS) facility is located on Captiva Island. **Figure 31** depicts the communication facility on Captiva Island located directly west of the South Seas Wastewater Treatment Plant. The South Seas tower was identified in the 2020 Captiva Island Resiliency Assessment produced by Integral consulting. Additional communication facilities across Lee County can be viewed in Appendix I.

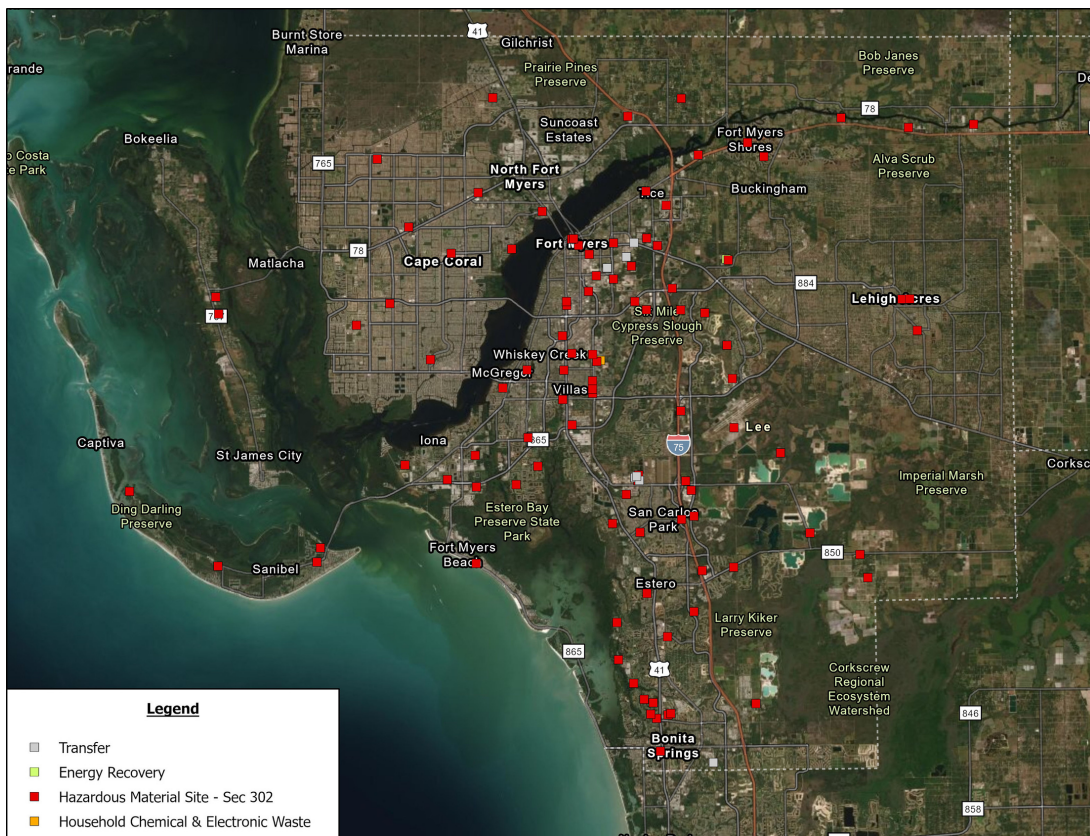
Figure 32. Lee County Solid and Hazardous Waste Facilities

A Solid and Hazardous Waste Facility does not exist on Captiva Island. The nearest facility, the Sanctuary Golf Club was examined for the purpose of this assessment and is located one mile from Captiva's southern tip (**Figure 32**). The average depth of anticipated inundation under the three inundation tipping point scenarios are as follows:

- 1 2.3 feet NAVD: 0.4 feet
- 2 3.5 feet NAVD: 0.8 feet
- 3 8.8 feet NAVD: 3.1 feet

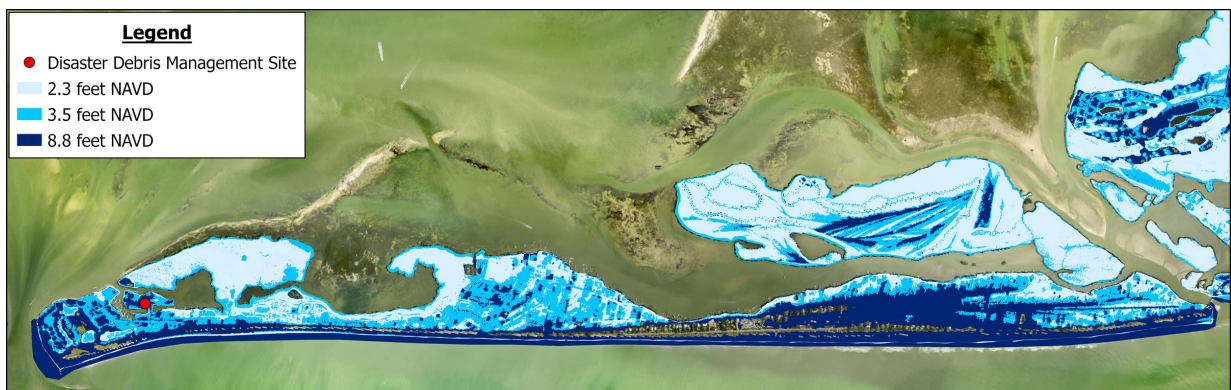
Figure 33. Disaster Debris Management Sites Inundation Map for Inundation Tipping Point Scenarios

One Disaster Debris Management Site (DDMS) is located on Captiva Island (Figure 33). A DDMS is a temporary staging area for disaster debris including demolition waste and yard waste. The DDS is located within South Seas, so is generally not accessible to all of Captiva residents. However, Disaster Debris Management Sites are a state defined critical asset, and thus it was included within this assessment.

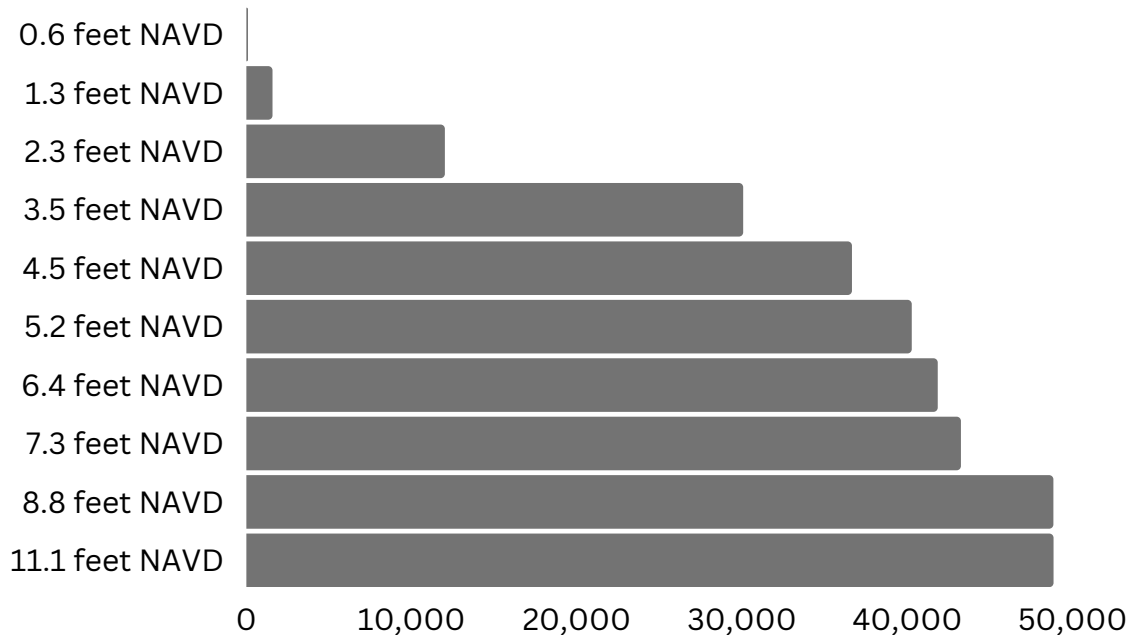
Figure 34. Roadway Exposure Across All Flood Scenarios (in linear feet)

A total of 48,797 linear feet of roads exist on Captiva Island and **Figure 34** outlines linear feet of roadway exposed per scenario.

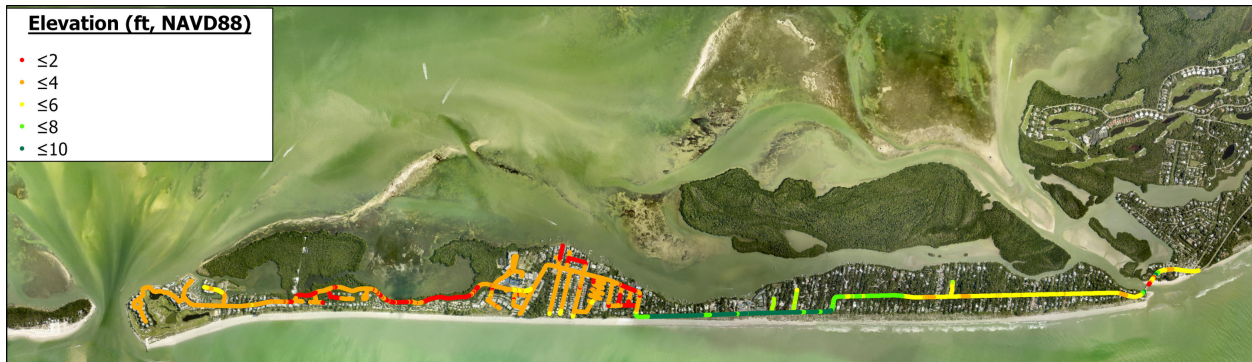
Figure 35. Captiva Roads Elevation Map

Figure 35 depicts road elevation for all roads on Captiva, which helps to visualize low lying areas and road segments that would be the first to flood. It is evident that the majority of roads on the northern half of the island are at lower elevations than roads on the southern half of the island.

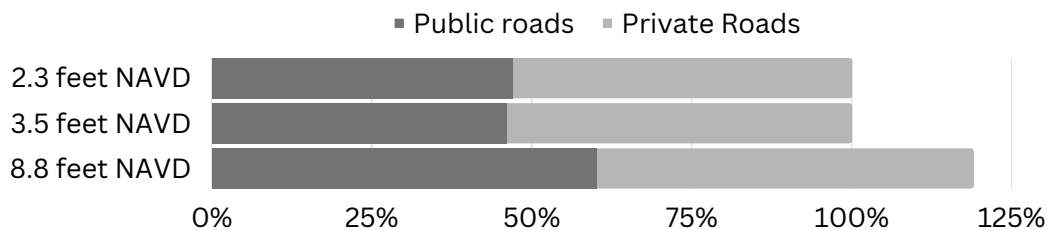
Figure 36. Percentage of Roadway Inundation by Roadway Type for Inundation Tipping Point Scenarios

Inundated roads were also classified by owner (**Table 9**). For the purpose of this analysis, public and private roads were identified. This evaluation and level of detail helps to characterize the impact of inundation on public roads vs private roads. **Figure 36** displays this breakdown via percentages to show approximately half of inundation impacts occur to public roads and half occur to private roads, under the three tipping point scenarios.
