April 2023 Board Meeting

MARCH 2023, REVISED

SEA LEVEL RISE VULNERABILITY ANALYSIS

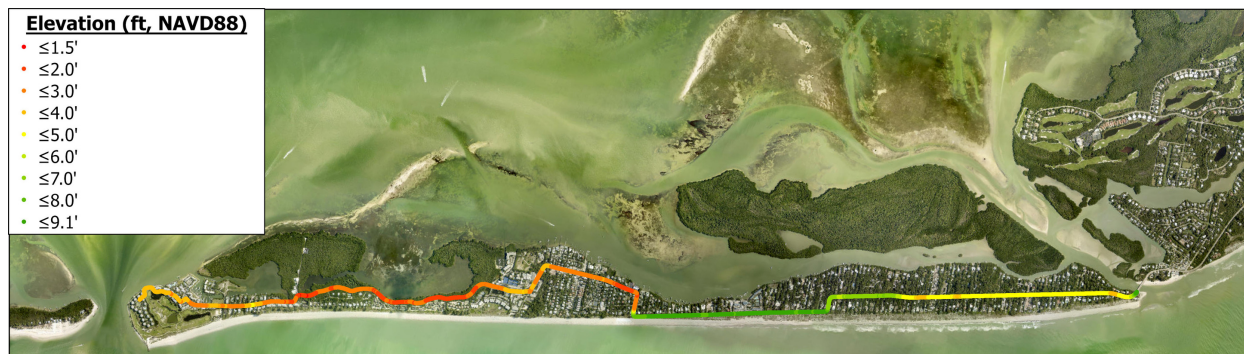
Figure 38. Captiva Evacuation Route Elevation

Captiva Drive serves as the island's evacuation route and its only connection to Sanibel. Inundation along this roadway could result in service interruptions, road closures, traffic delays, emergency service delays and overall loss of evacuation. The elevation of this roadway was assessed to determine the specific segments of the roadway at the lowest elevations, as these areas are most likely to flood first and to pose threat to service and evacuation interruptions. **Figure 38** depicts the results of the initial elevation evaluation. Overall, the northern portion of Captiva Island sits at a lower elevation than the remainder of the roadway and runs in close proximity to the bayside edge of Captiva Island with little to no buffer against the water body. It is important to note that Captiva Island is within evacuation zone A, and thus, it is expected that during storm surge events, the island will be evacuated, and roadway accessibility will not be required. However, flooding from tidal conditions, sea level rise, and compounded sources, pose inundation threats to the evacuation route, which residents would rely on to leave the island if circumstances necessitated.

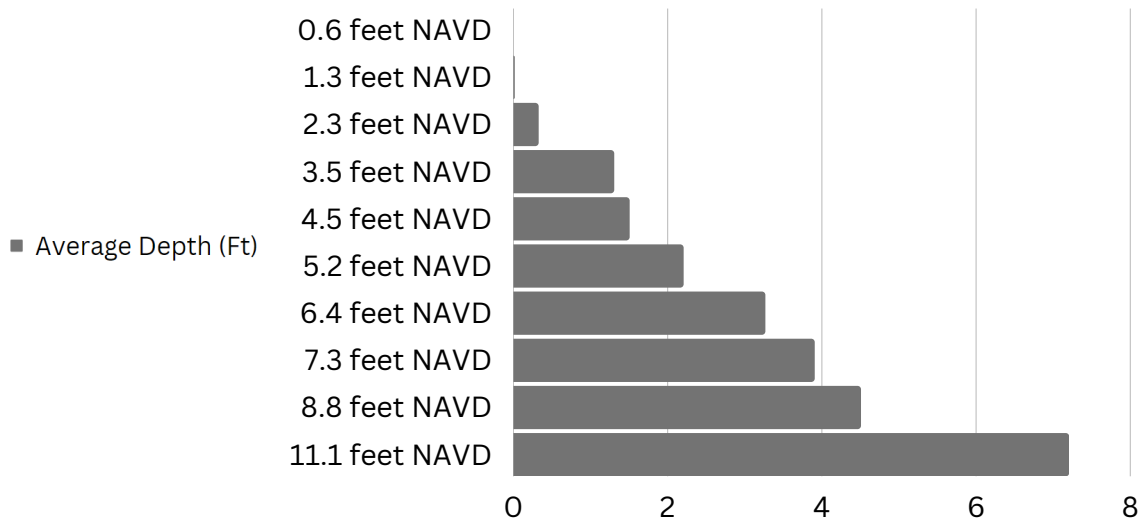
Figure 39. Captiva Evacuation Route Average Inundation Depth Across All Flood Scenarios

Utilizing the approximate centerline of Captiva Drive, road segments were then assessed to determine specific locations and magnitudes of inundation per scenario. The average inundation depth in feet for the evacuation route per scenario is outlined in **Figure 39**.

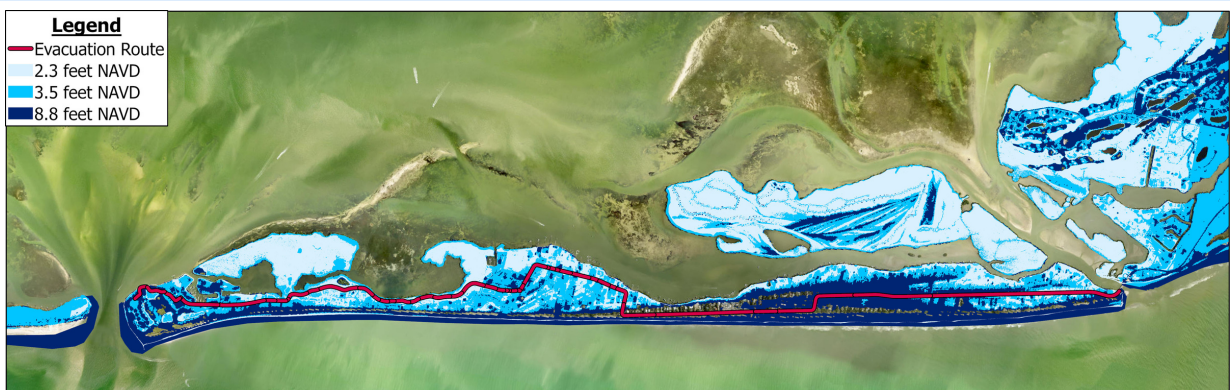
Figure 40. Evacuation Route Inundation Map for Inundation Tipping Point Scenarios

The average, minimum, and maximum, inundation depth for each inundation tipping point scenario is outlined in **Table 11**. Flooding depths greater than one foot have the ability to not only inhibit mobility but can eliminate the ability of emergency response and evacuation to and from the northern region of Captiva Island. In instances of hurricanes and storms, this can be extremely dangerous, leaving residents stranded without the ability to reach resources and aid. **Figure 40** depicts the predicted evacuation route inundation for the three inundation tipping point scenarios.

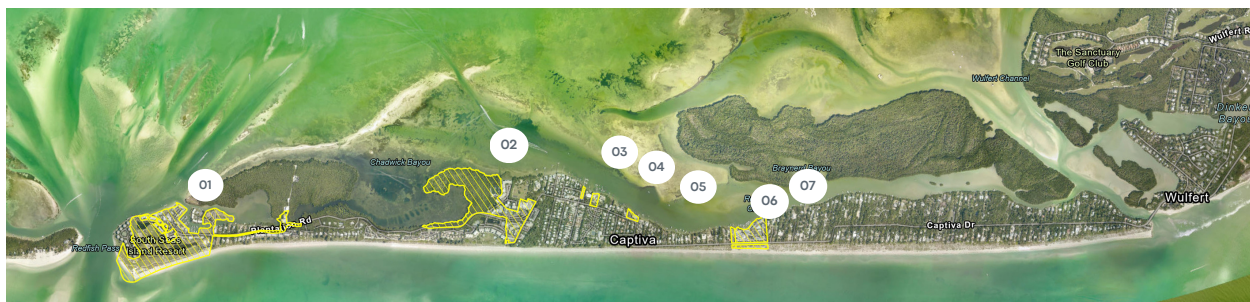
Figure 41. Captiva Marinas

Seven marinas exist on Captiva Island (**Figure 41**). The associated parcel for each marina coordinate point was utilized to estimate inundation under the ten flooding scenarios.

All scenarios cause flooding to all seven marinas, except for the scenarios with the two lowest water level elevations (0.6 feet NAVD and 1.3 feet NAVD), which impact four and six marinas respectively. To better understand the magnitude of this inundation, inundation depth was estimated for each marina, under each flood scenario. The results of this analysis for the three inundation tipping point scenarios are summarized in the subsequent pages, in **Figures 42-48** and **Table 12** and **Table 13**.

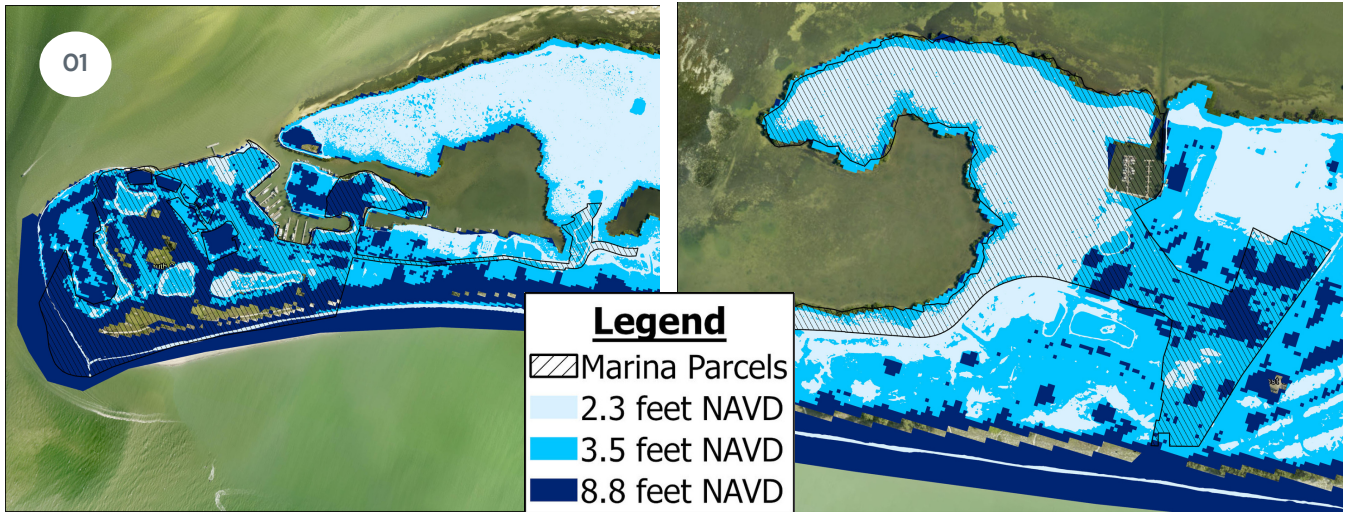
Figure 42. 1057-1900 South Seas Plantation Road Marina Inundation Map

Depth represents the average across the relevant parcel so while a greater extent of inundation may exist under certain scenarios, the flooding depths across the expanded area vary and reduced depths in some areas can result in a reduced overall average depth. Under Inundation Tipping Point Scenario 1 (2.3 feet NAVD), six of the seven marinas will experience nuisance flooding (<1 foot deep), and one marina (located at 2800-5640 South Seas Plantation Road) will experience more significant flooding at 1.6 feet deep. According to Inundation Tipping Point Scenario 2 (3.5 feet NAVD), the average inundation at all impacted marinas will be greater than 1.5 feet. Again, the marina located at 2800-5640 South Seas Plantation Road is anticipated to experience flooding at a greater depth than the others, at an average of 2.8 feet deep. The marina located at 15903 Captiva Drive is also projected to experience more impactful flooding, with an average inundation depth of 2.4 feet. The extent of flooding exposure for each marina was examined in detail to identify specific impacts on infrastructure and accessibility. The results of this qualitative review for Inundation Tipping Points 1 and 2 are summarized in **Table 14**. Inundation Tipping Point Scenario 3 (8.8 feet NAVD) was not included in **Table 14** because the majority of the island is inundated under this scenario, resulting in the inundation of all marinas.

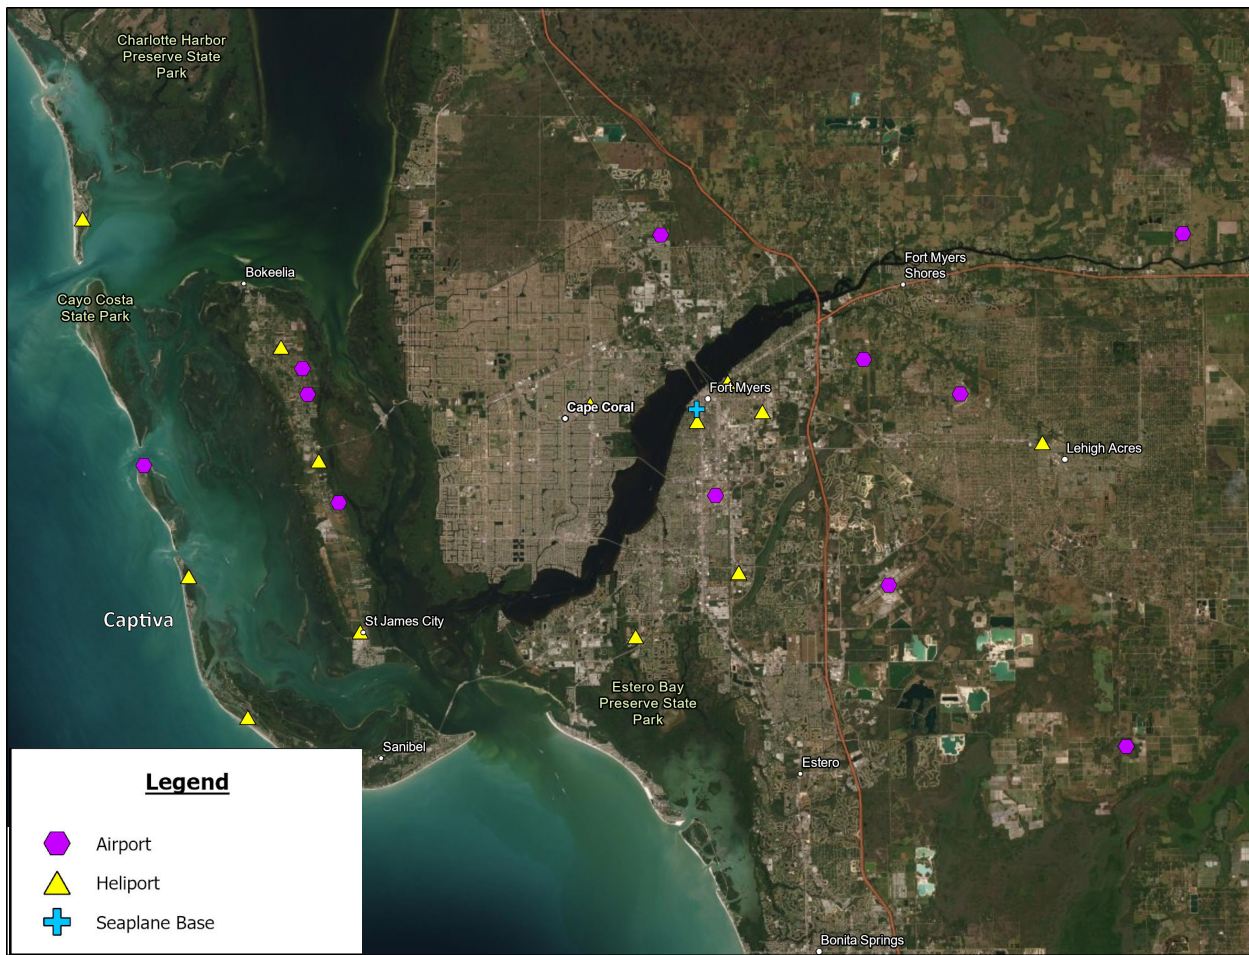
Figure 49. Lee County Airports, Ports, Bases, and Bus Terminals

While there are no airports, ports, or seaplane bases located on Captiva, the nearest facilities were mapped (Figure 49). There are no bus terminals or routes on Captiva either. Table 15 depicts the names of these facilities and the distance to them from Captiva.

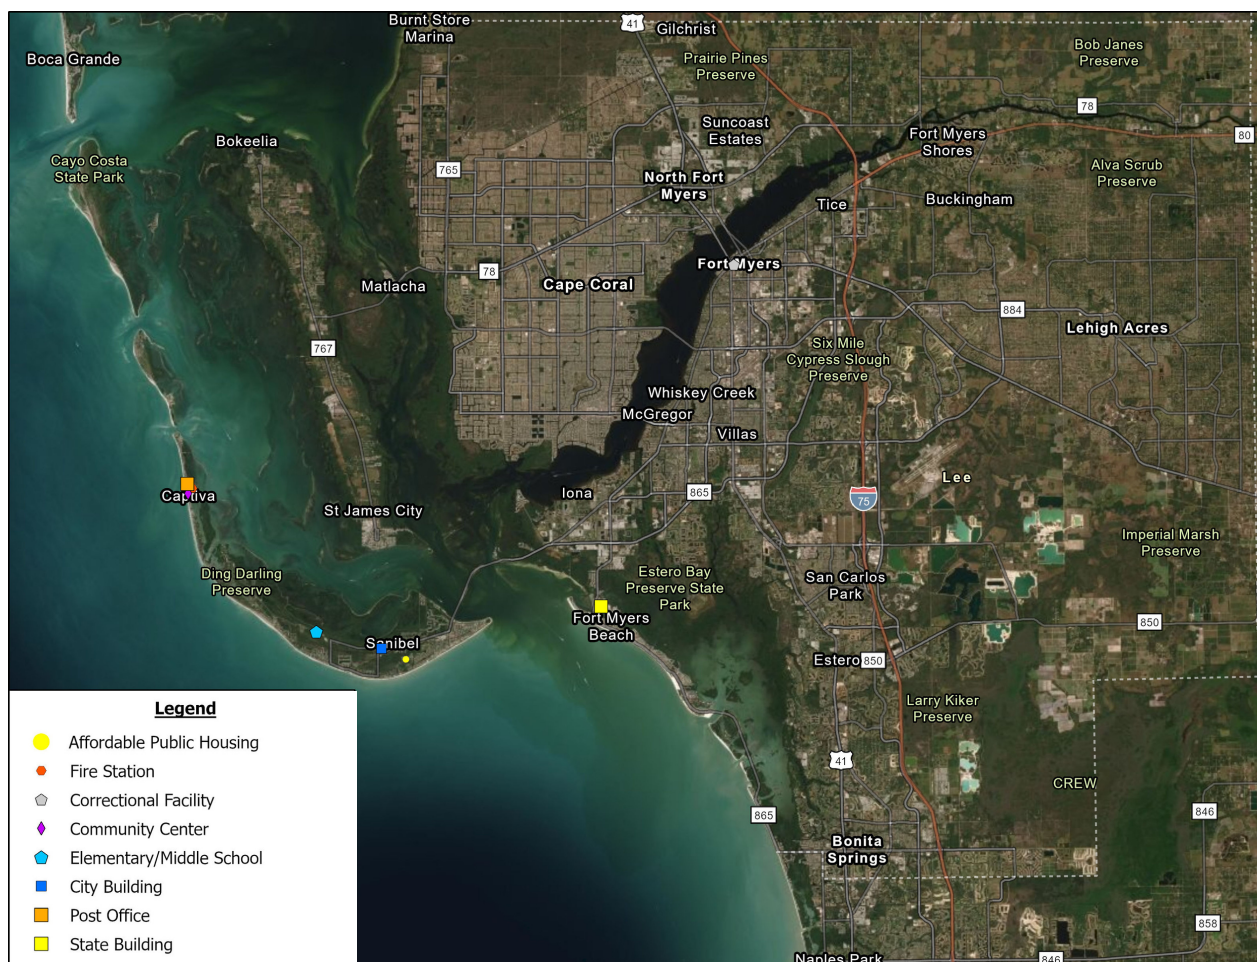
Figure 50. Off Island Critical Community Facilities Map

Critical community facilities are those facilities that are vital to the community's functioning, safety, and health. For the island of Captiva, critical facilities include schools, community centers, fire stations, law enforcements facilities, correctional facilities, local and state government facilities, healthcare facilities and hospitals. Point data for the nearest critical facilities were obtained and utilized for this analysis. As is evident in **Figure 50**, while some critical facilities serving Captiva are located on the island, many are located outside of the CEPD boundary. These facilities within the larger area of Lee County were still included within this analysis as they are critical to the functioning and wellbeing of the CEPD community and any risk of inundation and potential disturbance to these facilities would impact the lives of the CEPD residents dependent on them.

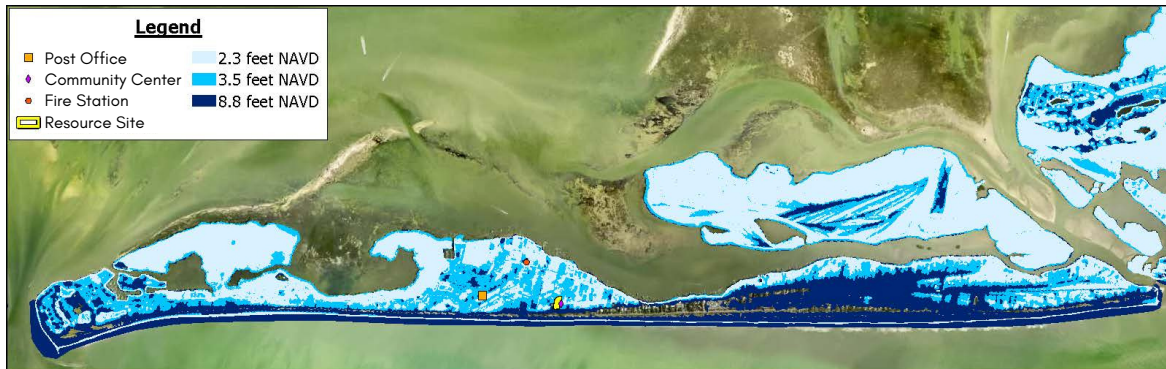
Figure 51. On Island Critical Community Facilities Map

In summary, point data for the closest critical facilities to CEPD were analyzed for initial inundation impact under the three inundation tipping point scenarios. One community center (Captiva Civic Association, Inc), one fire station (Captiva Fire Station #181), one federal government facility (U S. Postal Service Captiva), and one local law enforcement building are located on the island of Captiva and serve the island's community (**Figure 51**).

2022 LiDAR data associated with Hurricane Ian was utilized to approximate elevations and inundation depths for these four assets, as the 2017 LIDAR used for all other assets within this report did not account for building construction and elevation increases of these four buildings that occurred after 2017. Flooding is not anticipated for the four critical community assets under current extreme tidal flooding conditions (2.3 feet NAVD) (**Table 16**). Under 2040 tidal flooding conditions (3.5 feet NAVD), the resource site is anticipated to experience nuisance flooding. Captiva's Post Office proves to not be vulnerable to flooding, even under 8.8 feet NAVD. Under this flood scenario, the fire station, community center, and resources site are expected to experience impactful flooding with an average depth of 3.2 feet NAVD, 4.6 feet, and 5.5 feet NAVD, respectively.

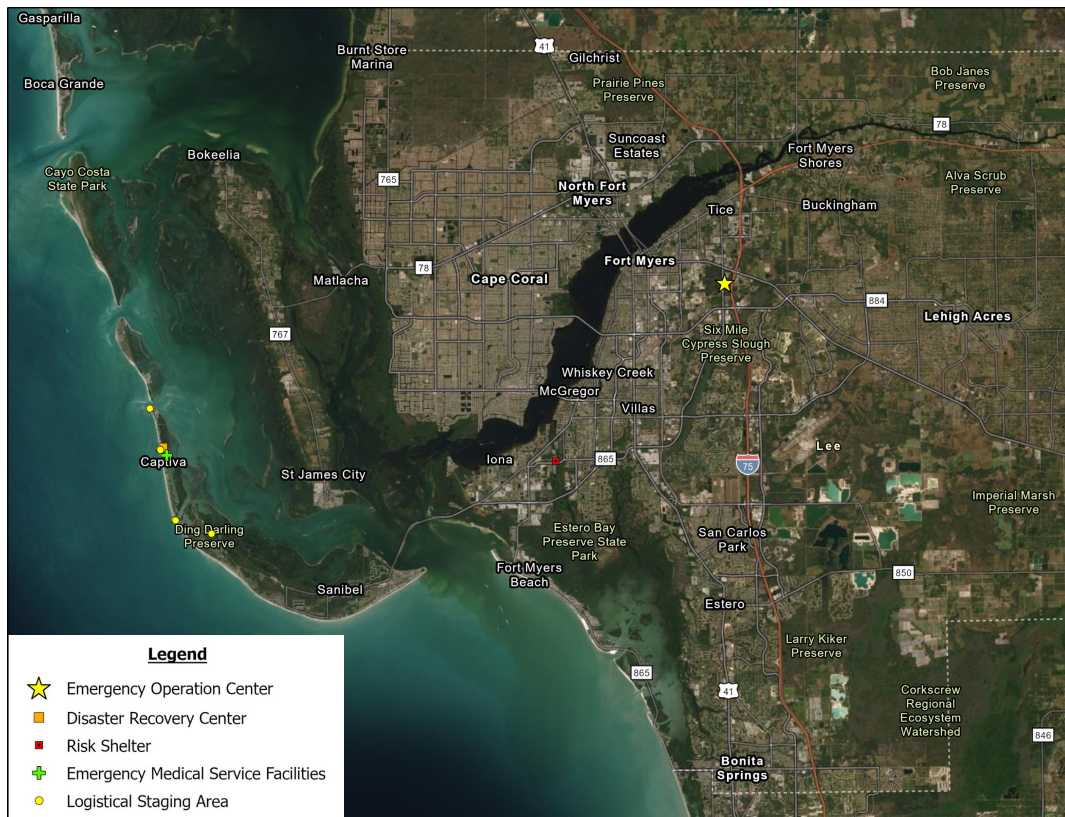
Figure 52. Off Island Emergency Facilities Map

Emergency facilities included in this assessment consist of three facilities on Captiva and two outside of Captiva, displayed in **Figure 52**. These facilities can be critical to the safety and survival of residents during and after a hazard or disaster.

The emergency medical service facility, disaster recovery center, and logistical staging area are located on the island of Captiva (**Figure 52**). The local fire station (Captiva Fire Station #18) mentioned previously serves as the local emergency medical service facility and will respond to emergency calls on the island of Captiva. The results of the fire station inundation analysis were reviewed in the previous section.

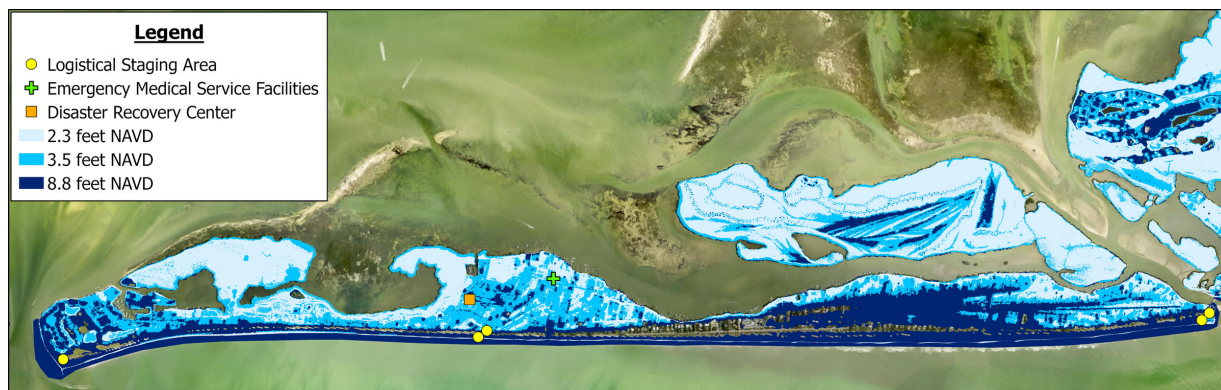
Figure 53. On Island Emergency Facilities Map

However, according to the 3.5 feet NAVD and 8.8 feet NAVD water level elevations, Chadwick’s is likely to experience impactful inundation at an average depth of 2.8 and 5.8 feet, respectively. This degree of flooding has the potential to make the DCR inoperable, which would prohibit residents from receiving the aid and assistance needed. The logistical staging areas along Captiva are predicted to experience nuisance flooding under 2.3 feet NAVD (with an average depth of 0.6 feet) and under 3.5 feet NAVD (with an average depth of 0.1 feet). While the 3.5 feet NAVD scenario represents a higher water level elevation, the type of flooding impacts the direction and introduction of water to the area, and when averaged across multiple parcels, the average can sometimes be reduced. Inundation depths for the individual Staging Areas can be reviewed in Appendix VI. **Table 18** summarizes inundation depths and **Figure 53** represents the spatial impacts to the facilities under the three inundation scenarios.

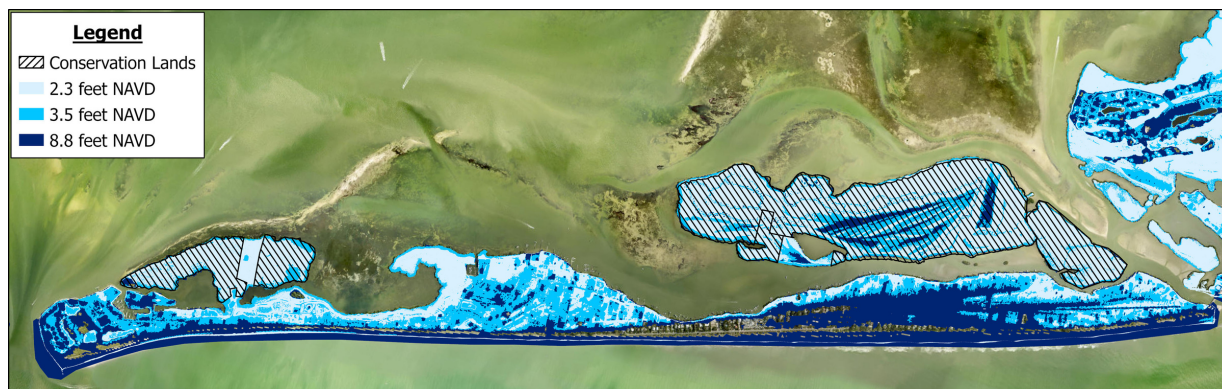
Figure 54. Conservation Land Inundation Map for Inundation Tipping Point Scenarios

While not necessarily critical to the survival or basic functionality of the island, the natural and cultural and historical resources on Captiva prove to be essential to the island's integrity and identity. The natural resources considered in this report include conservation lands, parks, and wetlands. Conservation land data was downloaded from the Florida Natural Areas Inventory and was analyzed for impact and average depth over the entire areas. In general, the acreage of conservation lands inundated for each flood scenario remains rather constant across all flood scenarios, increasing by only four acres from the 0.3 feet NAVD water level elevation to the 11.1 feet NAVD water level elevation. It is important to note that the results of this analysis and the subsequent analysis of mangrove inundation represent some degree of overlap. **Figure 54** depicts the locations of conservation lands across the Island of Captiva. While Buck Key was not factored into the calculation of inundation acreage of conservation land, it is identified within **Figure 54**, as it plays a role in storm surge and wave protection for Captiva Island.

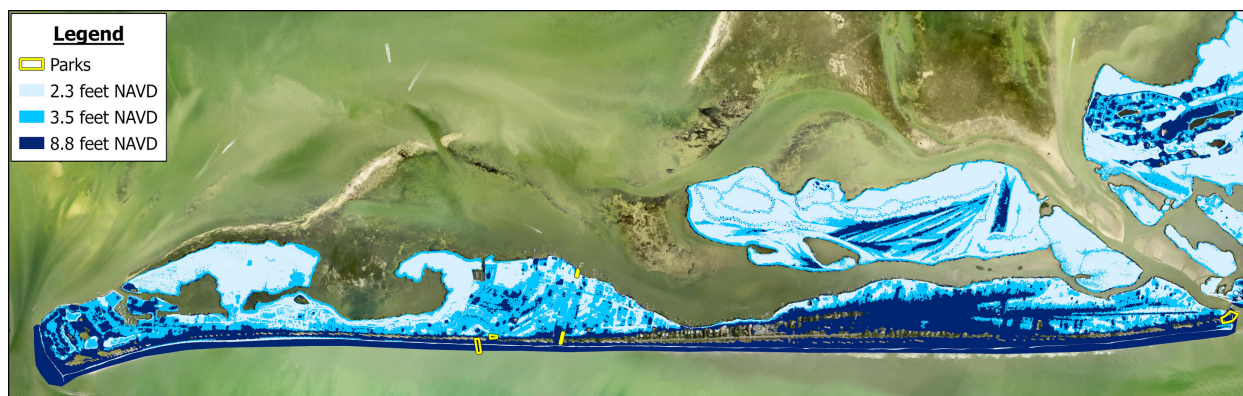
Figure 55. Park Inundation Map for Inundation Tipping Point Scenarios

County parks, preserves, zoned parks, and beach access areas related to greenspace, totaling 2.4 acres, were included in the following analysis as they are mostly all managed by CEPD. **Figure 55** depicts projected inundation impacts for all parks along Captiva Island under the inundation tipping point scenarios. Park inundation does not prove to be a major anticipated threat under 2.3 feet NAVD (Inundation Tipping Point 1), which estimates that only 8% of parks will experience

flooding with an average depth of 0.7 feet. The predicted average inundation depth is the same under 3.5 feet NAVD (Inundation Tipping Point 2), with only 12% of parks inundated. As was the case with the conservation lands and wetlands, under 8.8 feet NAVD (Inundation Tipping Point 3), 100% of all parks will experience flooding (average depth: 6.5 feet).

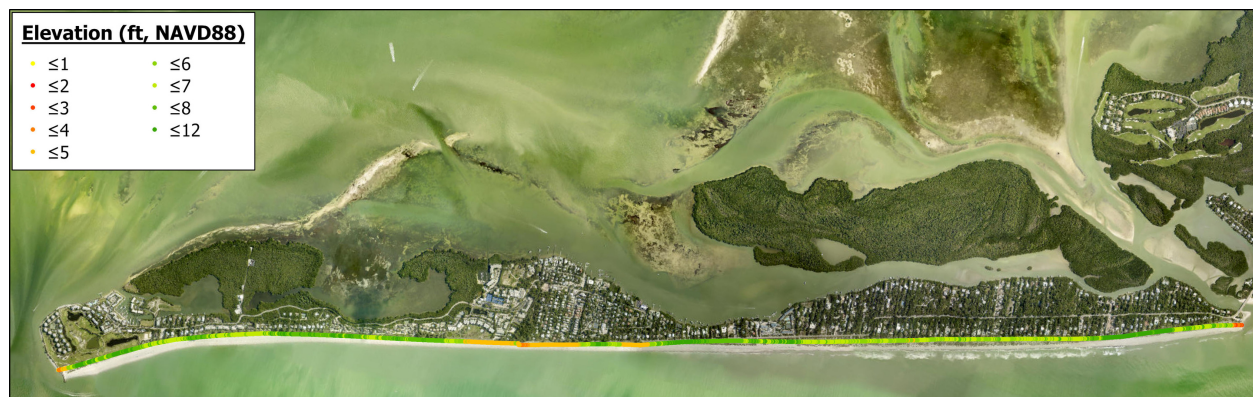
Figure 56. Shoreline Elevation Map.

To determine estimated gulf-front shoreline inundation, the 1982 and 1983 Erosion Control Lines (ECL) were assessed under the relevant inundation scenarios. The ECLs cover the island's beach front running from the groin at South Seas to the groin at Turner Beach. Beach profiles were not utilized to estimate inundation. **Figure 56** highlights the elevation of Captiva's shoreline.

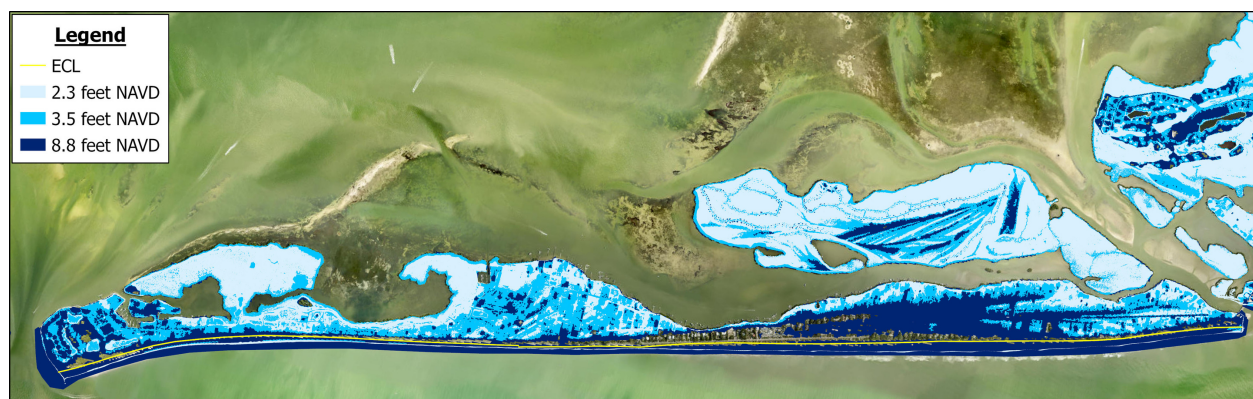
Figure 57. Shoreline Inundation Map for Inundation Tipping Point Scenarios.

Captiva Island possesses 25,823 linear feet of gulf-front shoreline and under 2.3 feet NAVD (Inundation Tipping Point 1), 0% of the shoreline will experience inundation. The degree of shoreline inundation increases to only 1% according to the 3.5 feet NAVD water level elevation (Inundation Tipping Point 2). Gulf-front shoreline inundation increases drastically under the 8.8 feet NAVD water level elevation (Inundation Tipping Point 3), which anticipates that 60% of shorelines will be impacted by flooding (**Figure 57**).

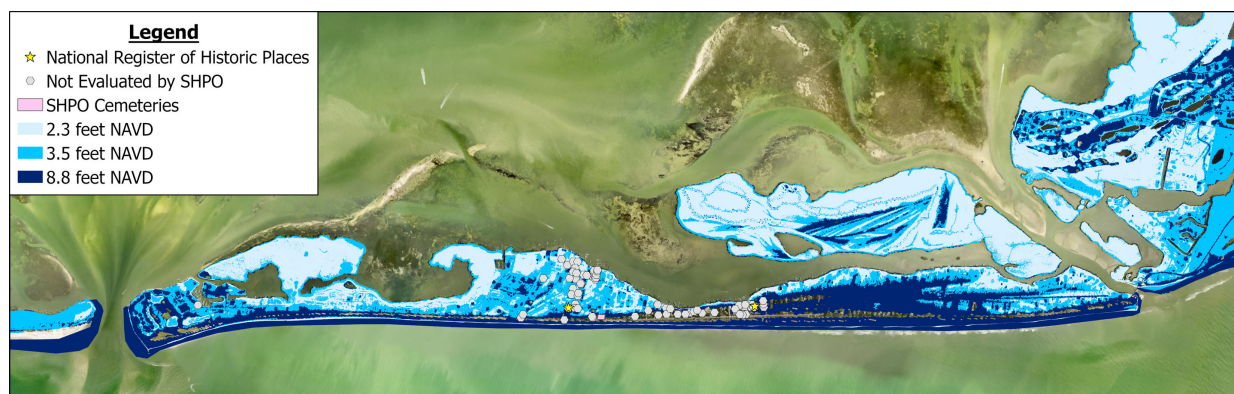
Figure 58. Historical and Cultural Assets Inundation Map for Inundation Tipping Point Scenarios

Historic and cultural facility data are logged and maintained at the state level by the Florida's State Historic Preservation Offices (SHPO) of the Florida Bureau of Historic Preservation (BHP). Nationally, facilities are tracked by the National Park Service (NPS) who compile the National Register of Historic Places (NRHP). The NRHP is the official list of properties and areas recognized as historical and nationally preserved, two of which are located within Captiva Island (the Tween Waters Inn Historic District and the Chapel-by-the-Sea Historic District). **Figure 58** depicts the general locations of these historic districts, indicated by stars on the map. An additional 73 properties have been identified by the SHPO as potential historical and cultural sites, labeled on **Figure 58** as "Not Evaluated by SHPO".

When assessing the NRHP districts and the SHPO potential historical places for predicted inundation, 21% are likely to experience flooding under Inundation Tipping Point 1, 45% are likely to experience flooding under Inundation Tipping Point 2, and 69% are likely to experience flooding under Inundation Tipping Point 3.
